## PLANNING APPLICATION FORM

Application Number PA2025301 Assess No: A7379

This report has been prepared in accordance with the **Practice Note Guidelines for Landslide Risk Management 2007** and the **Tasmanian Planning Scheme – State Planning Provisions C15.0 Landslip Hazard Code**.

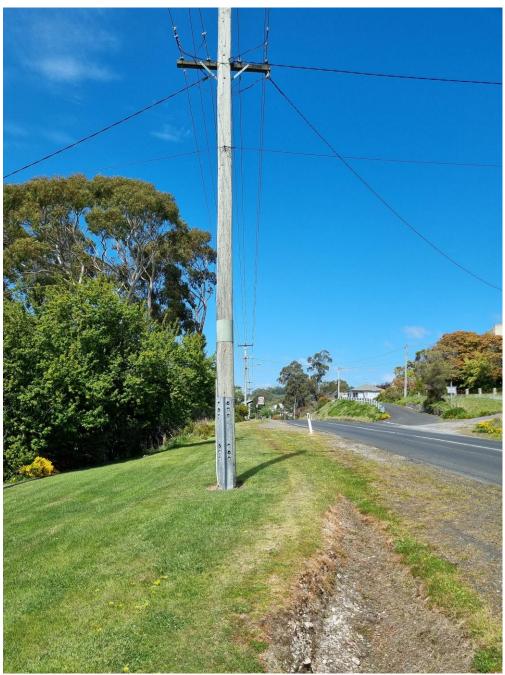
## Flinders Street frontage: 166 Flinders Street

The surface of Flinders Street appears to be in good condition. There is a power pole west of the house, which has been reinforced on two sides and has a slight downhill lean. There is a surface drain downslope of Flinders Street which captures runoff from the road. This flows north, and underneath the driveway in a culvert before continuing in an open drain north of the site and eventually discharging onto the foreshore.

Date & Time	16 Oct 2025 11:51
Coordinates	No coordinates
Description	Power pole
Comments	Reinforced on two sides, slight downhill lean

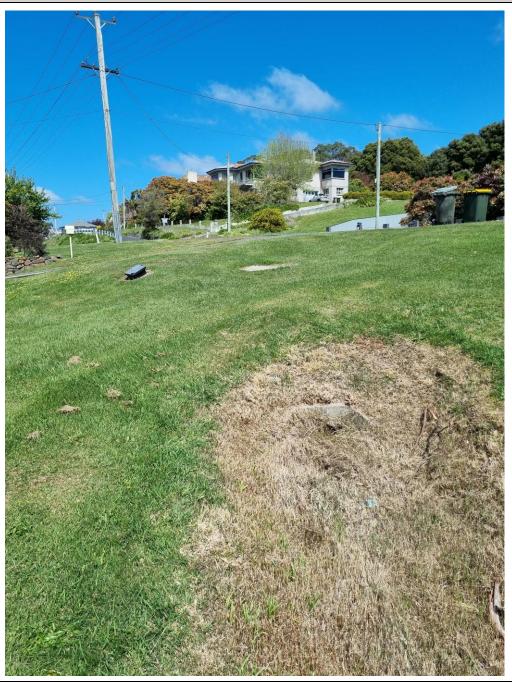
## Flinders Street frontage : 166 Flinders Street

Date & Time	16 Oct 2025 11:55
Coordinates	485086mE, 5444269mN
Description	Culvert and stormwater lid
Comments	Drain overgrown, moist in base

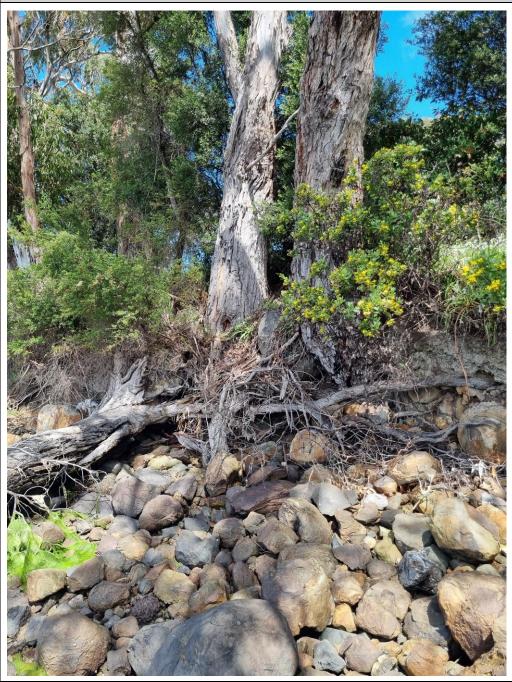
Date & Time	16 Oct 2025 12:09
Coordinates	No coordinates
Description	Undercutting tree roots and fallen trees where revetment is absent/collapsed
Comments	None

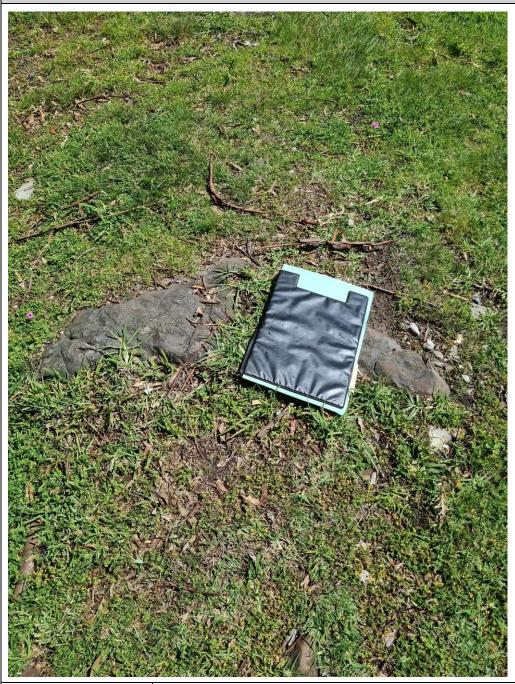
#### South of house: 166 Flinders Street

Date & Time	16 Oct 2025 12:21
Coordinates	485032mE, 5444141mN
Description	Boulders in lawn, south of house
Comments	Talus

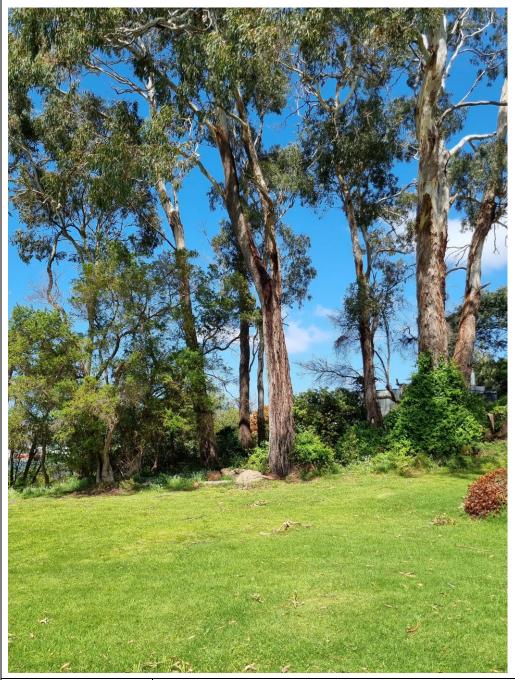
## Southern boundary: 166 Flinders Street

Surrounding the house the site is generally vegetated with grass (lawn), with scattered trees, particularly near the southern boundary. The trees do not exhibit bent trunks or leans which may be associated with landslide movement. There is a groundwater spring in the south-western corner of the site, at the base of the embankment below Flinders Street. There is a poorly defined drainage path across the lawn at the rear of the carport, where the groundwater seepage flows towards the east, and the surface soils are moist in this area. There is also an area of moist surface soil near the south-eastern corner of the hardstand, without an apparent source. There are occasional basalt cobbles or boulders in the soil in the southern part of the site.

Date & Time	16 Oct 2025 12:22
Coordinates	No coordinates
Description	No consistent lean or trunk bends diagnostic of landslide
Comments	None

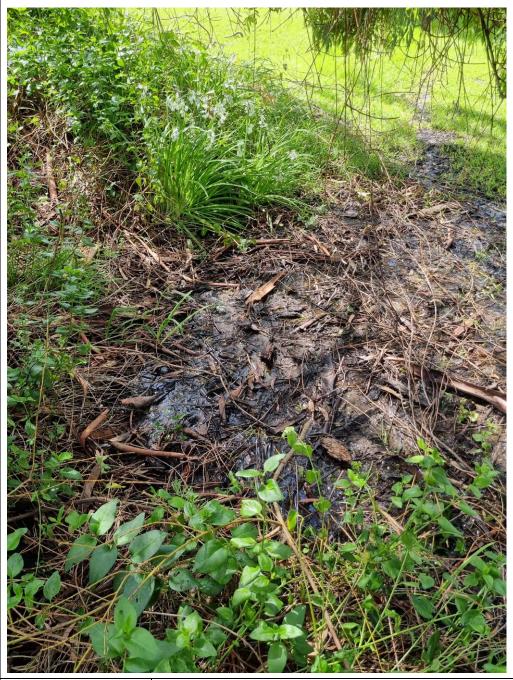
#### South West of house: 166 Flinders Street

Date & Time	16 Oct 2025 12:24
Coordinates	485124mE, 5444177mN
Description	Groundwater seepage/spring
Comments	None

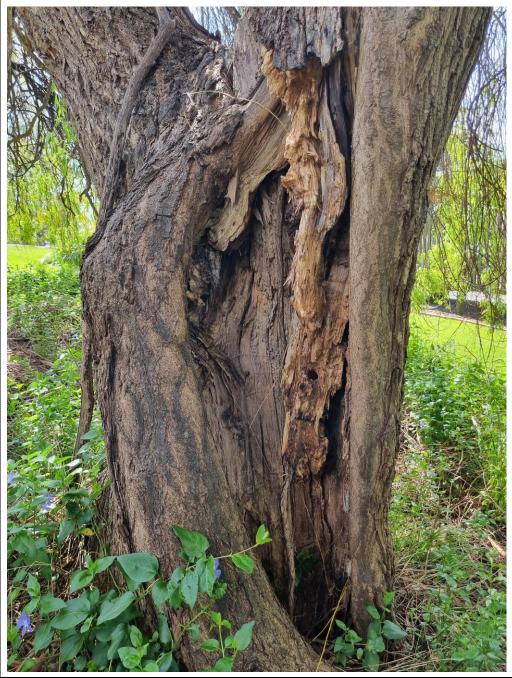
## Tree next to spring: 166 Flinders Street

Date & Time	16 Oct 2025 12:25
Coordinates	No coordinates
Description	Trunk Hollow, northern bifurcation leaning northwest(?)
Comments	Near spring

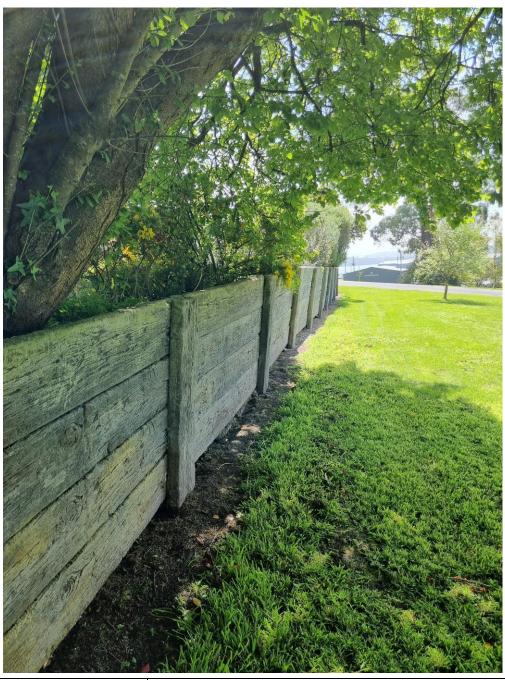
#### West of house: 166 Flinders Street

Date & Time	16 Oct 2025 12:29
Coordinates	No coordinates
Description	Retaining wall above house, leaning downslope. Concrete post and whalers.
Comments	10-12 degrees off vertical

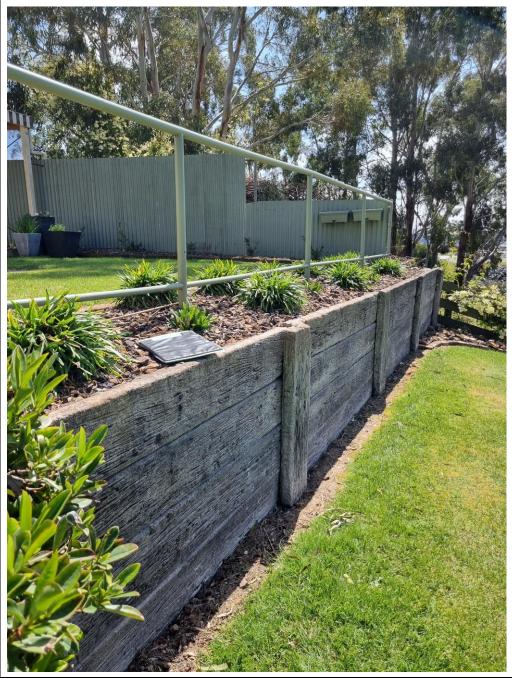
#### North Eastern corner: 166 Flinders Street

Date & Time	16 Oct 2025 12:34
Coordinates	485247mE, 5444366mN
Description	Retaining wall
Comments	Slight lean downhill, not much

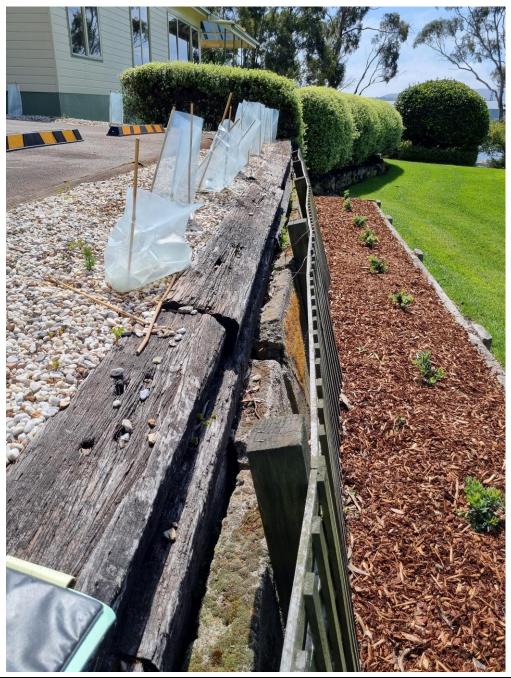
#### South east of house: 166 Flinders Street

The house and outbuildings all appear to be in good condition. The asphalt sealed driveway and hardstand surfaces are in good condition, apart from some minor cracking of the asphalt within the carport. The eastern side of the hardstand is about 1m above the natural ground level and is retained with concrete blocks and timber. Whilst the retention is clearly not engineered, it appears to be sufficient for purposes (considering the low height), and wheel stop beams prevent parking close to the retained edge.

Date & Time	16 Oct 2025 12:37
Coordinates	No coordinates
Description	Retaining for parking hardstand
Comments	Not professionally constructed, about 1m high

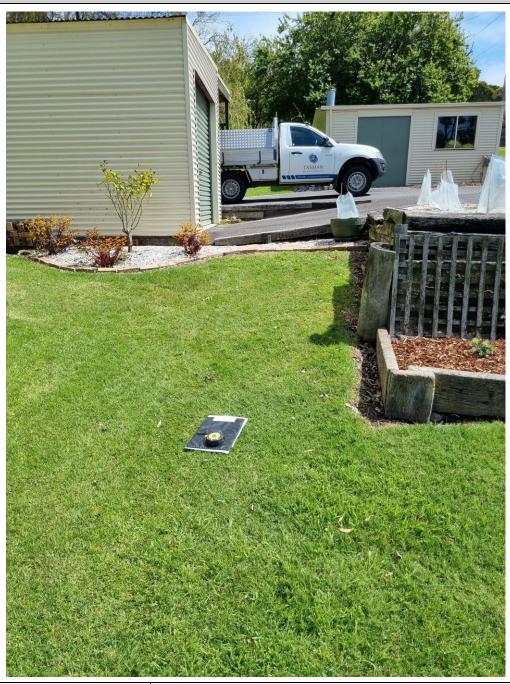
### South east of house : 166 Flinders Street

Date & Time	16 Oct 2025 12:49
Coordinates	No coordinates
Description	Surface soils moist to wet near clipboard
Comments	Source uncertain

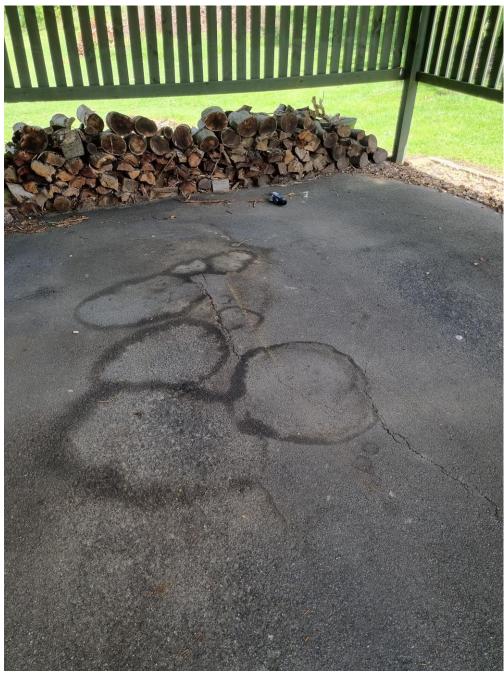
### **Carport: 166 Flinders Street**

Date & Time	16 Oct 2025 12:50	
Coordinates	No coordinates	
Description	iption Minor cracking in asphalt	
Comments	Comments In carport

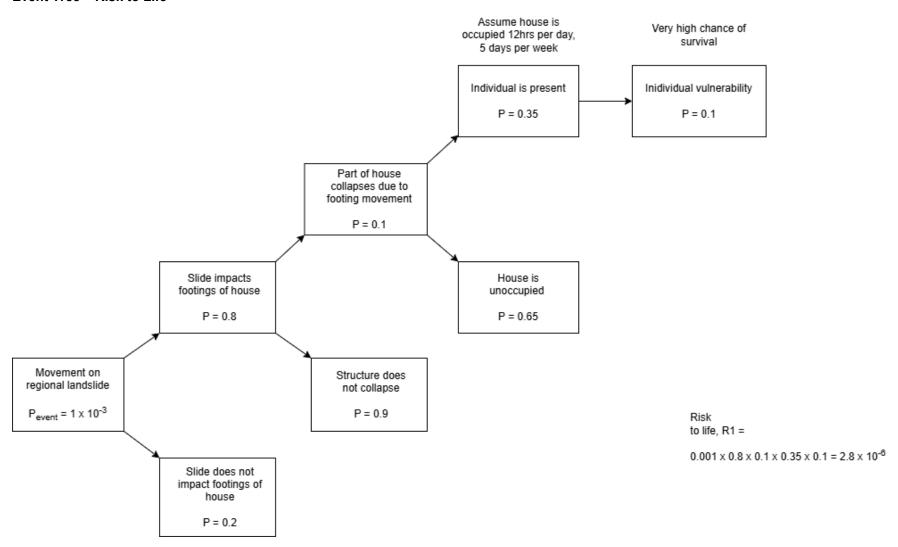
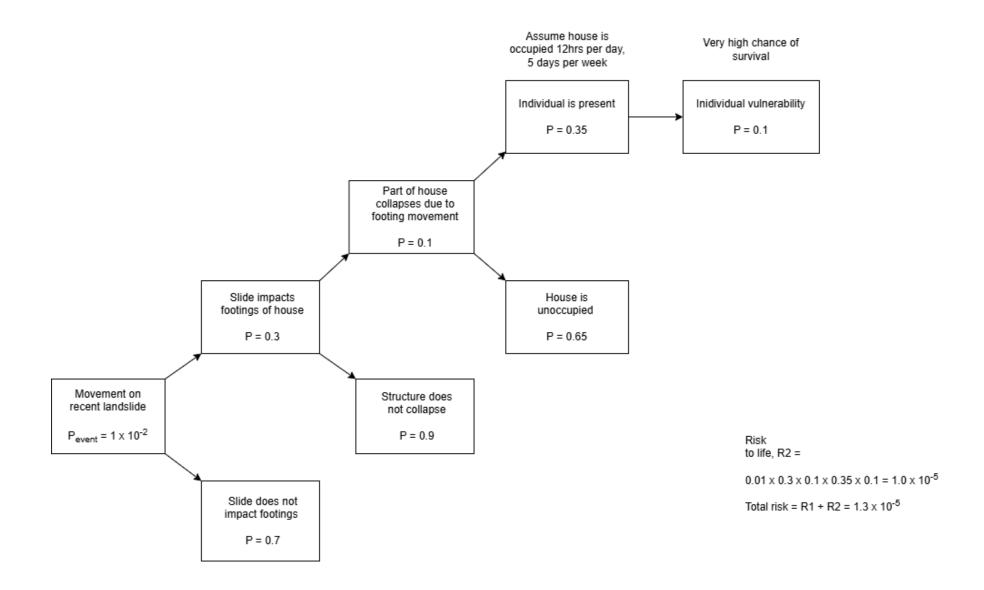
#### Event Tree - Risk to Life

An event tree showing a possible sequence of events is presented in Appendix D for the landslide hazards identified in Section 4.3. The risk assessment shows that the estimated Risk to Life is 1.3 x 10<sup>-5</sup>, lower than the adopted tolerable risk. This assumes occupancy 5 days per week, which may be an overestimate of the actual achieved occupancy across an average year.
