## PLANNING APPLICATION FORM

<b>Address</b>	420 Deviot Road, Deviot
<b>Property ID</b>	6099646
<b>Title</b>	64037/3
<b>Land Area</b>	2408m <sup>2</sup>
<b>Planning Authority</b>	West Tamar Council
<b>Proposed Use</b>	Residential
<b>Proposed Development</b>	Proposed Main Dwelling, Secondary Dwelling and Shed/Workshop & Store
<b>Zone(s)</b>	10.0 Low Density Residential
<b>Code Overlay(s)</b>	C2.0 Parking and Transport Code C7.0 Natural Assets Code C10.0 Coastal Erosion Hazard Code C11.0 Coastal Inundation Hazard Code C13.0 Bushfire-Prone Areas Code ( <i>Bushfire Hazard Report to be completed during Building Documentation stage</i> )
<b>Existing Access</b>	Vehicular access from Deviot Road
<b>Water</b>	Taswater Water Service
<b>Sewer</b>	New Onsite Wastewater Design, refer to concept design by Tasman Geotechnics
<b>Stormwater</b>	New Onsite Stormwater Design, refer to Site Stormwater Plan by Exceed Engineering

**COASTAL HAZARDS REPORT**  
**PROPOSED DEMOLITION, NEW DWELLING &**  
**ANCILLARY STRUCTURES**  
**420 DEVIOT ROAD, DEVIOT**

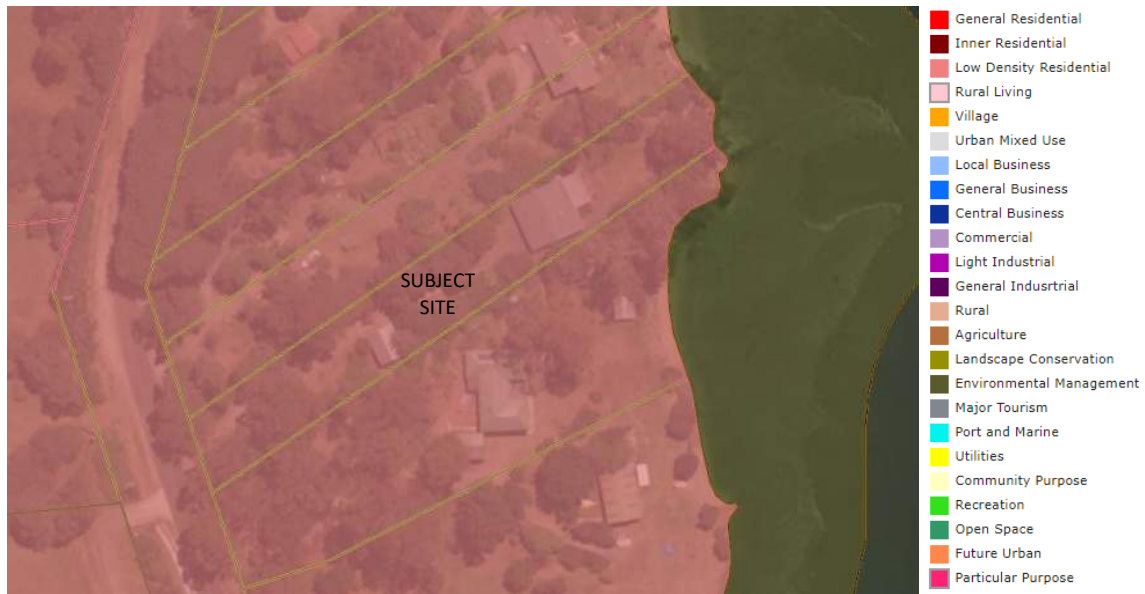
Figure 2 – Zoning of subject site (Source: LISTmap)

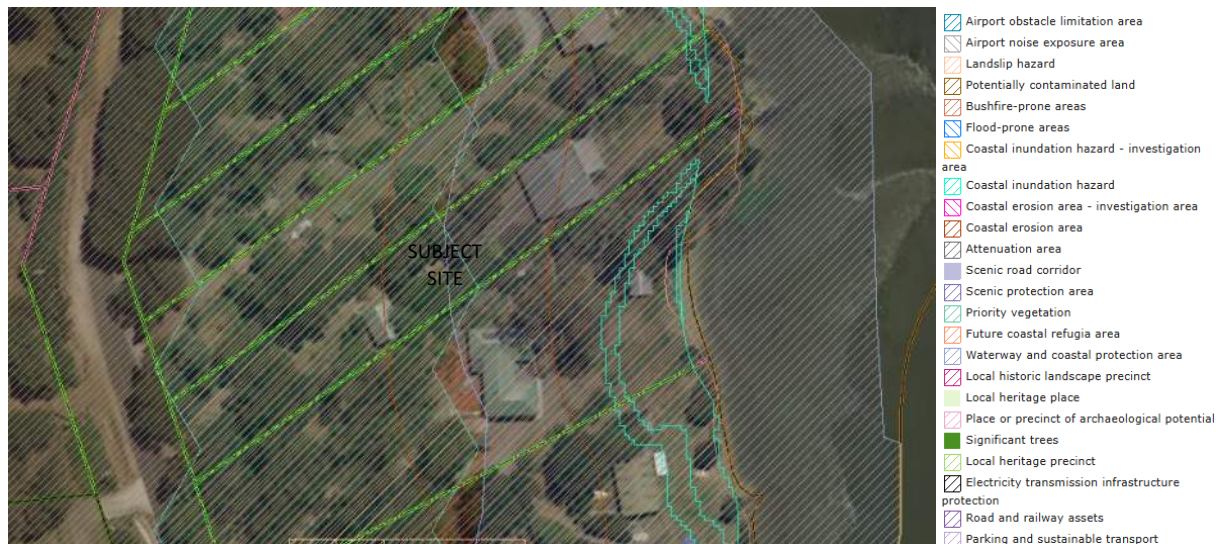
Figure 3 – Overlays of subject site (Source: LISTmap)

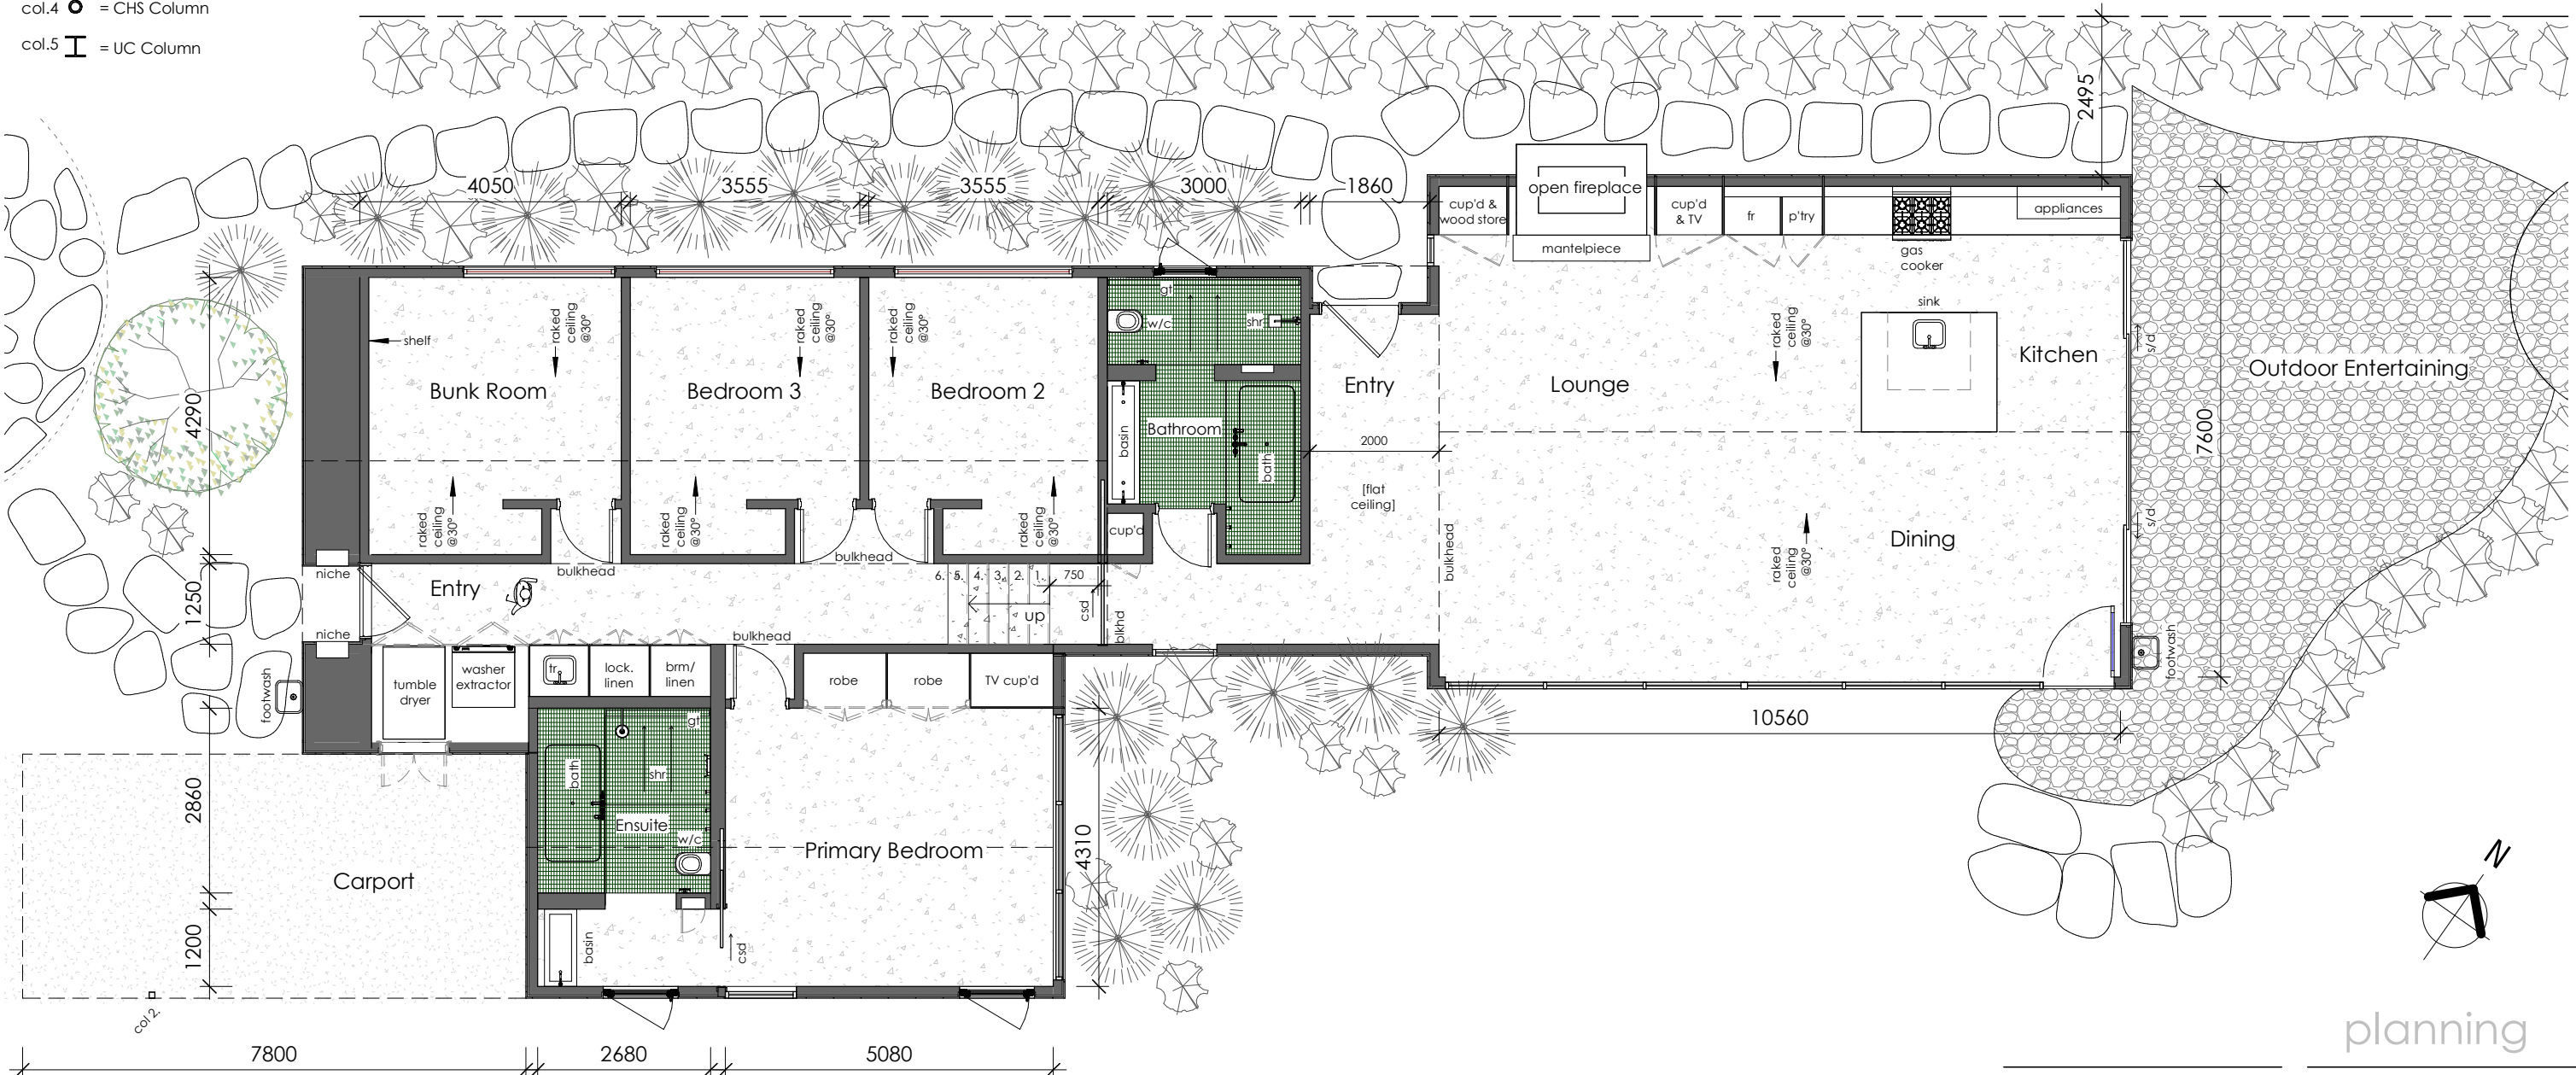
PROPOSED FLOOR PLAN

Total Floor Area	m <sup>2</sup>	sq
Boat Shed/Sauna	23.85	2.57
Main Dwelling	238.88	25.71
Main Dwelling Carport	30.95	3.33
Secondary Dwelling	39.40	4.24
Secondary Dwelling Carport	24.50	2.64
Shed/Workshop & Gym	118.33	12.74

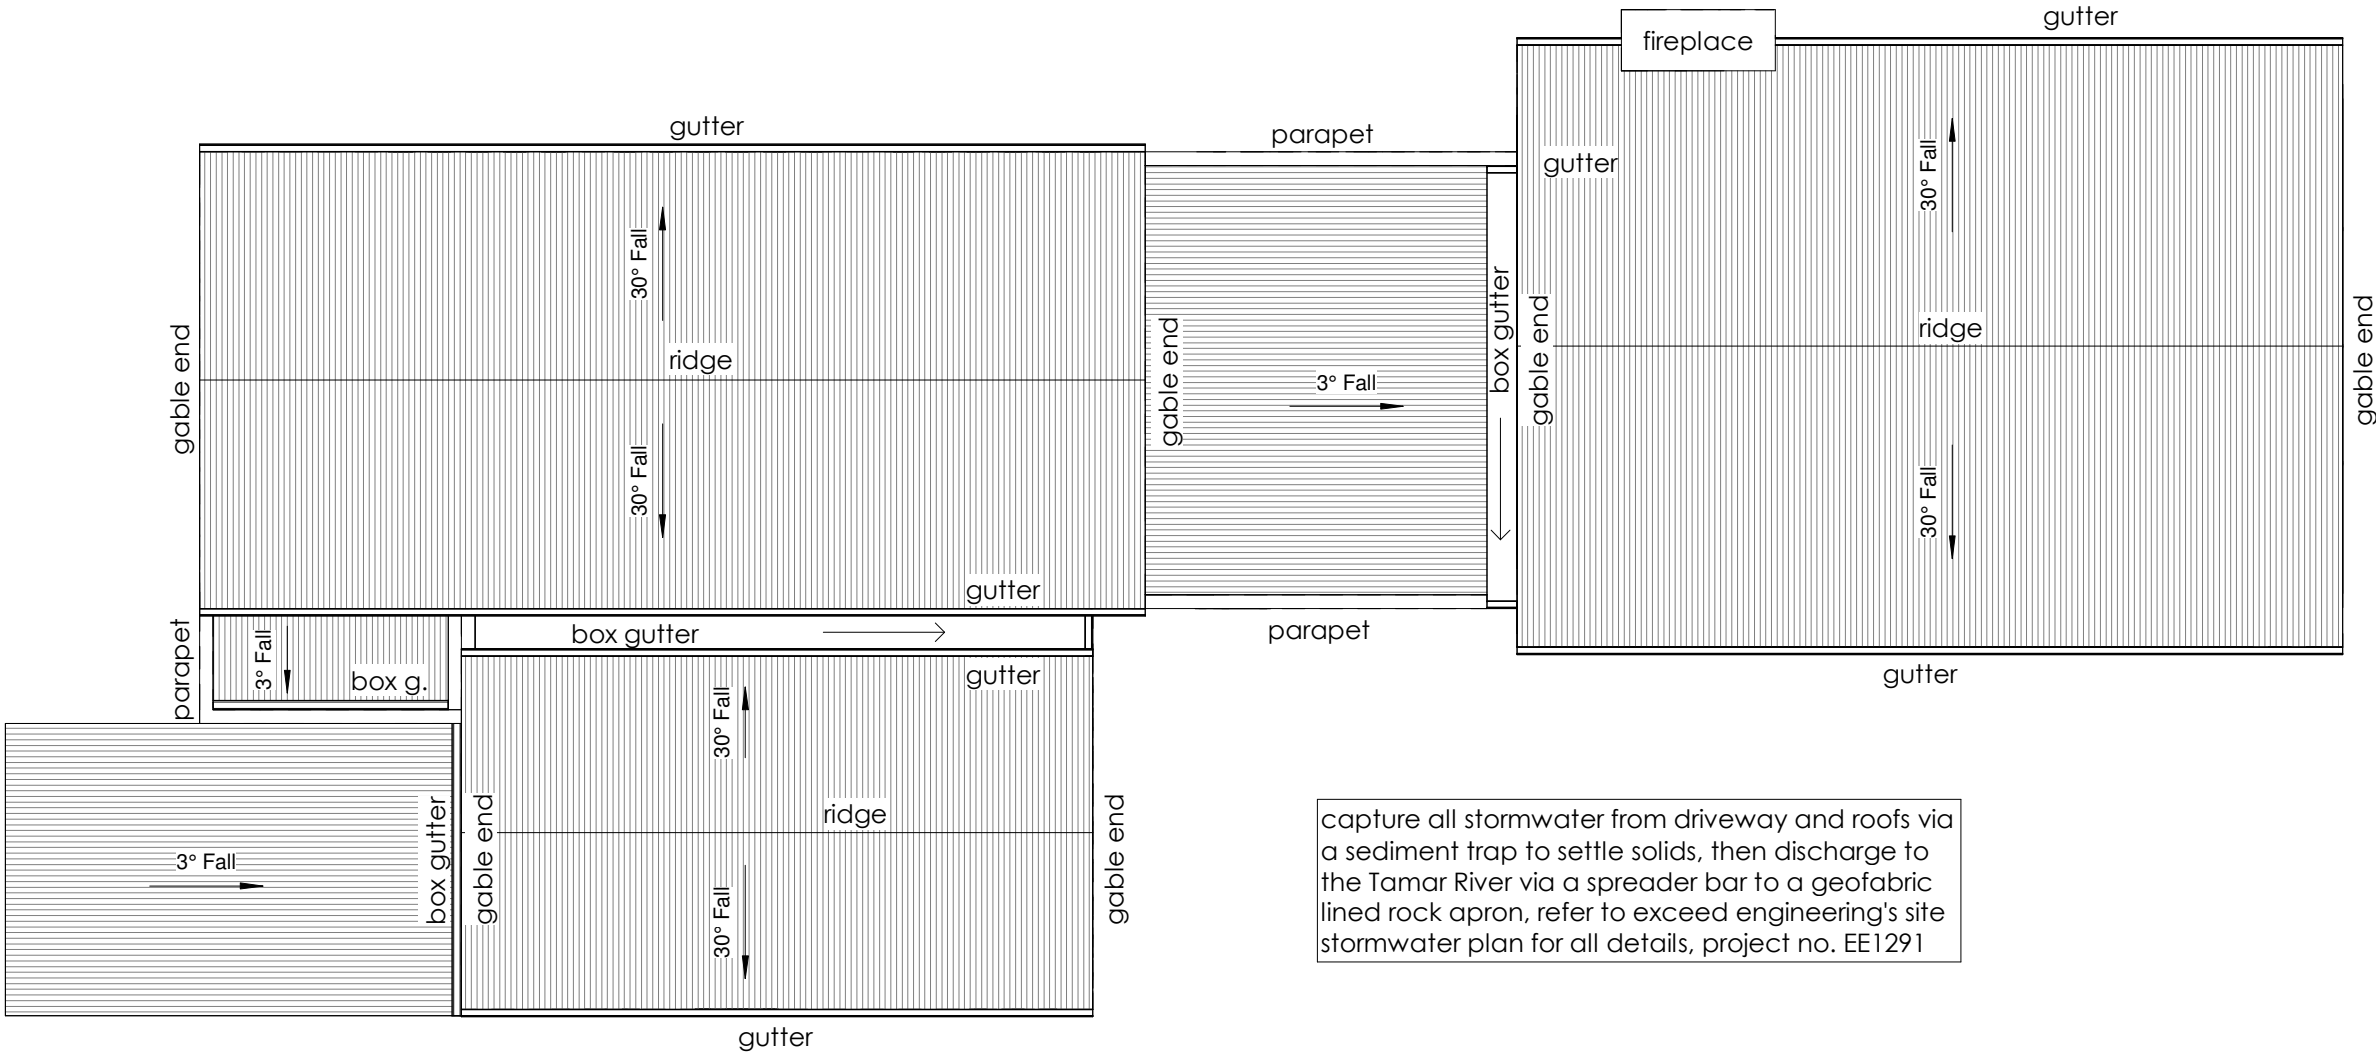
COLORBOND CLADDING FITTED TO ROOF AS PER  
AS1562.1 AND PART 7.2 OF NCC.

capture all stormwater from driveway and roofs via a sediment trap to settle solids, then discharge to the Tamar River via a spreader bar to a geofabric lined rock apron, refer to exceed engineering's site stormwater plan for all details, project no. EE1291

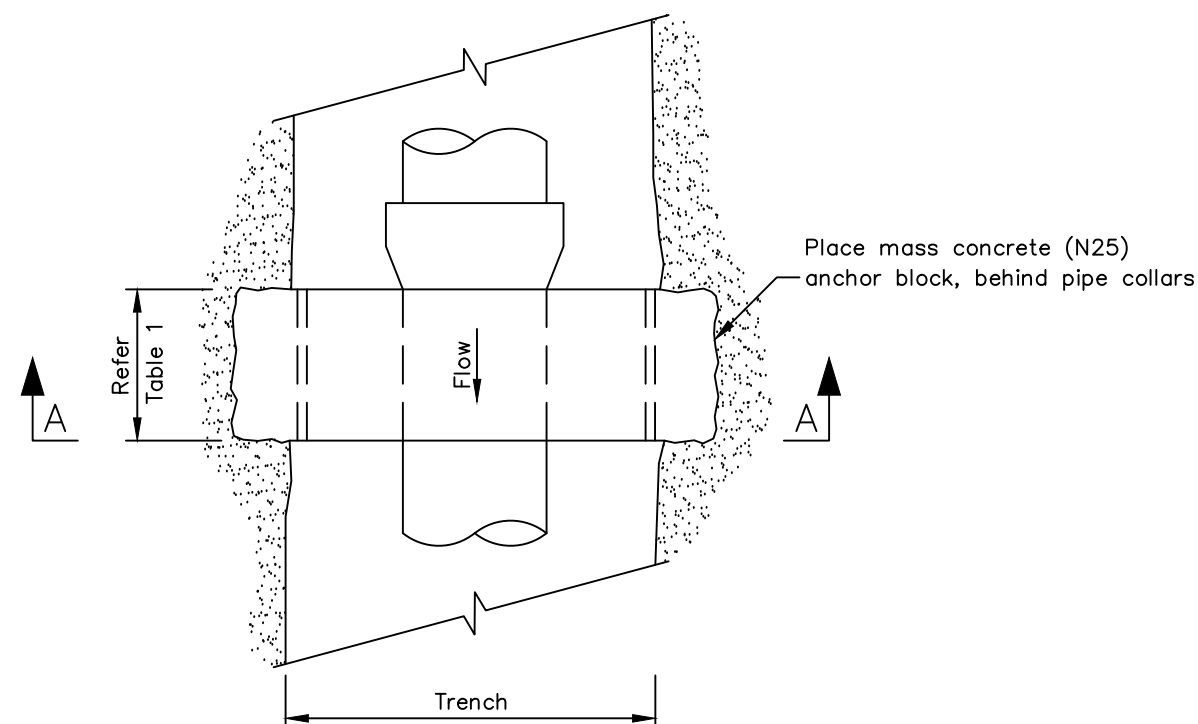
PLAN  
N.T.S.

PIPE DIAMETER	ANCHOR BLOCK WIDTH
≤ 450	Pipe diameter + 150 mm
> 450	Design required

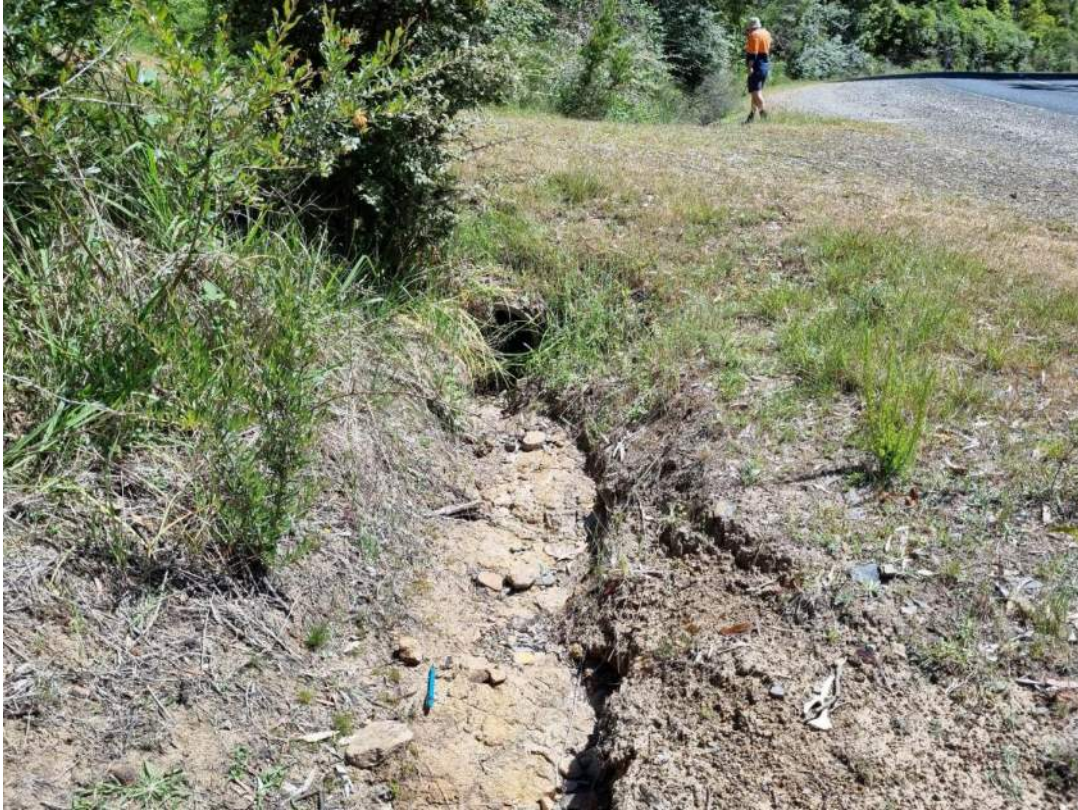
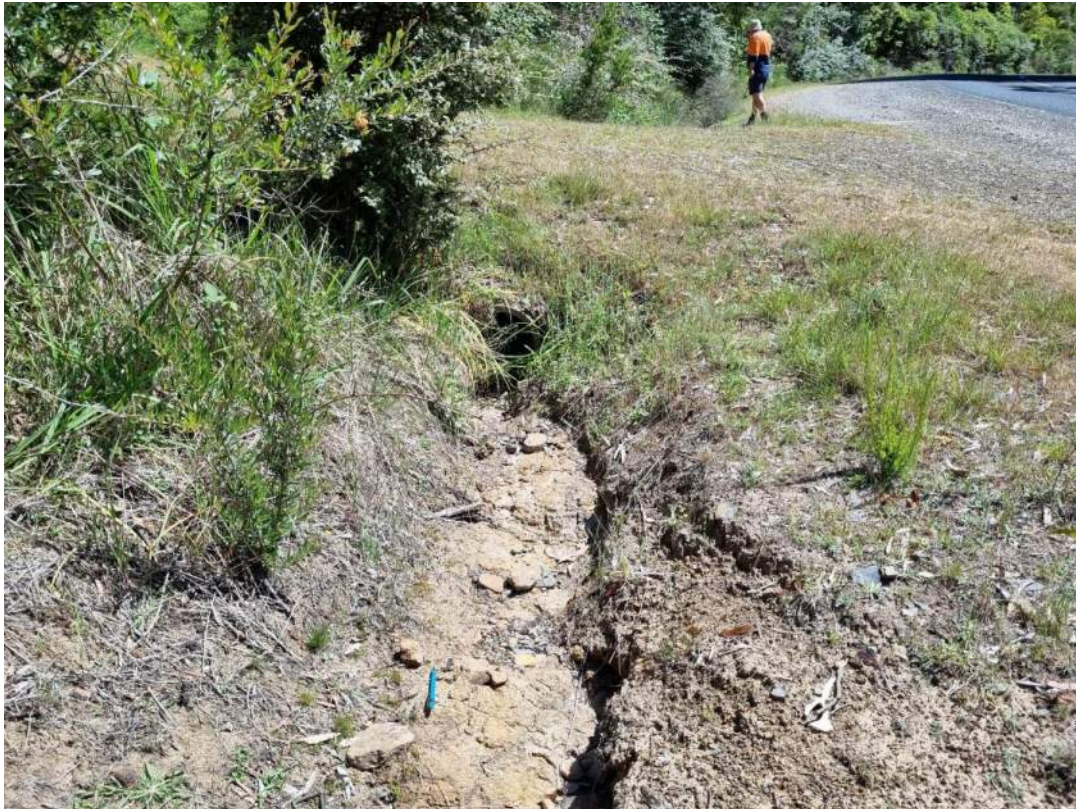
Photo 1: Dolerite bedrock exposed in drain on Deviot Road, opposite site driveway entrance, looking north-northwest.

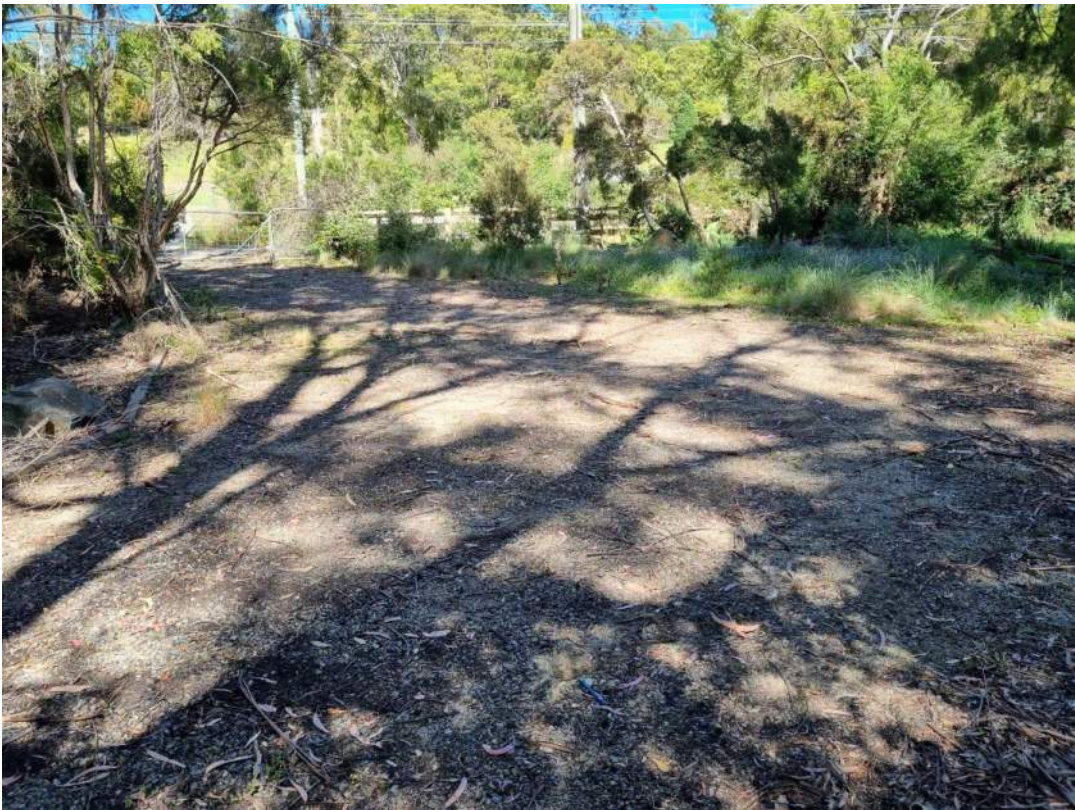
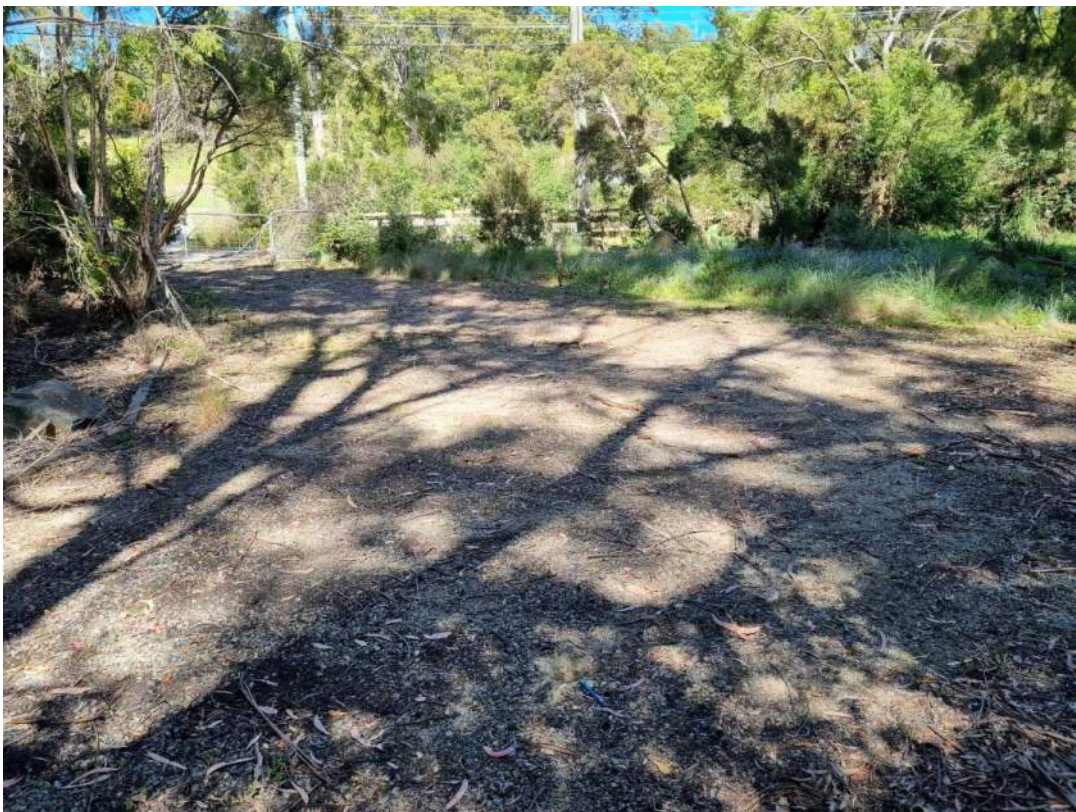
Photo 2: Borehole BH9 location (foreground) and driveway entrance to site (background), looking west.

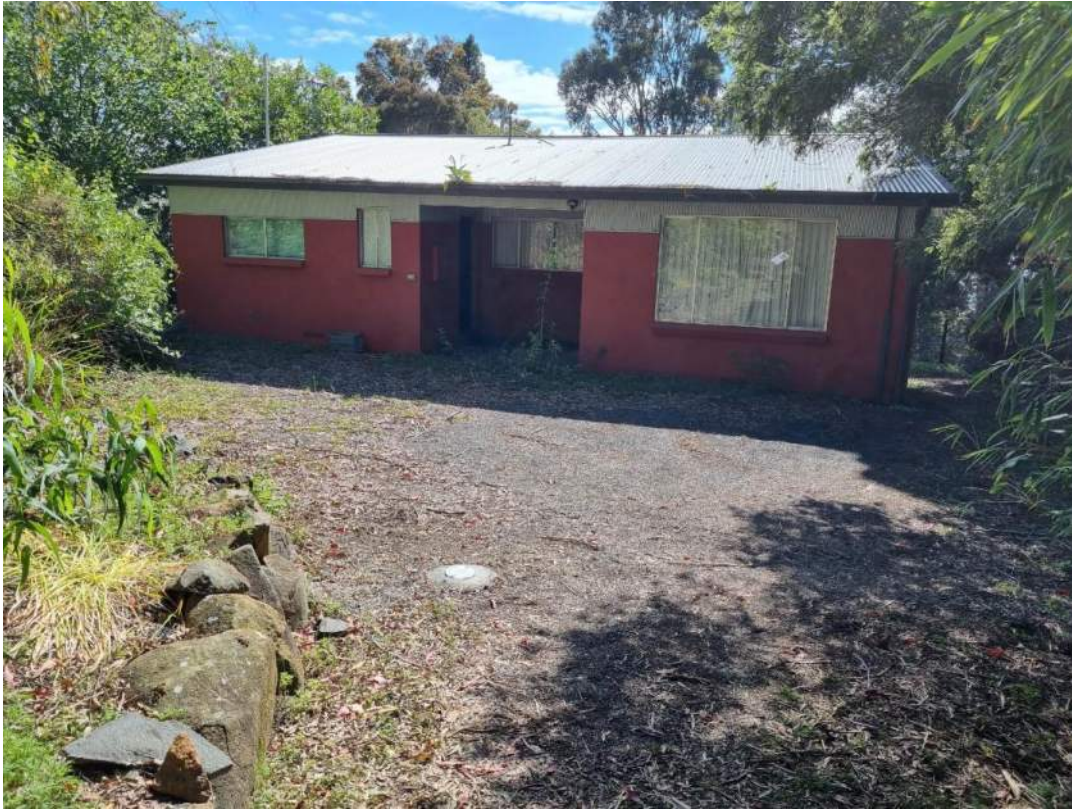
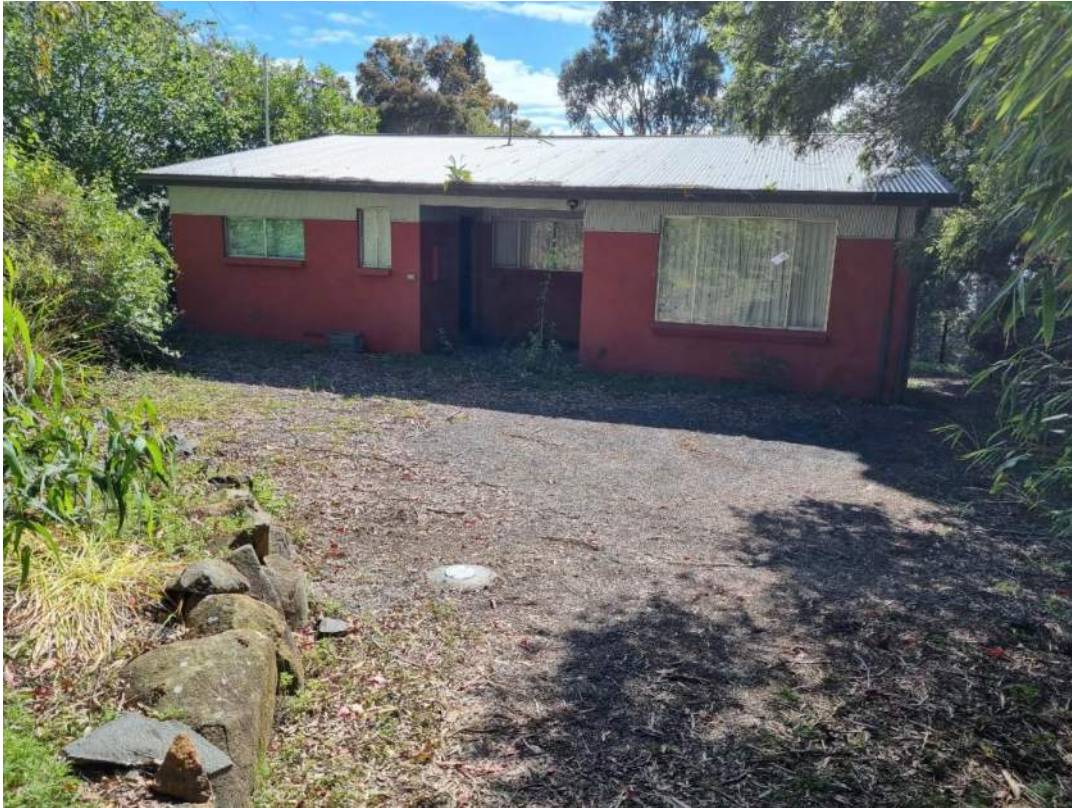
Photo 3: Existing dwelling and borehole BH5 location (water monitoring well), looking northeast.

No groundwater inflow was observed while drilling the boreholes. Groundwater monitoring wells were installed in BH5 and BH8 to 5m below ground level. The wells were dipped on 19 November 2024 (7-days after installation) and both were dry.

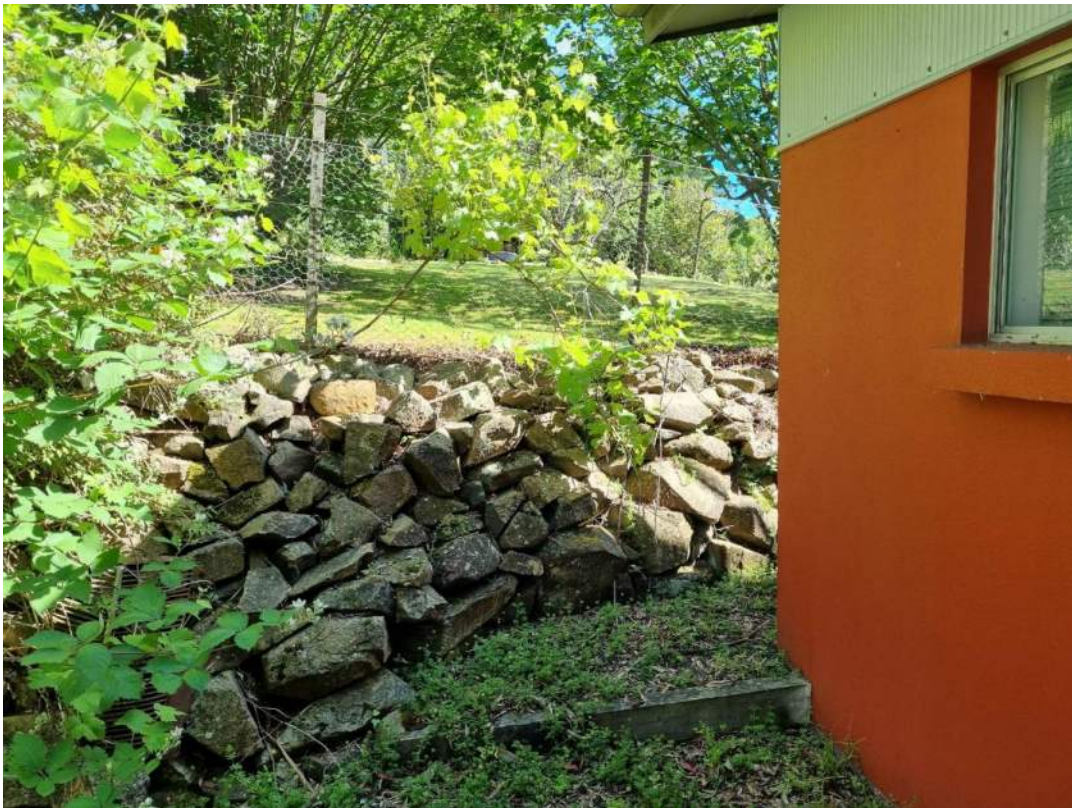
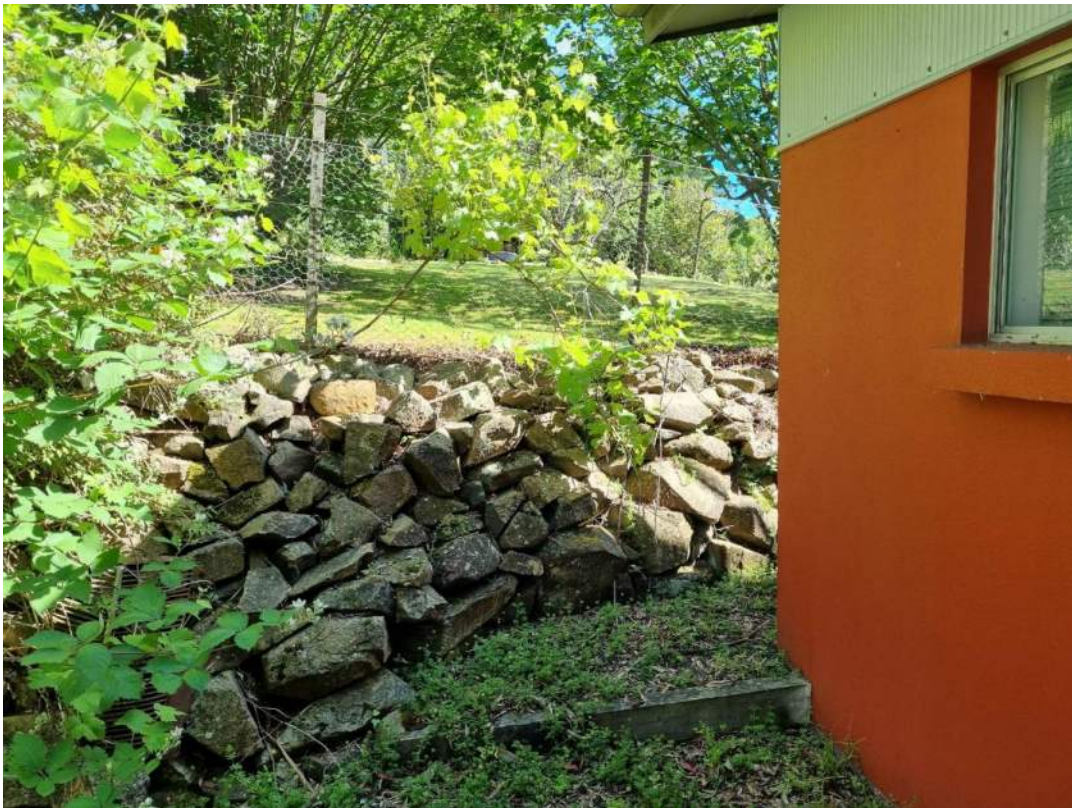
Photo 4: Dry-stacked dolerite boulder retaining wall adjacent to existing dwelling, looking north.

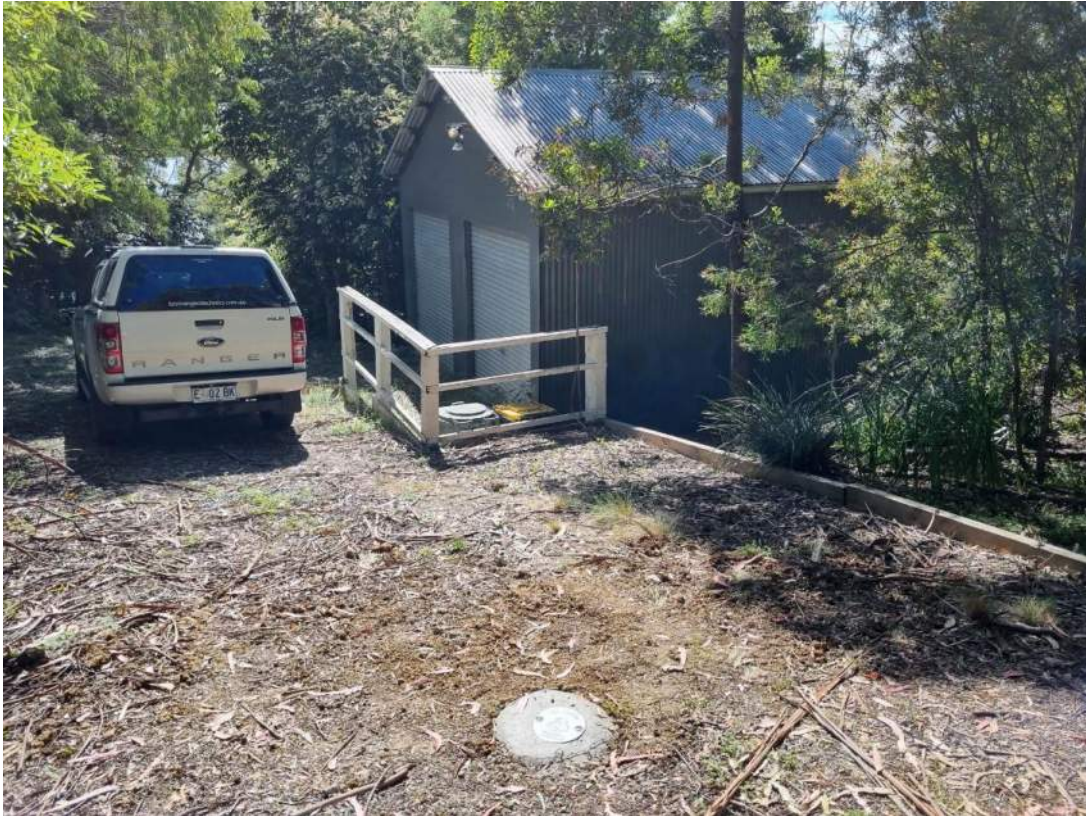
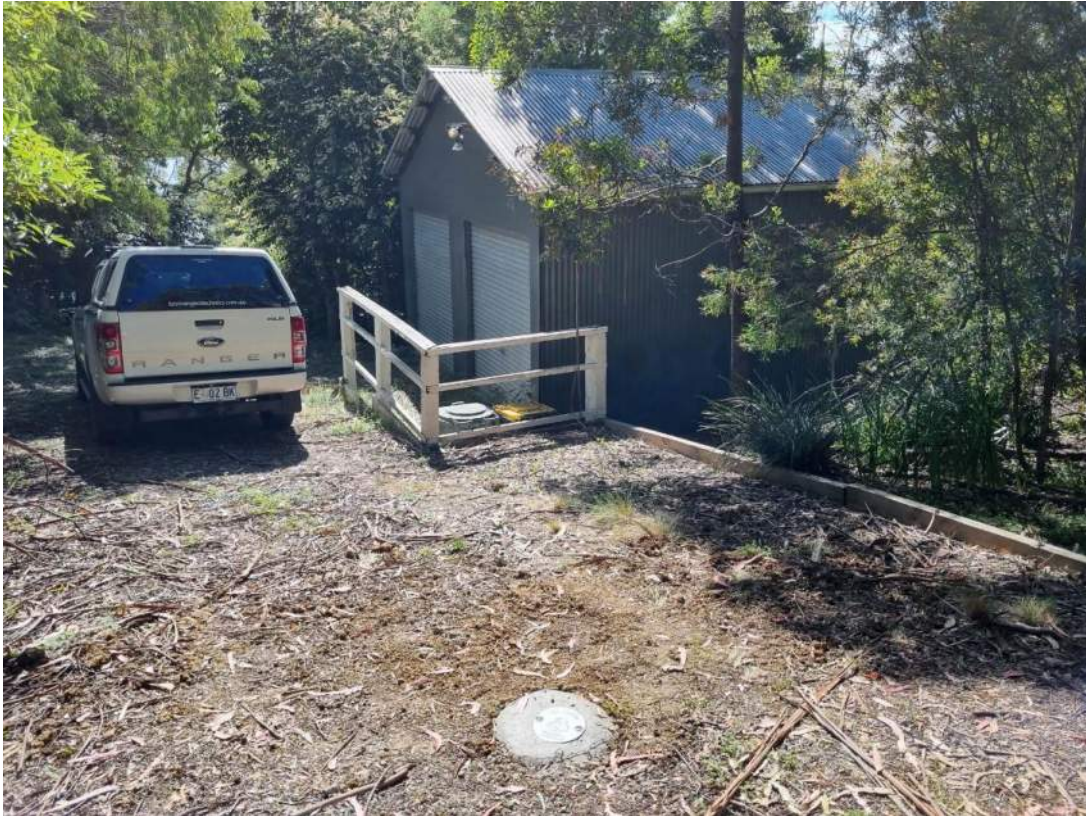
Photo 5: Existing shed and borehole BH8 (water monitoring well), looking east.

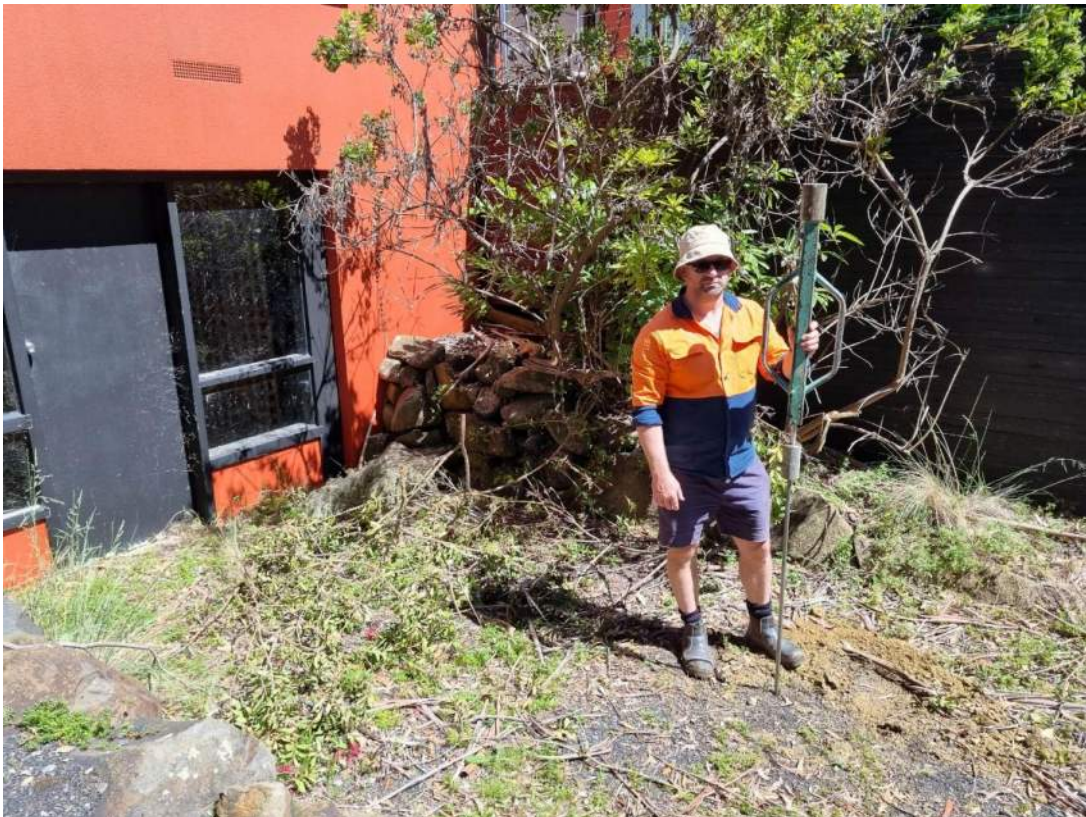
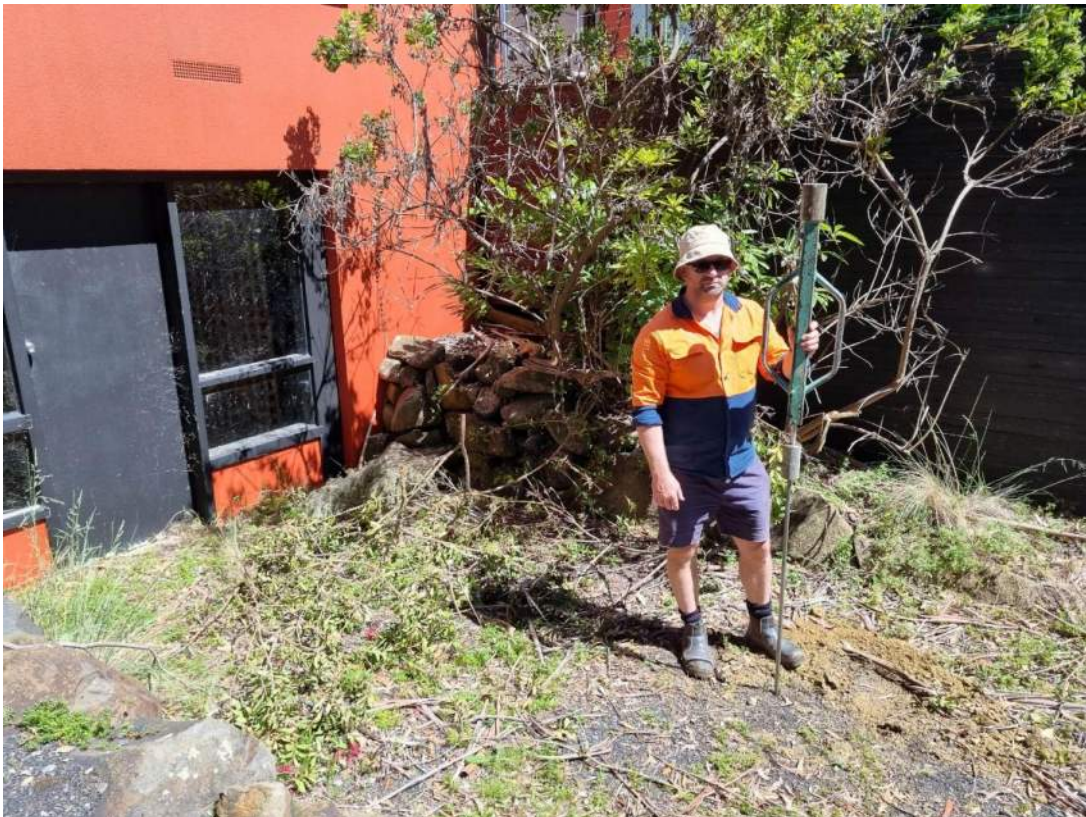
Photo 6: Borehole BH4 and Dynamic Cone Penetrometer Test DCP1 location, looking northwest.

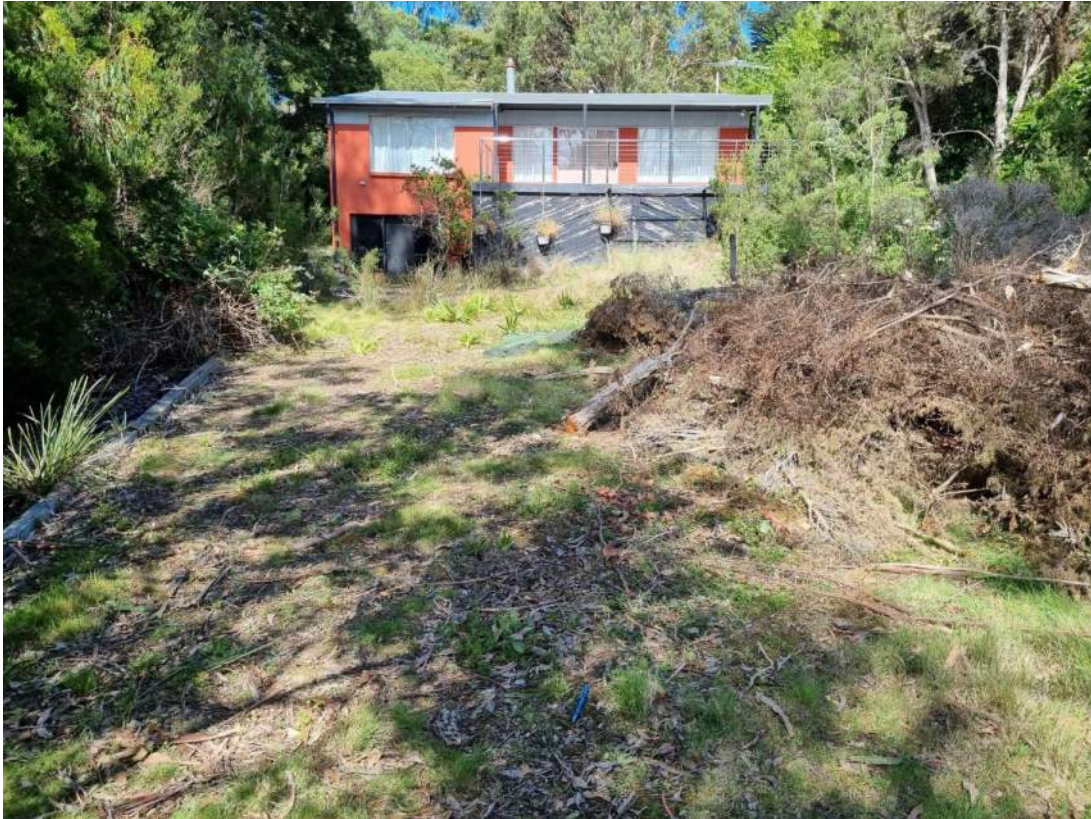
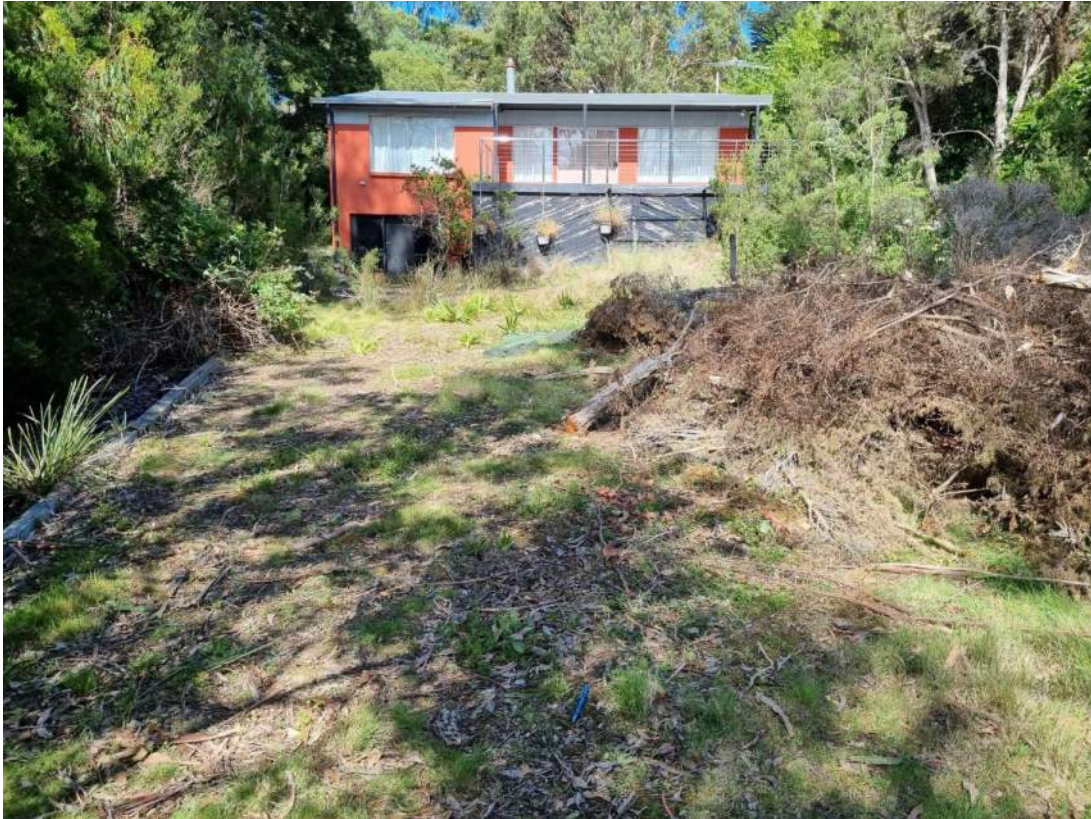
Photo 7: Borehole BH1 location, looking southwest.

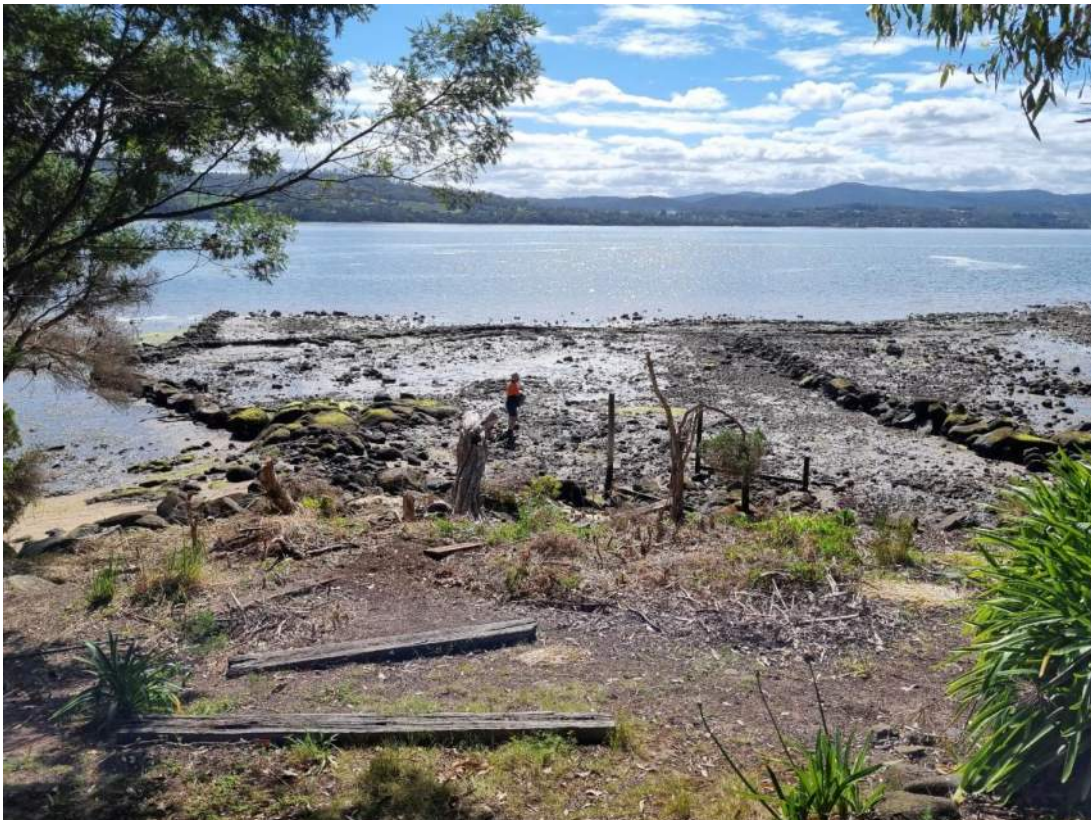
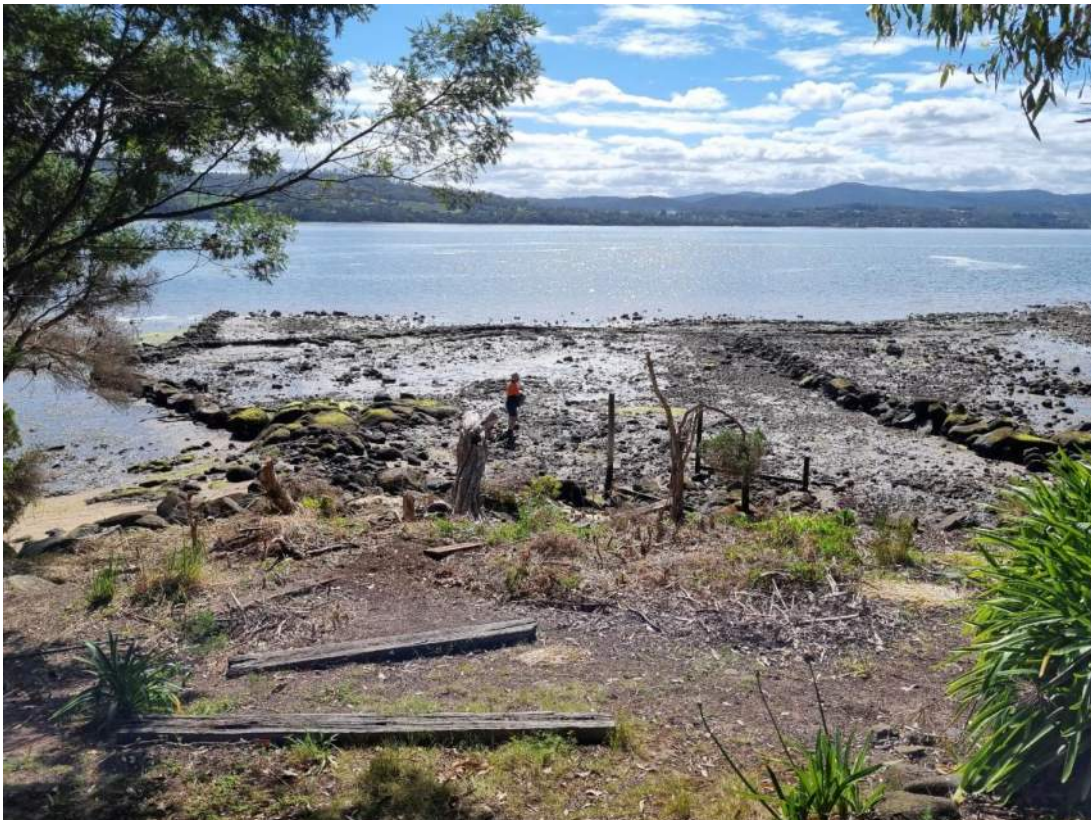
Photo 8: Foreshore and River Tamar to the east of the site, looking east. Note dolerite boulder groynes extending out from the site.
