## PLANNING APPLICATION FORM

<b>Address</b>	420 Deviot Road, Deviot
<b>Property ID</b>	6099646
<b>Title</b>	64037/3
<b>Land Area</b>	2408m <sup>2</sup>
<b>Planning Authority</b>	West Tamar Council
<b>Proposed Use</b>	Residential
<b>Proposed Development</b>	Proposed Main Dwelling, Secondary Dwelling and Shed/Workshop & Store
<b>Zone(s)</b>	10.0 Low Density Residential
<b>Code Overlay(s)</b>	C2.0 Parking and Transport Code C7.0 Natural Assets Code C10.0 Coastal Erosion Hazard Code C11.0 Coastal Inundation Hazard Code C13.0 Bushfire-Prone Areas Code ( <i>Bushfire Hazard Report to be completed during Building Documentation stage</i> )
<b>Existing Access</b>	Vehicular access from Deviot Road
<b>Water</b>	Taswater Water Service
<b>Sewer</b>	New Onsite Wastewater Design, refer to concept design by Tasman Geotechnics
<b>Stormwater</b>	New Onsite Stormwater Design, refer to Site Stormwater Plan by Exceed Engineering

**COASTAL HAZARDS REPORT**  
**PROPOSED DEMOLITION, NEW DWELLING &**  
**ANCILLARY STRUCTURES**  
**420 DEVIOT ROAD, DEVIOT**

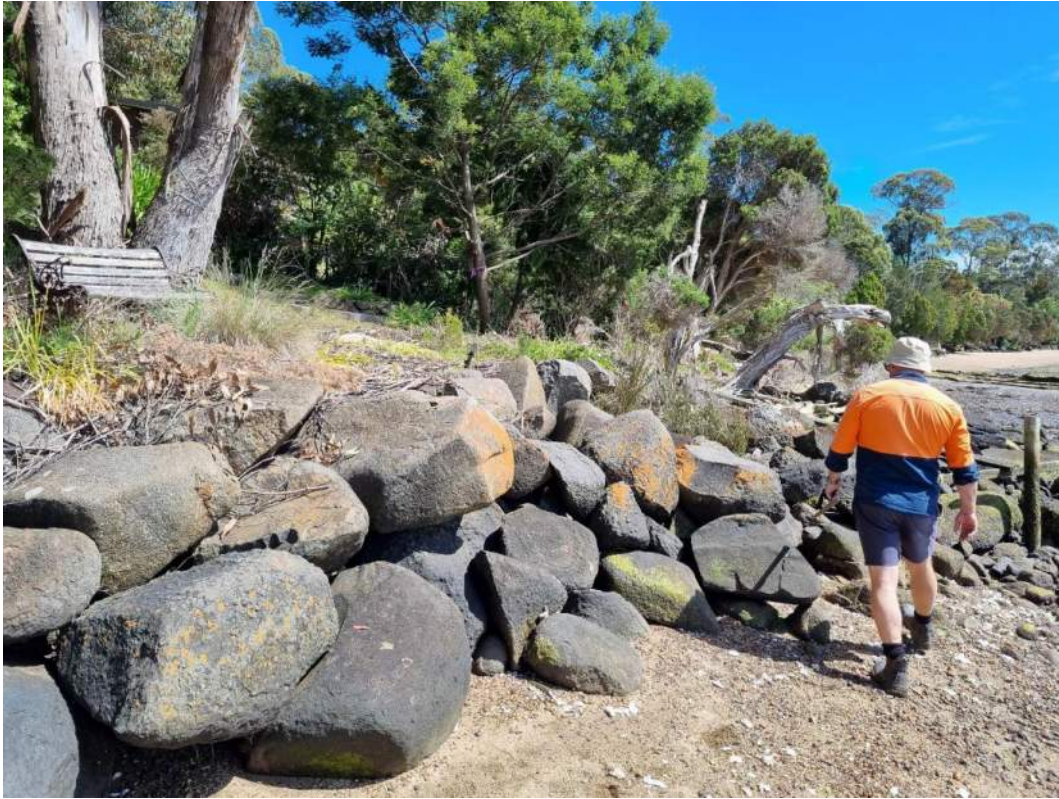
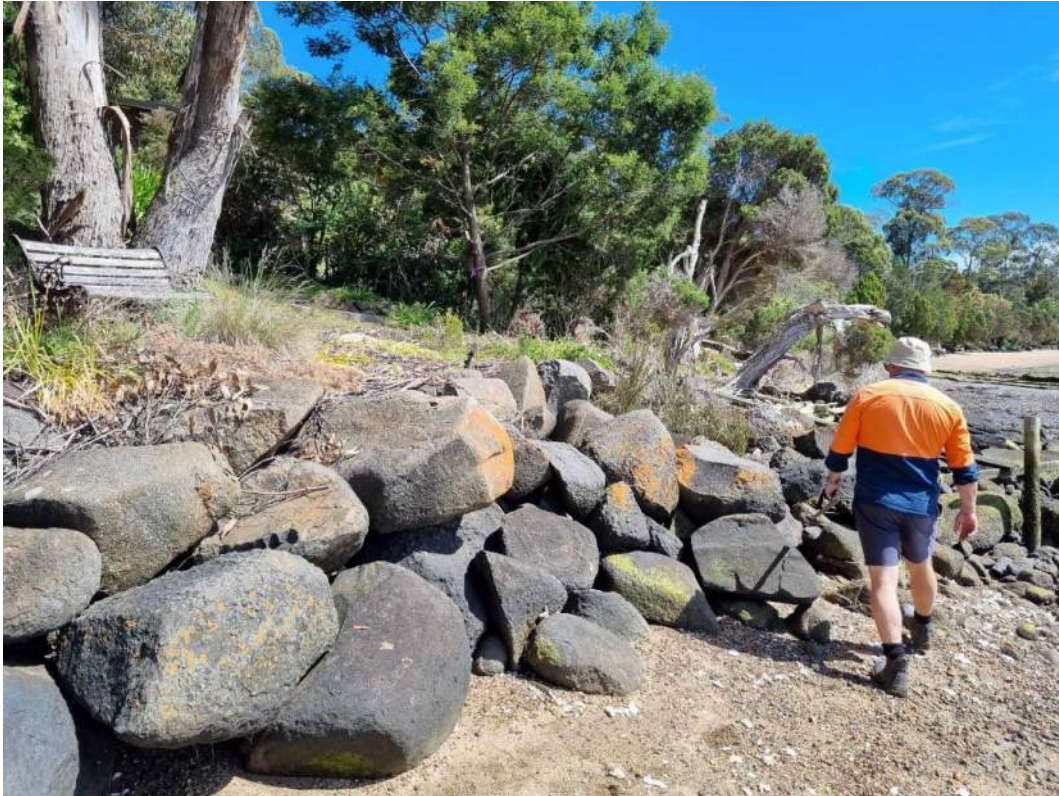
Photo 9: Dry-stacked dolerite boulder wall on eastern boundary of site to protect site from erosion.

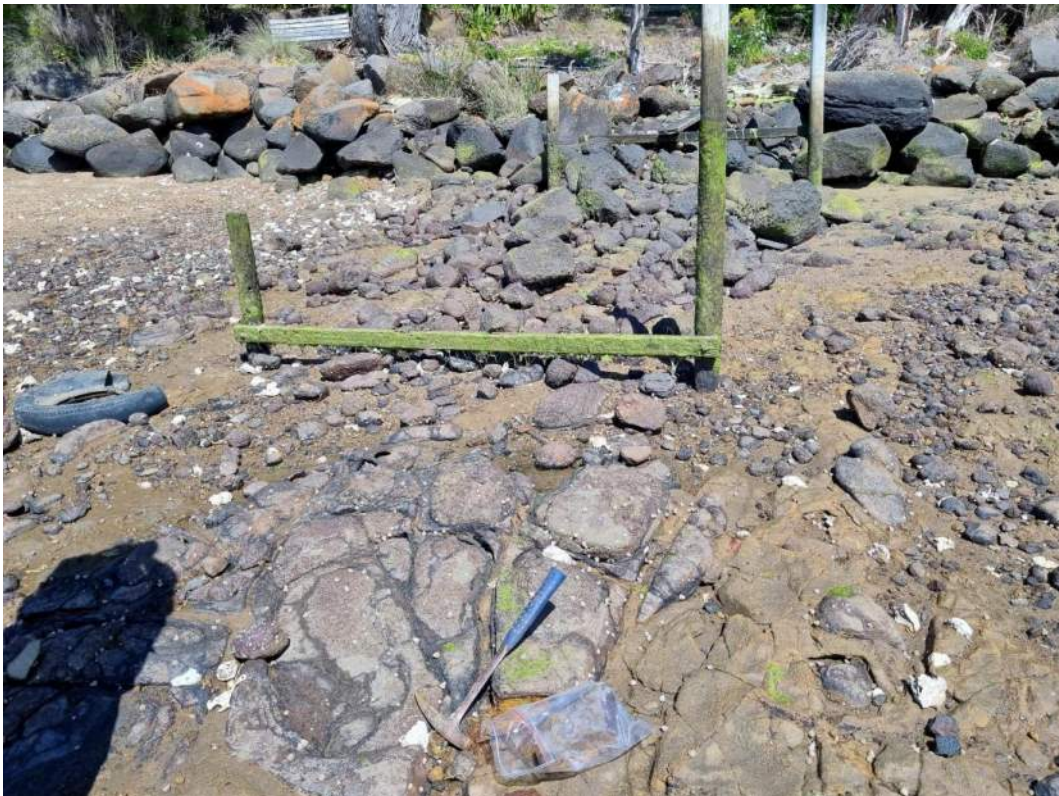
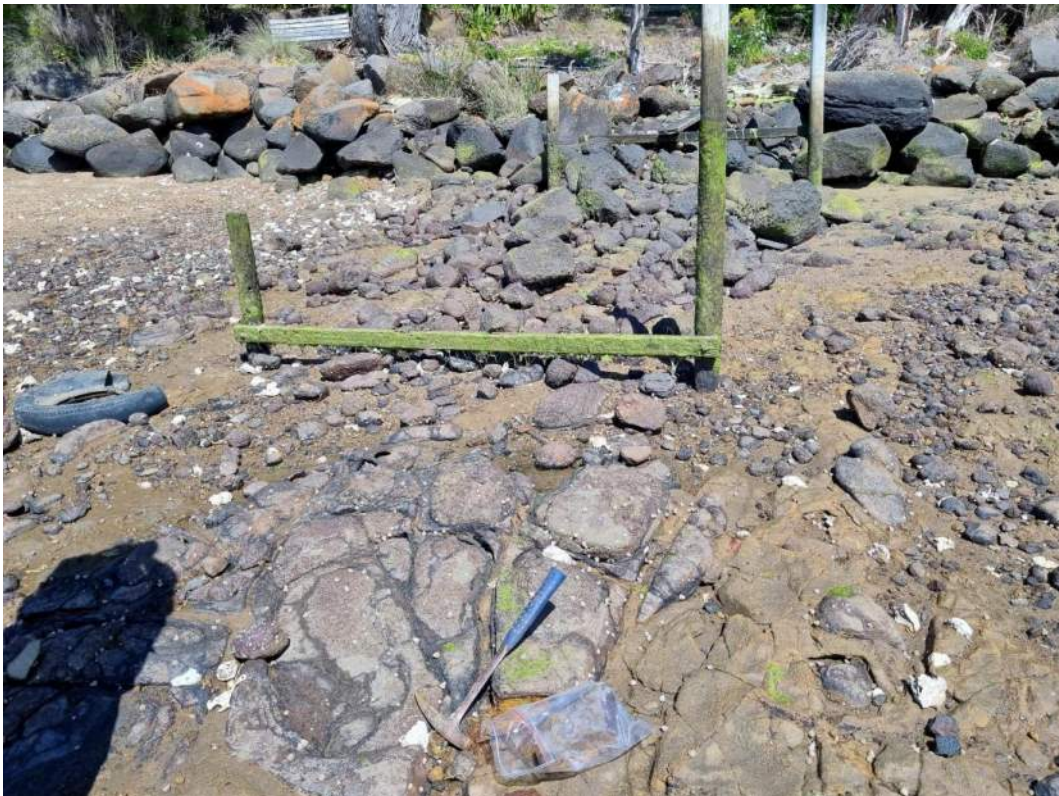
Photo 10: Moderately to Highly Weathered dolerite bedrock (Rock Sample location, RS3), and remnants of timber jetty/pier on foreshore to the east of the site, looking southwest. Note spherical or “onion-skin” weathering in the dolerite.

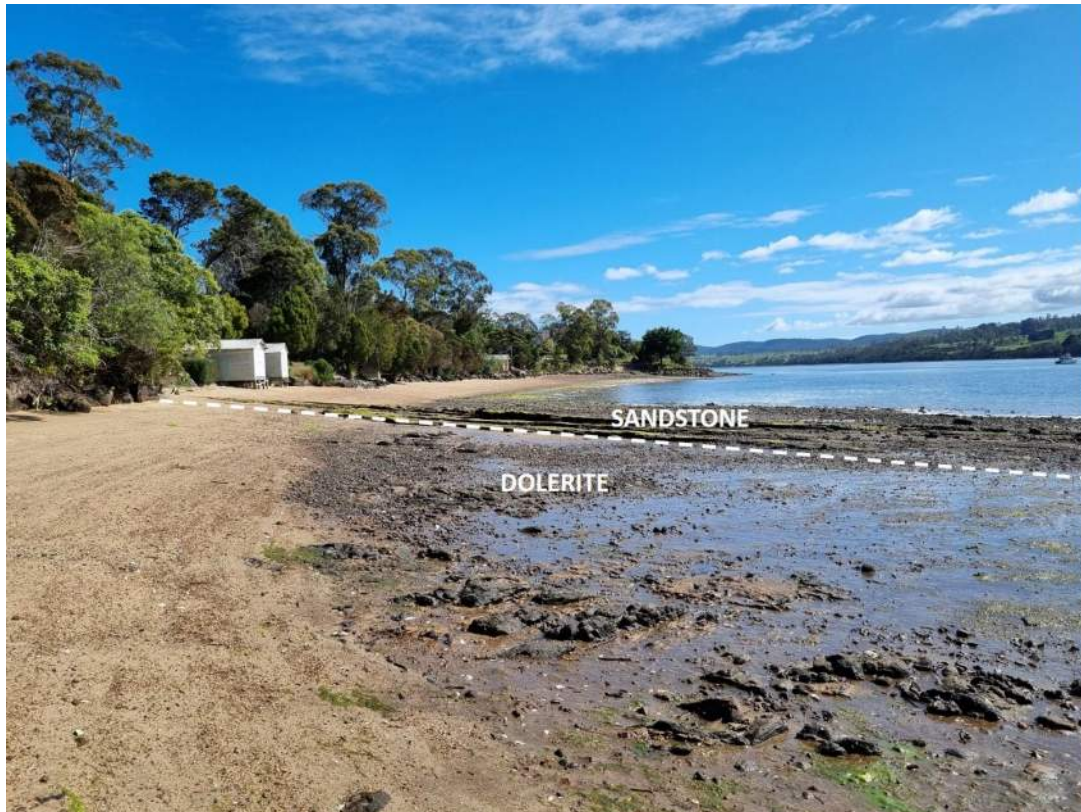
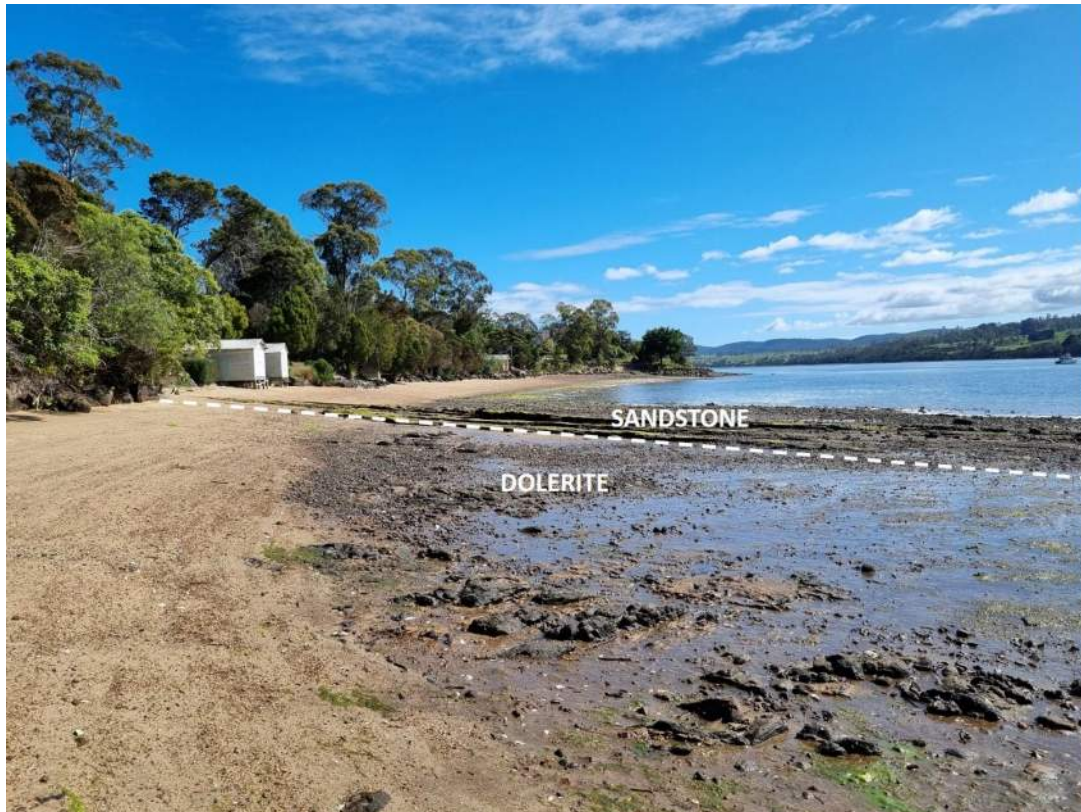
Photo 11: Contact between outcropping dolerite and sandstone bedrock on foreshore, looking north-northeast.

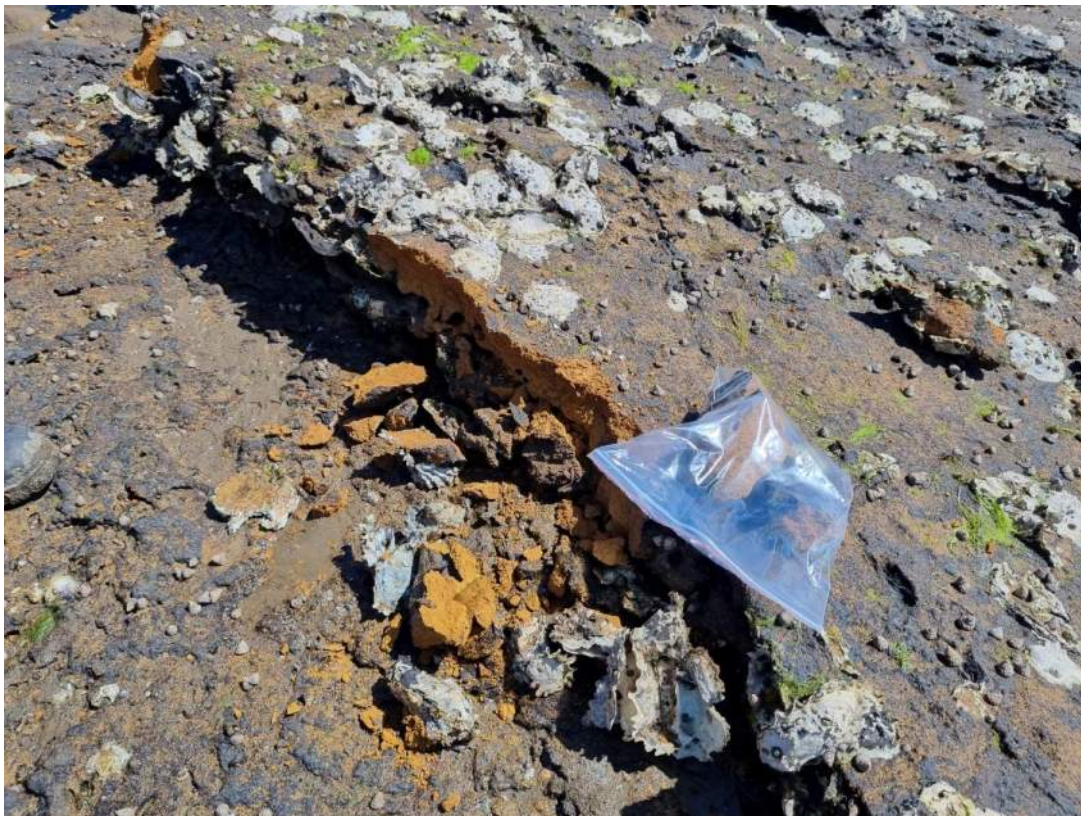
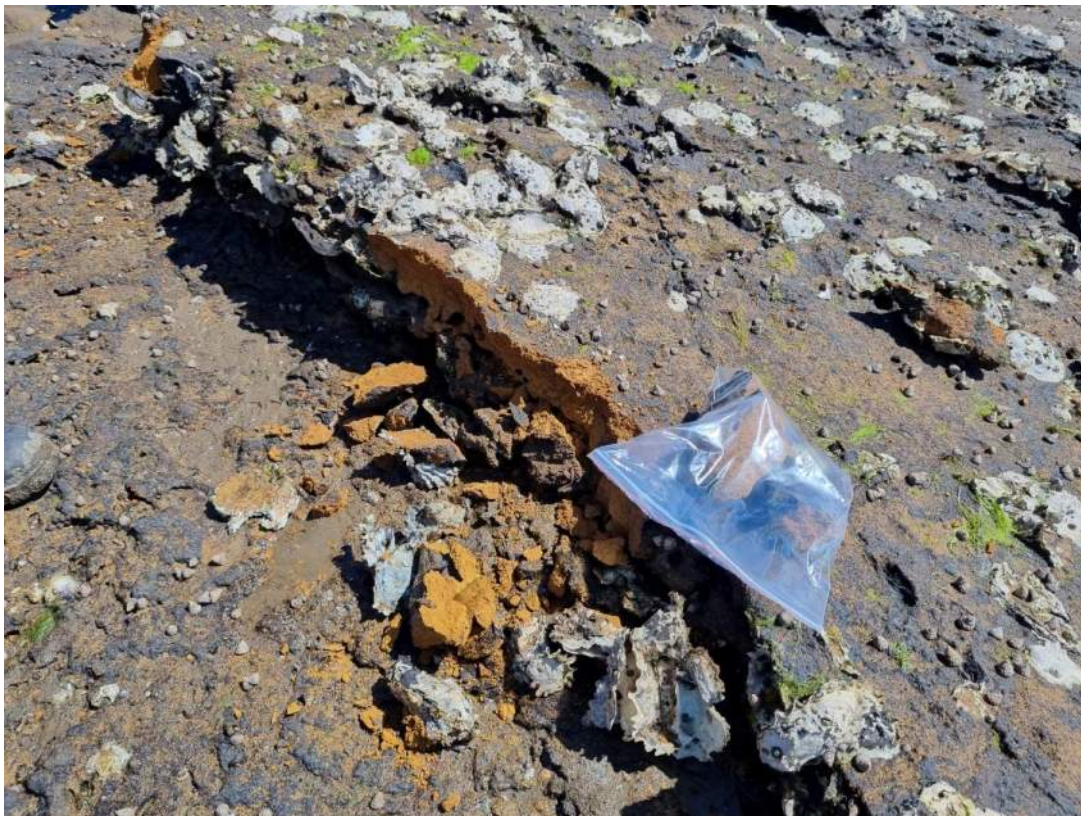
Photo 12: Highly Weathered sandstone bedrock (Rock Sample location, RS4) outcropping on foreshore to the east of the site.
