#### PLANNING APPLICATION FORM

This report has been prepared in support of a planning permit application under Section 57 of the *Land use Planning and Approval Act 1993 (*the 'Act') to subdivide one lot into two lots at 20 Tanner Drive, Legana (the 'subject site').

A review of the Land Information System Tasmania (LIST) website shows the site is located within low to medium landslide hazard bands, and hence an area of doubtful stability. As such, the purpose of the investigation is to conduct the following:

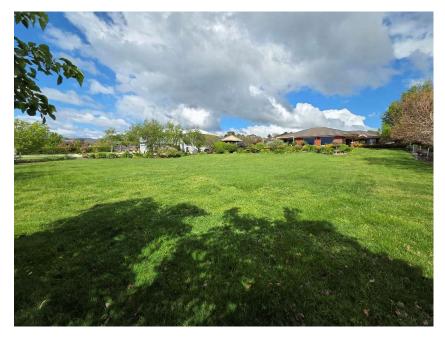
Photo from the NE corner of the subject site towards the existing house

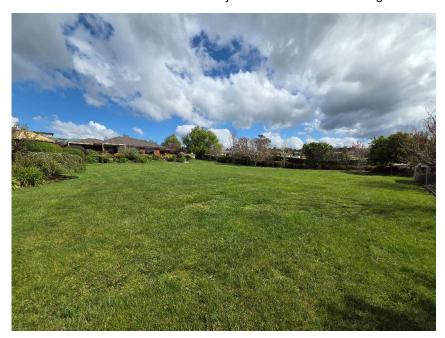
Photo from the NW corner of the subject site towards the existing house

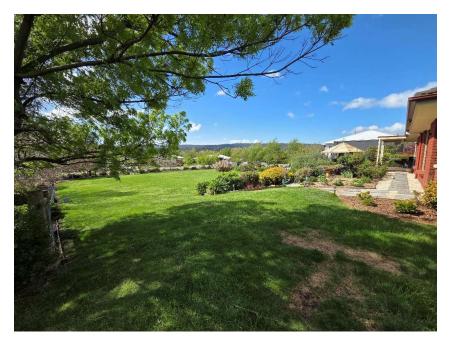
Photo of the subject site from Waterview Court towards the NE corner of the site.

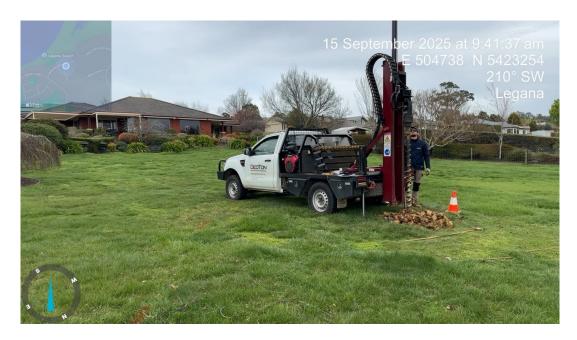
Plate 1: View of the site and the existing dwelling from the northern boundary looking towards the southwest, 15/09/2025.

The slopes within and surrounding the site are typically smooth convex slopes, with no obvious signs of recent landslide activity. The existing dwelling and adjacent roads are in good condition, showing no obvious signs of landslide damage.

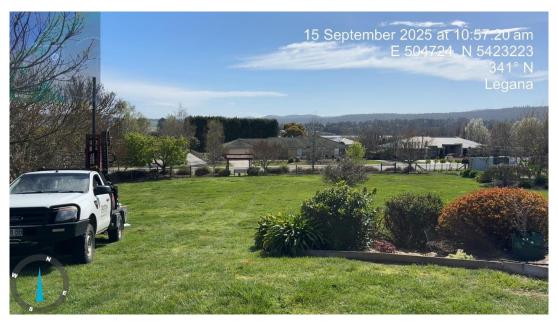
Plate 2: View of the site looking to the northwest, 15/09/2025.

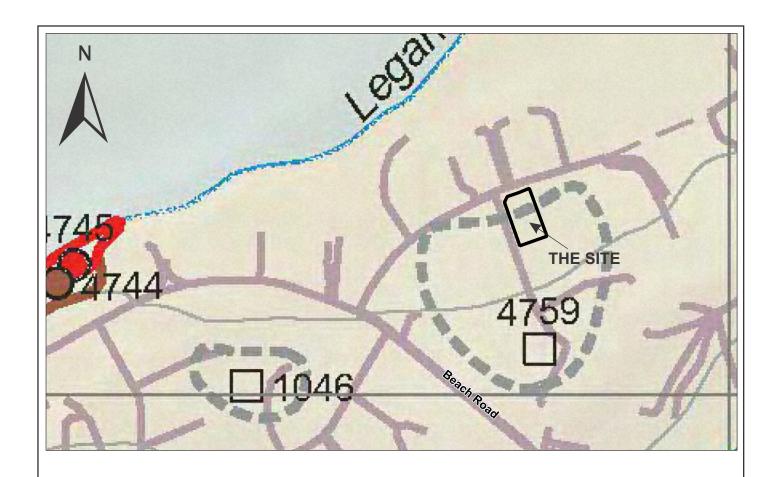
C				client:	ROSS AND JUNE ME	ZGER
GEOION Pty Ltd		project:	20 TANNER DRIVE			
date	6/10/2025	drawn	ВА		LEGANA	
scale	As Shown	approved	ТВ	title: LANDSLIDE INVENTORY SHEET		DRY SHEET
original size	A4	rev		project no:	GL25548A	Drawing no. 2

MAP EXTRACT FROM - MRT TASMANIAN LANDSLIDE MAP SERIES : WINDERMERE - LANDSLIDE INVENTORY

Examination of the MRT Tasmanian Landslide Hazard series, Windermere – Landslide Inventory sheet, 1:25,000 scale, indicates that the site is predominantly located within a possible landslide of unknown activity (Landslide ID: 4759).

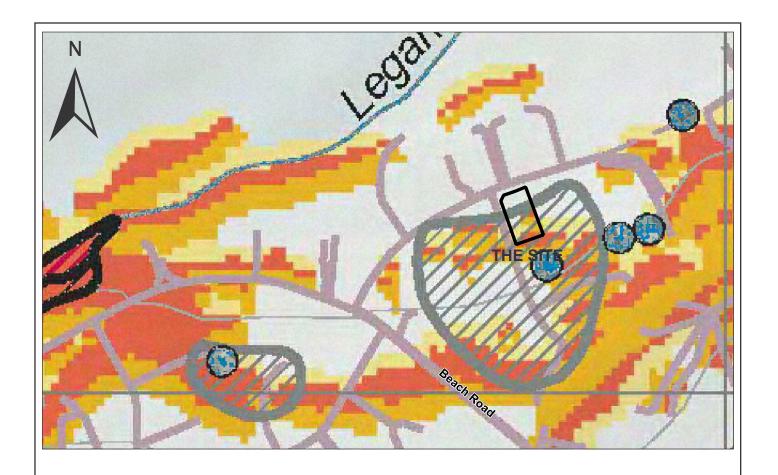
MAP EXTRACT FROM - MRT TASMANIAN LANDSLIDE MAP SERIES : WINDERMERE - SLIDE SUSCEPTIBILITY

Regression area: An area up-slope of a source area that could fail following a deep-seated landslide movement (a.k.a retrogression or set-back area)

Source area: An area of hillside with the potential to form a slope failure, identified largely on the basis of slope angle and geology

Examination of the MRT Tasmanian Landslide Hazard series, Windermere – Slide Susceptibility sheet, 1:25,000 scale, indicates that the uphill southern portion of the site and localised area within the middle portion of the site, along the proposed boundary of Lot 1 and Lot 2, are mapped as source areas (that correlates to the medium hazard band), i.e. "an area of hillside with the potential to form slope failure, identified largely on the basis of slope angle and geology". The areas immediately upslope of source

areas are mapped as regression areas, i.e. "An area up-slope of a source area that could fail following a landslide movement (a.k.a retrogression or set-back area)"

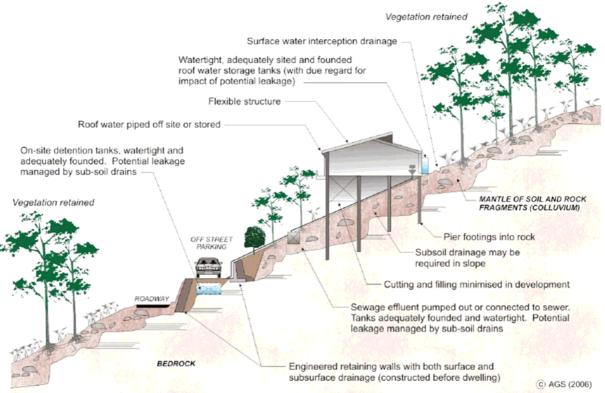
# EXAMPLES OF GOOD HILLSIDE PRACTICE

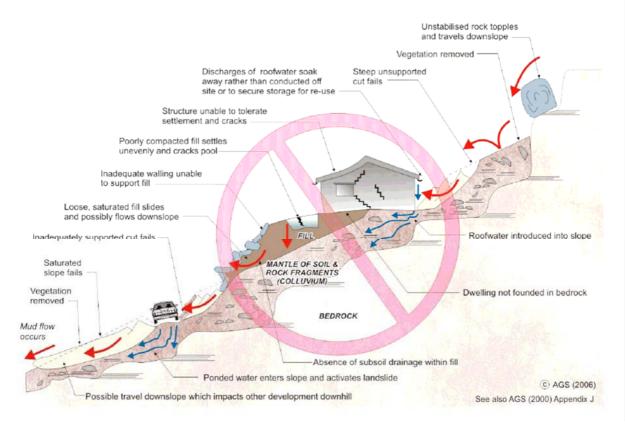
# **EXAMPLES OF POOR HILLSIDE PRACTICE**
