## PLANNING APPLICATION FORM

Application Number PA2025301 Assess No: A7379

This report has been prepared in accordance with the **Practice Note Guidelines for Landslide Risk Management 2007** and the **Tasmanian Planning Scheme – State Planning Provisions C15.0 Landslip Hazard Code**.

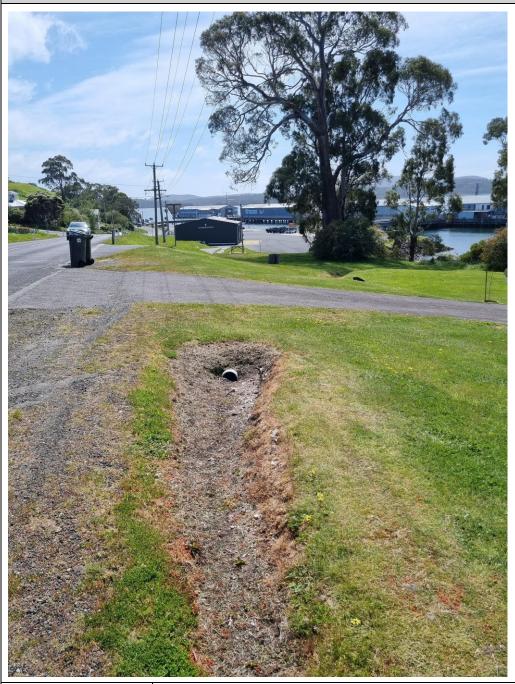
## Flinders Street frontage: 166 Flinders Street

Date & Time	16 Oct 2025 11:52
Coordinates	No coordinates
Description	Surface water drain and culvert under driveway
Comments	None

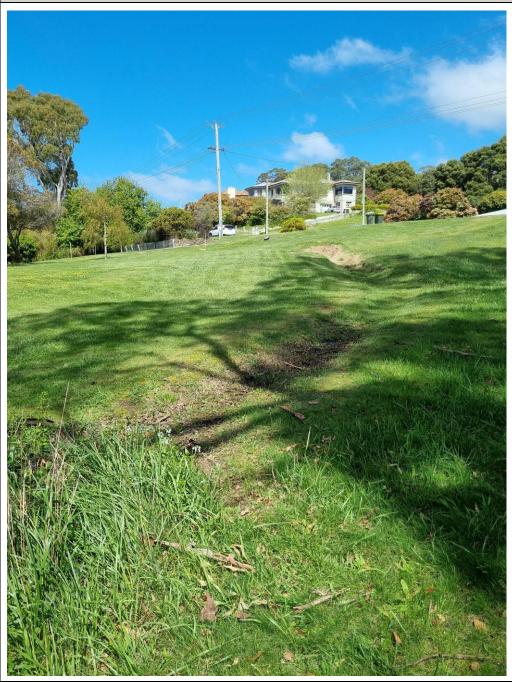
## North of property : 166 Flinders Street

Date & Time	16 Oct 2025 11:56
Coordinates	485087mE, 5444263mN
Description	Surface drain continues
Comments	None

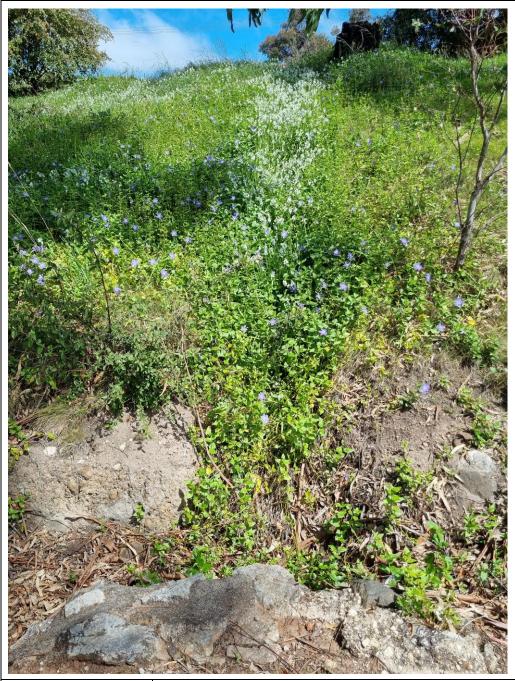
#### North East of site: 166 Flinders Street

Date & Time	16 Oct 2025 11:58
Coordinates	485186mE, 5444404mN
Description	Surface drain discharges to culvert under foreshore track
Comments	None

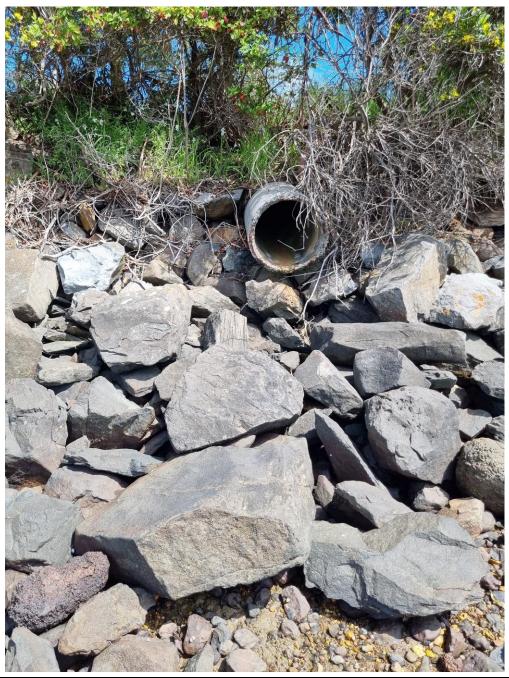
Date & Time	16 Oct 2025 11:59
Coordinates	485145mE, 5444403mN
Description	Culvert discharge
Comments	None

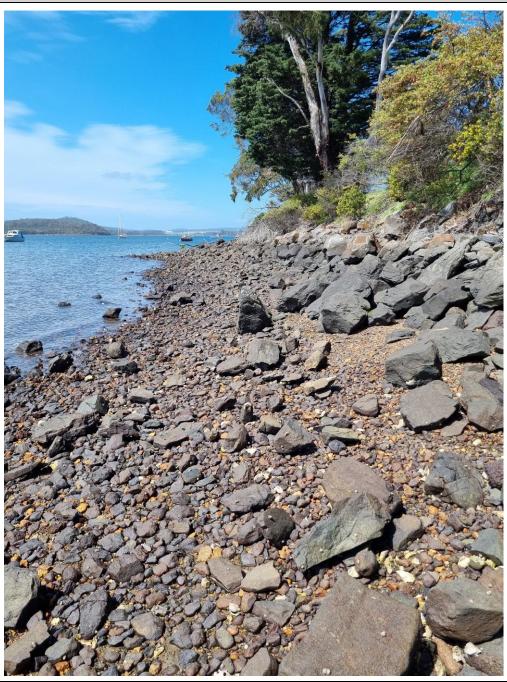
Date & Time	16 Oct 2025 12:00
Coordinates	No coordinates
Description	Basalt gravel lag, cobble to boulder sized and revetment
Comments	None

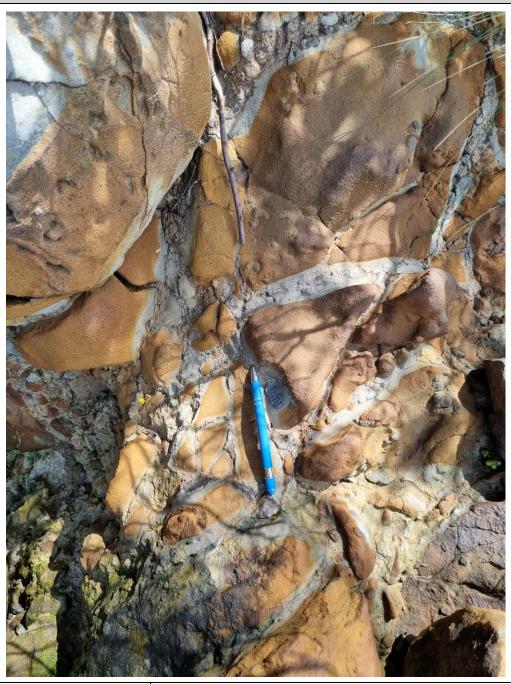
Date & Time	16 Oct 2025 12:05
Coordinates	485239mE, 5444390mN
Description	Apparently in-situ weathered rock with clay seams
Comments	None

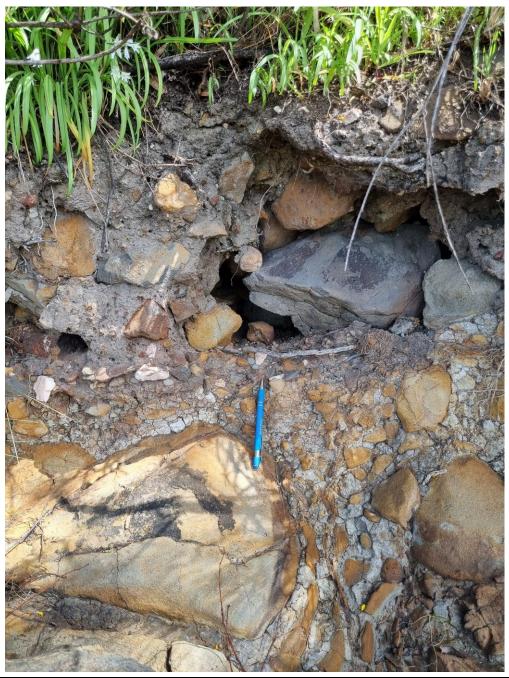
Date & Time	16 Oct 2025 12:06
Coordinates	485181mE, 5444202mN
Description	Probable talus overlying gravels, overlying weathered rock
Comments	None

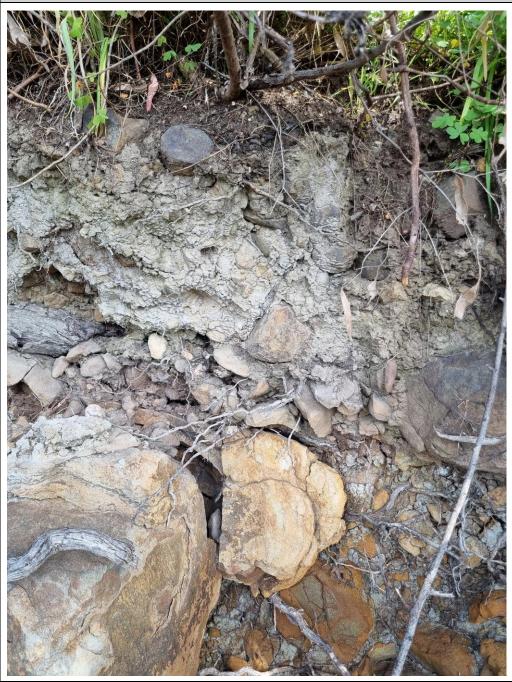
Date & Time	16 Oct 2025 12:08
Coordinates	485185mE, 5444185mN
Description	Probable talus overlying weathered rock
Comments	None

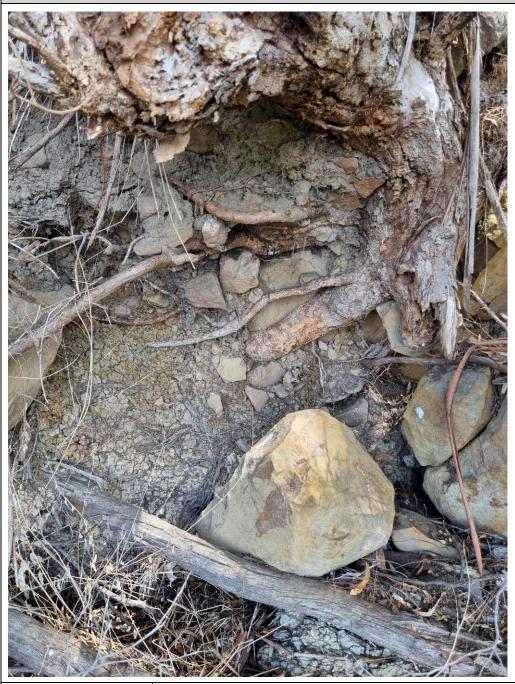
Date & Time	16 Oct 2025 12:11
Coordinates	485223mE, 5444390mN
Description	Clayey talus with gravel to cobble size angular/sub-angular material
Comments	None

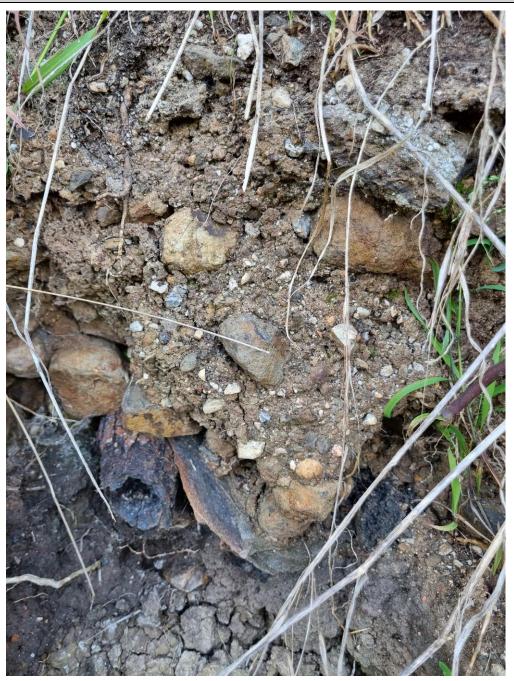
Date & Time	16 Oct 2025 12:15
Coordinates	485168mE, 5444155mN
Description	Poorly sorted material
Comments	None

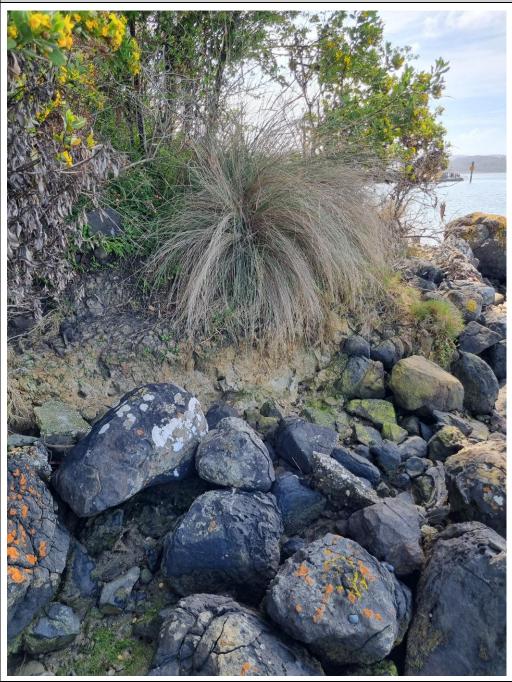
Date & Time	16 Oct 2025 12:17
Coordinates	485186mE, 5444153mN
Description	Soft clayey deposits
Comments	None

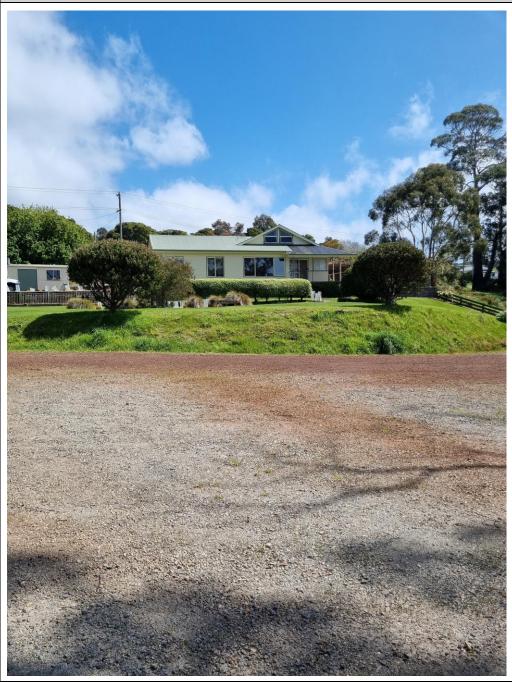
#### Eastern side on foreshore track: 166 Flinders Street

Date & Time	16 Oct 2025 12:19
Coordinates	No coordinates
Description	View from foreshore lot (NRE) towards house
Comments	None

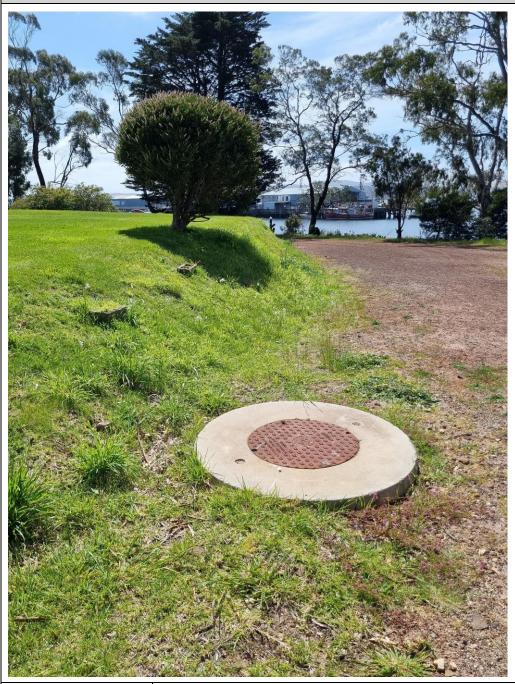
#### East of house: 166 Flinders Street

Date & Time	16 Oct 2025 12:19
Coordinates	485164mE, 5444160mN
Description	Sewerage pit
Comments	Near site boundary

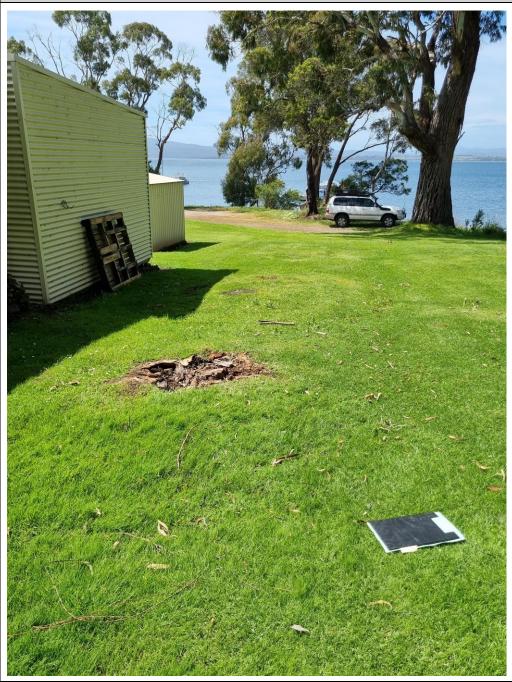
#### South of house: 166 Flinders Street

Date & Time	16 Oct 2025 12:27
Coordinates	No coordinates
Description	Minor drain, presume for spring
Comments	Carport/shed to left of frame

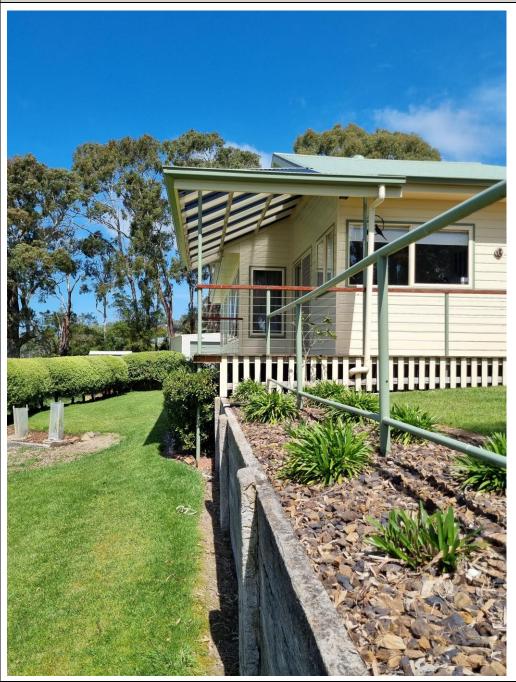
#### North Eastern side of house: 166 Flinders Street

Date & Time	16 Oct 2025 12:35
Coordinates	485154mE, 5444208mN
Description	None
Comments	None

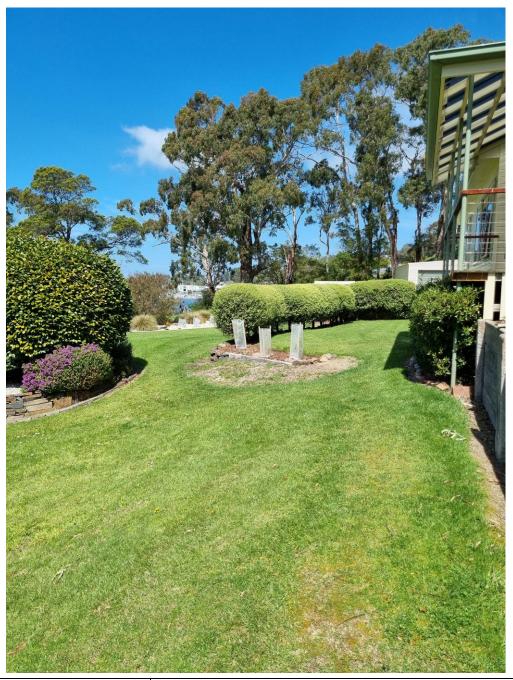
#### Yard East of house: 166 Flinders Street

Date & Time	16 Oct 2025 12:35
Coordinates	No coordinates
Description	Lawn below house
Comments	None

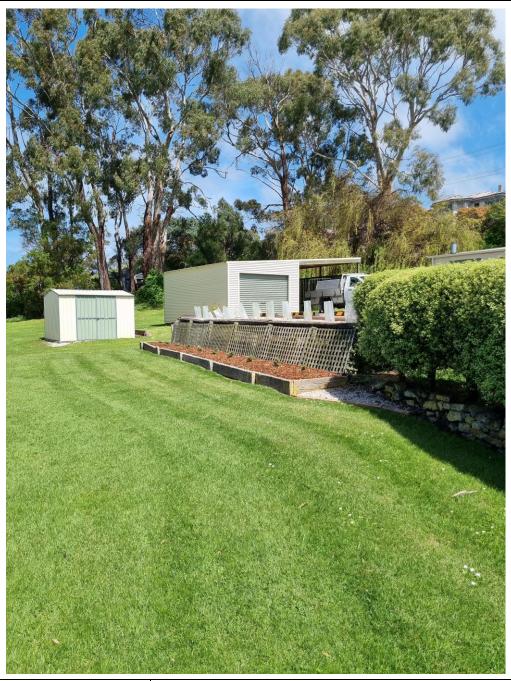
#### Yard south east of house: 166 Flinders Street

Date & Time	16 Oct 2025 12:36
Coordinates	No coordinates
Description	Lawn below hardstand
Comments	None

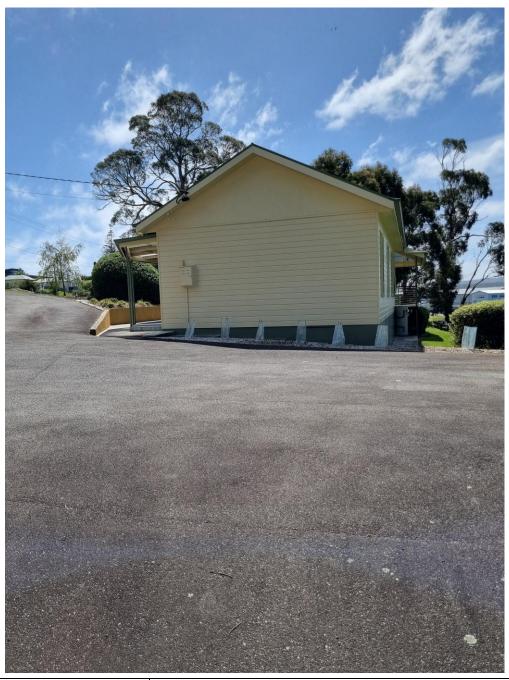
#### Southern side of house: 166 Flinders Street

Date & Time	16 Oct 2025 12:39
Coordinates	No coordinates
Description	All in good order
Comments	None

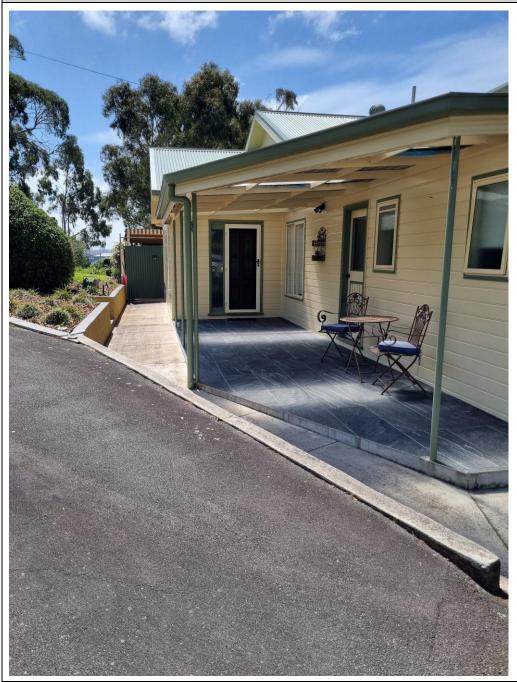
#### Western side of house: 166 Flinders Street

Date & Time	16 Oct 2025 12:39
Coordinates	No coordinates
Description	In good order
Comments	None

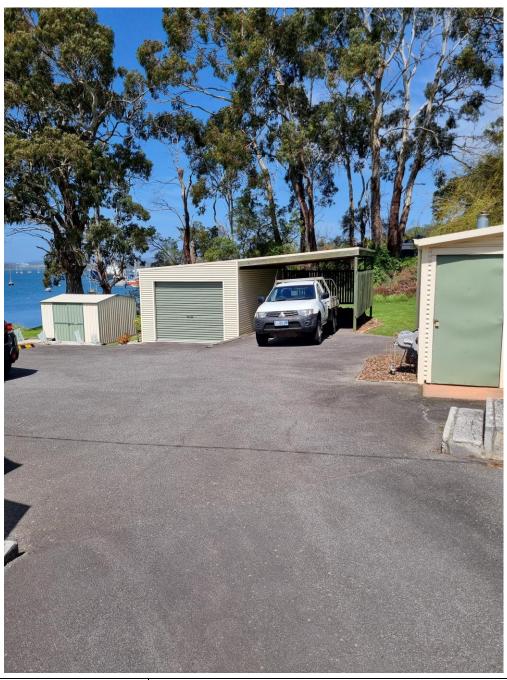
#### Southern side of house: 166 Flinders Street

Date & Time	16 Oct 2025 12:40
Coordinates	485013mE, 5444229mN
Description	Carport and outbuildings
Comments	In good order

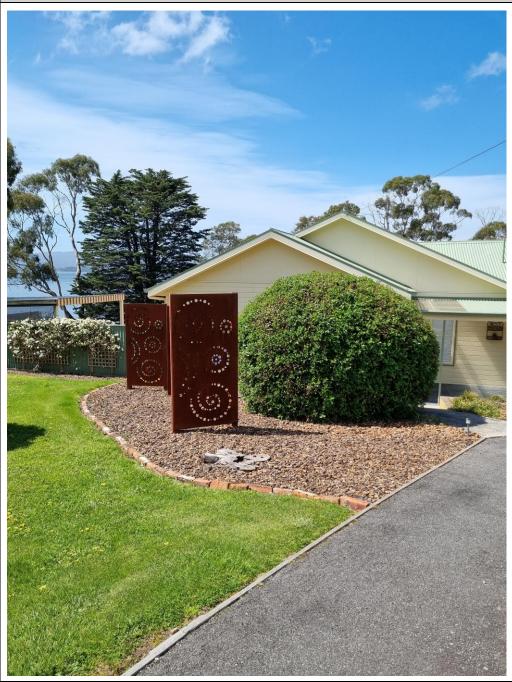
#### Western side of house: 166 Flinders Street

Date & Time	16 Oct 2025 12:42
Coordinates	No coordinates
Description	In good order
Comments	None

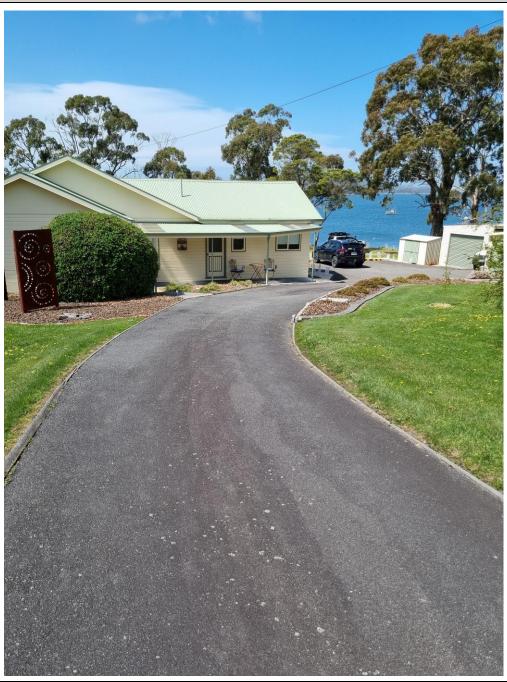
#### Western side of house: 166 Flinders Street

Date & Time	16 Oct 2025 12:42
Coordinates	No coordinates
Description	Driveway in good order
Comments	None

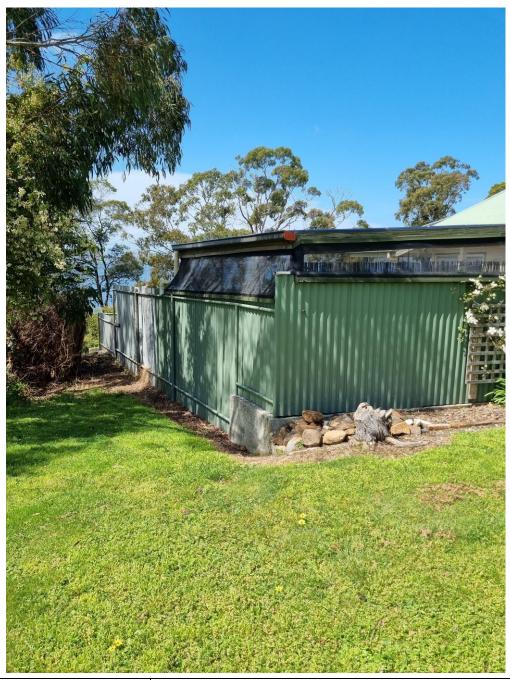
#### North-western corner of house: 166 Flinders Street

Date & Time	16 Oct 2025 12:43
Coordinates	No coordinates
Description	Northern site boundary
Comments	None

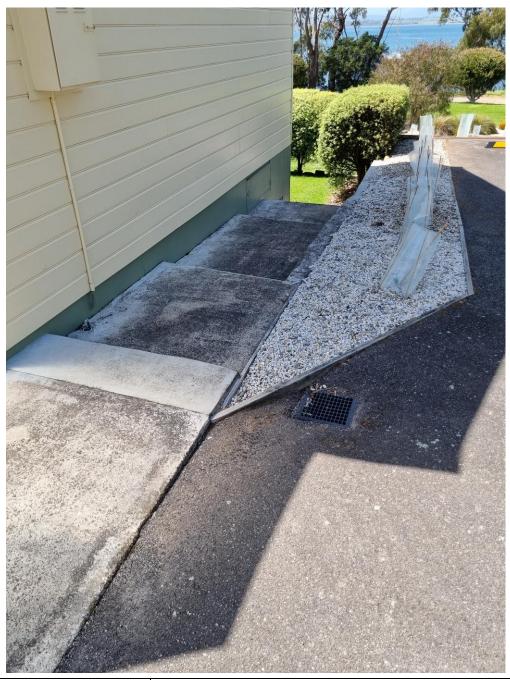
#### Southern side of house: 166 Flinders Street

Date & Time	16 Oct 2025 12:44
Coordinates	No coordinates
Description	Pit for driveway runoff
Comments	None

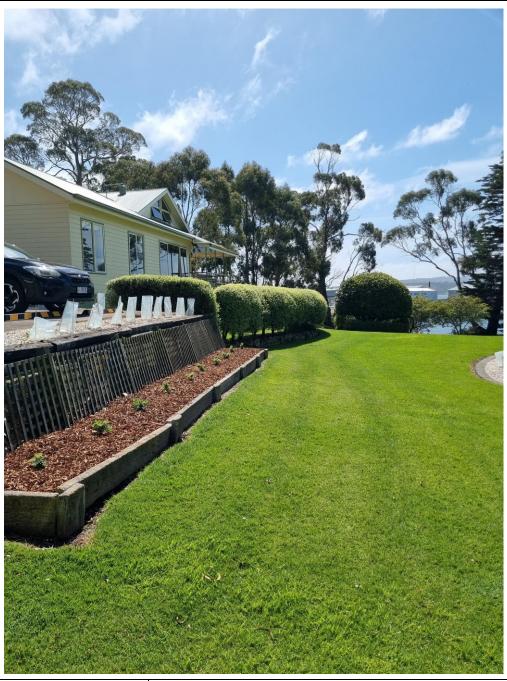
#### Eastern side of house: 166 Flinders Street

Date & Time	16 Oct 2025 12:46
Coordinates	485108mE, 5444330mN
Description	Lawns, all in good order
Comments	None
