PLANNING APPLICATION FORM

Application Number PA2025251

PROPOSAL PLAN — 10 LOT SUBDIVISION PLUS BALANCE AND ROAD	DATE 1 Nov 2025	SCALE 1:2000 @ A3	A.J PHILLIPS SURVEYING 6 BINDAREE ROAD LEGANA 7277 email: ajpsurv@bigpond.net.au Mobile 0412 315 880	MICHAEL ALAN CLIFFORD & MICHELLE ELIZABETH CLIFFORD CT 135214-1, CT 162598-1 & CT 111574-3 176A FRESHWATER POINT ROAD, LEGANA 7277 GLADYS M PARRY , Lynne M PARRY & WENDY J PARRY CT 35391/2 176B FRESHWATER POINT ROAD, LEGANA 7277
	DRAWN AJP	FILE 6034 31		
	SURVEYED AJP

LANDSLIDE RISK ASSESSMENT

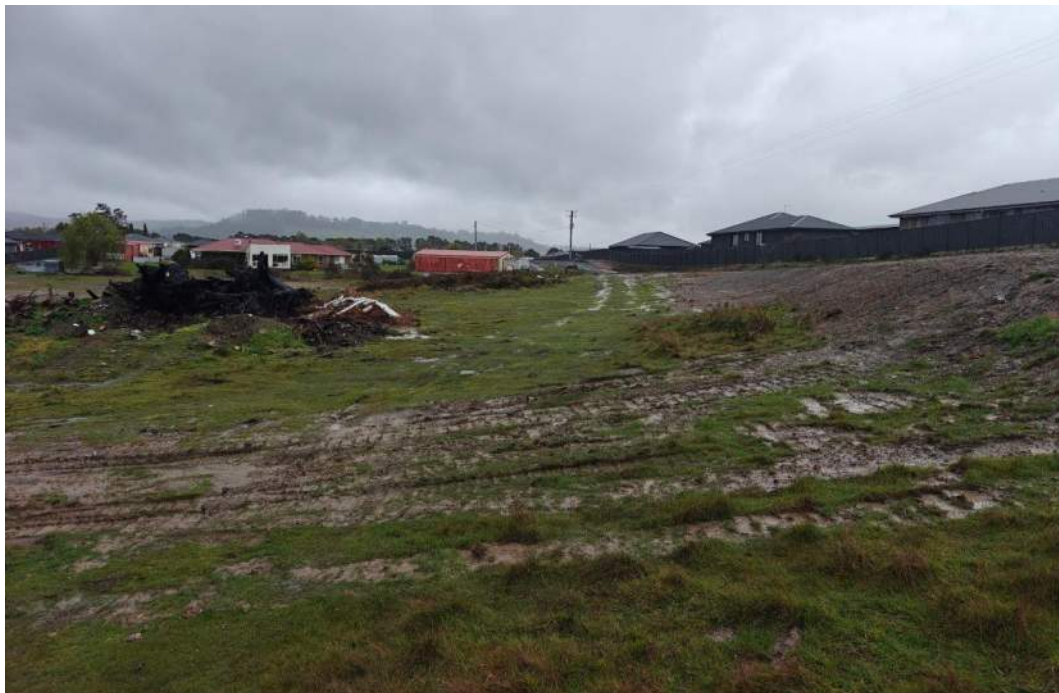
Plate 1: View of the middle and western portions of the site looking towards the west

At the time of the investigation, the site typically had a cover of grass, with the steeper northeastern portion covered in dense, native vegetation comprising Eucalypts and shrubs (Plates 1 and 2).

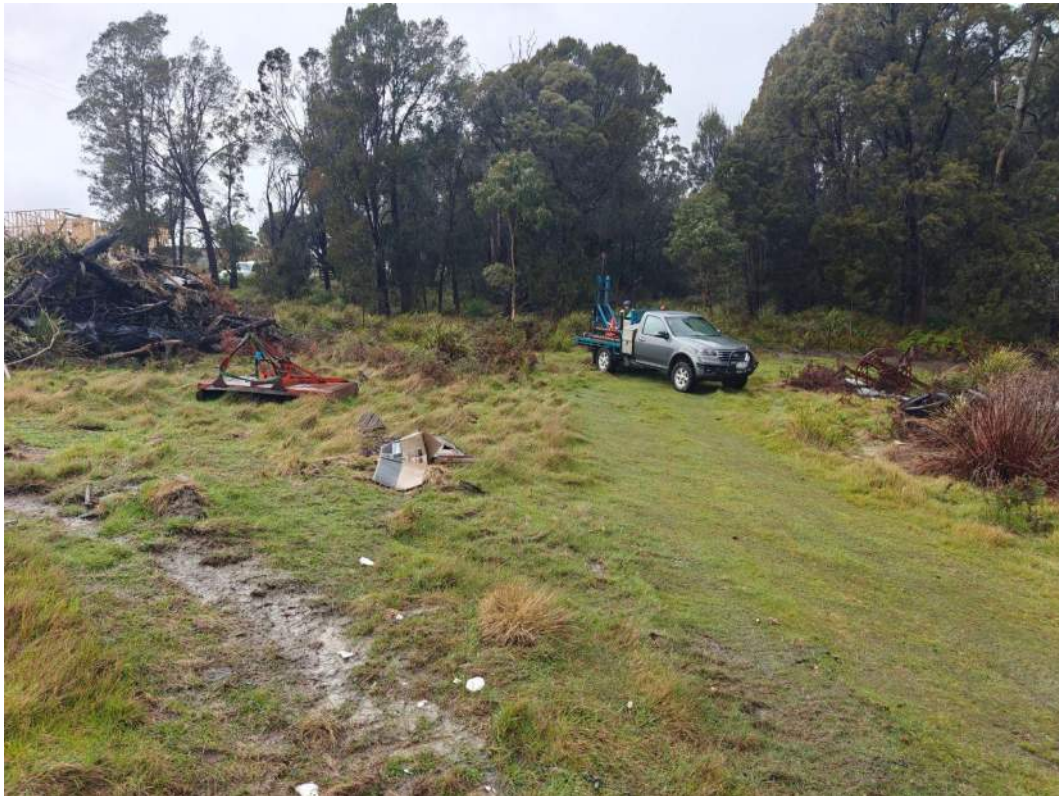
Plate 2: View of the steeper slopes within the northeastern portion of the site, looking towards the east

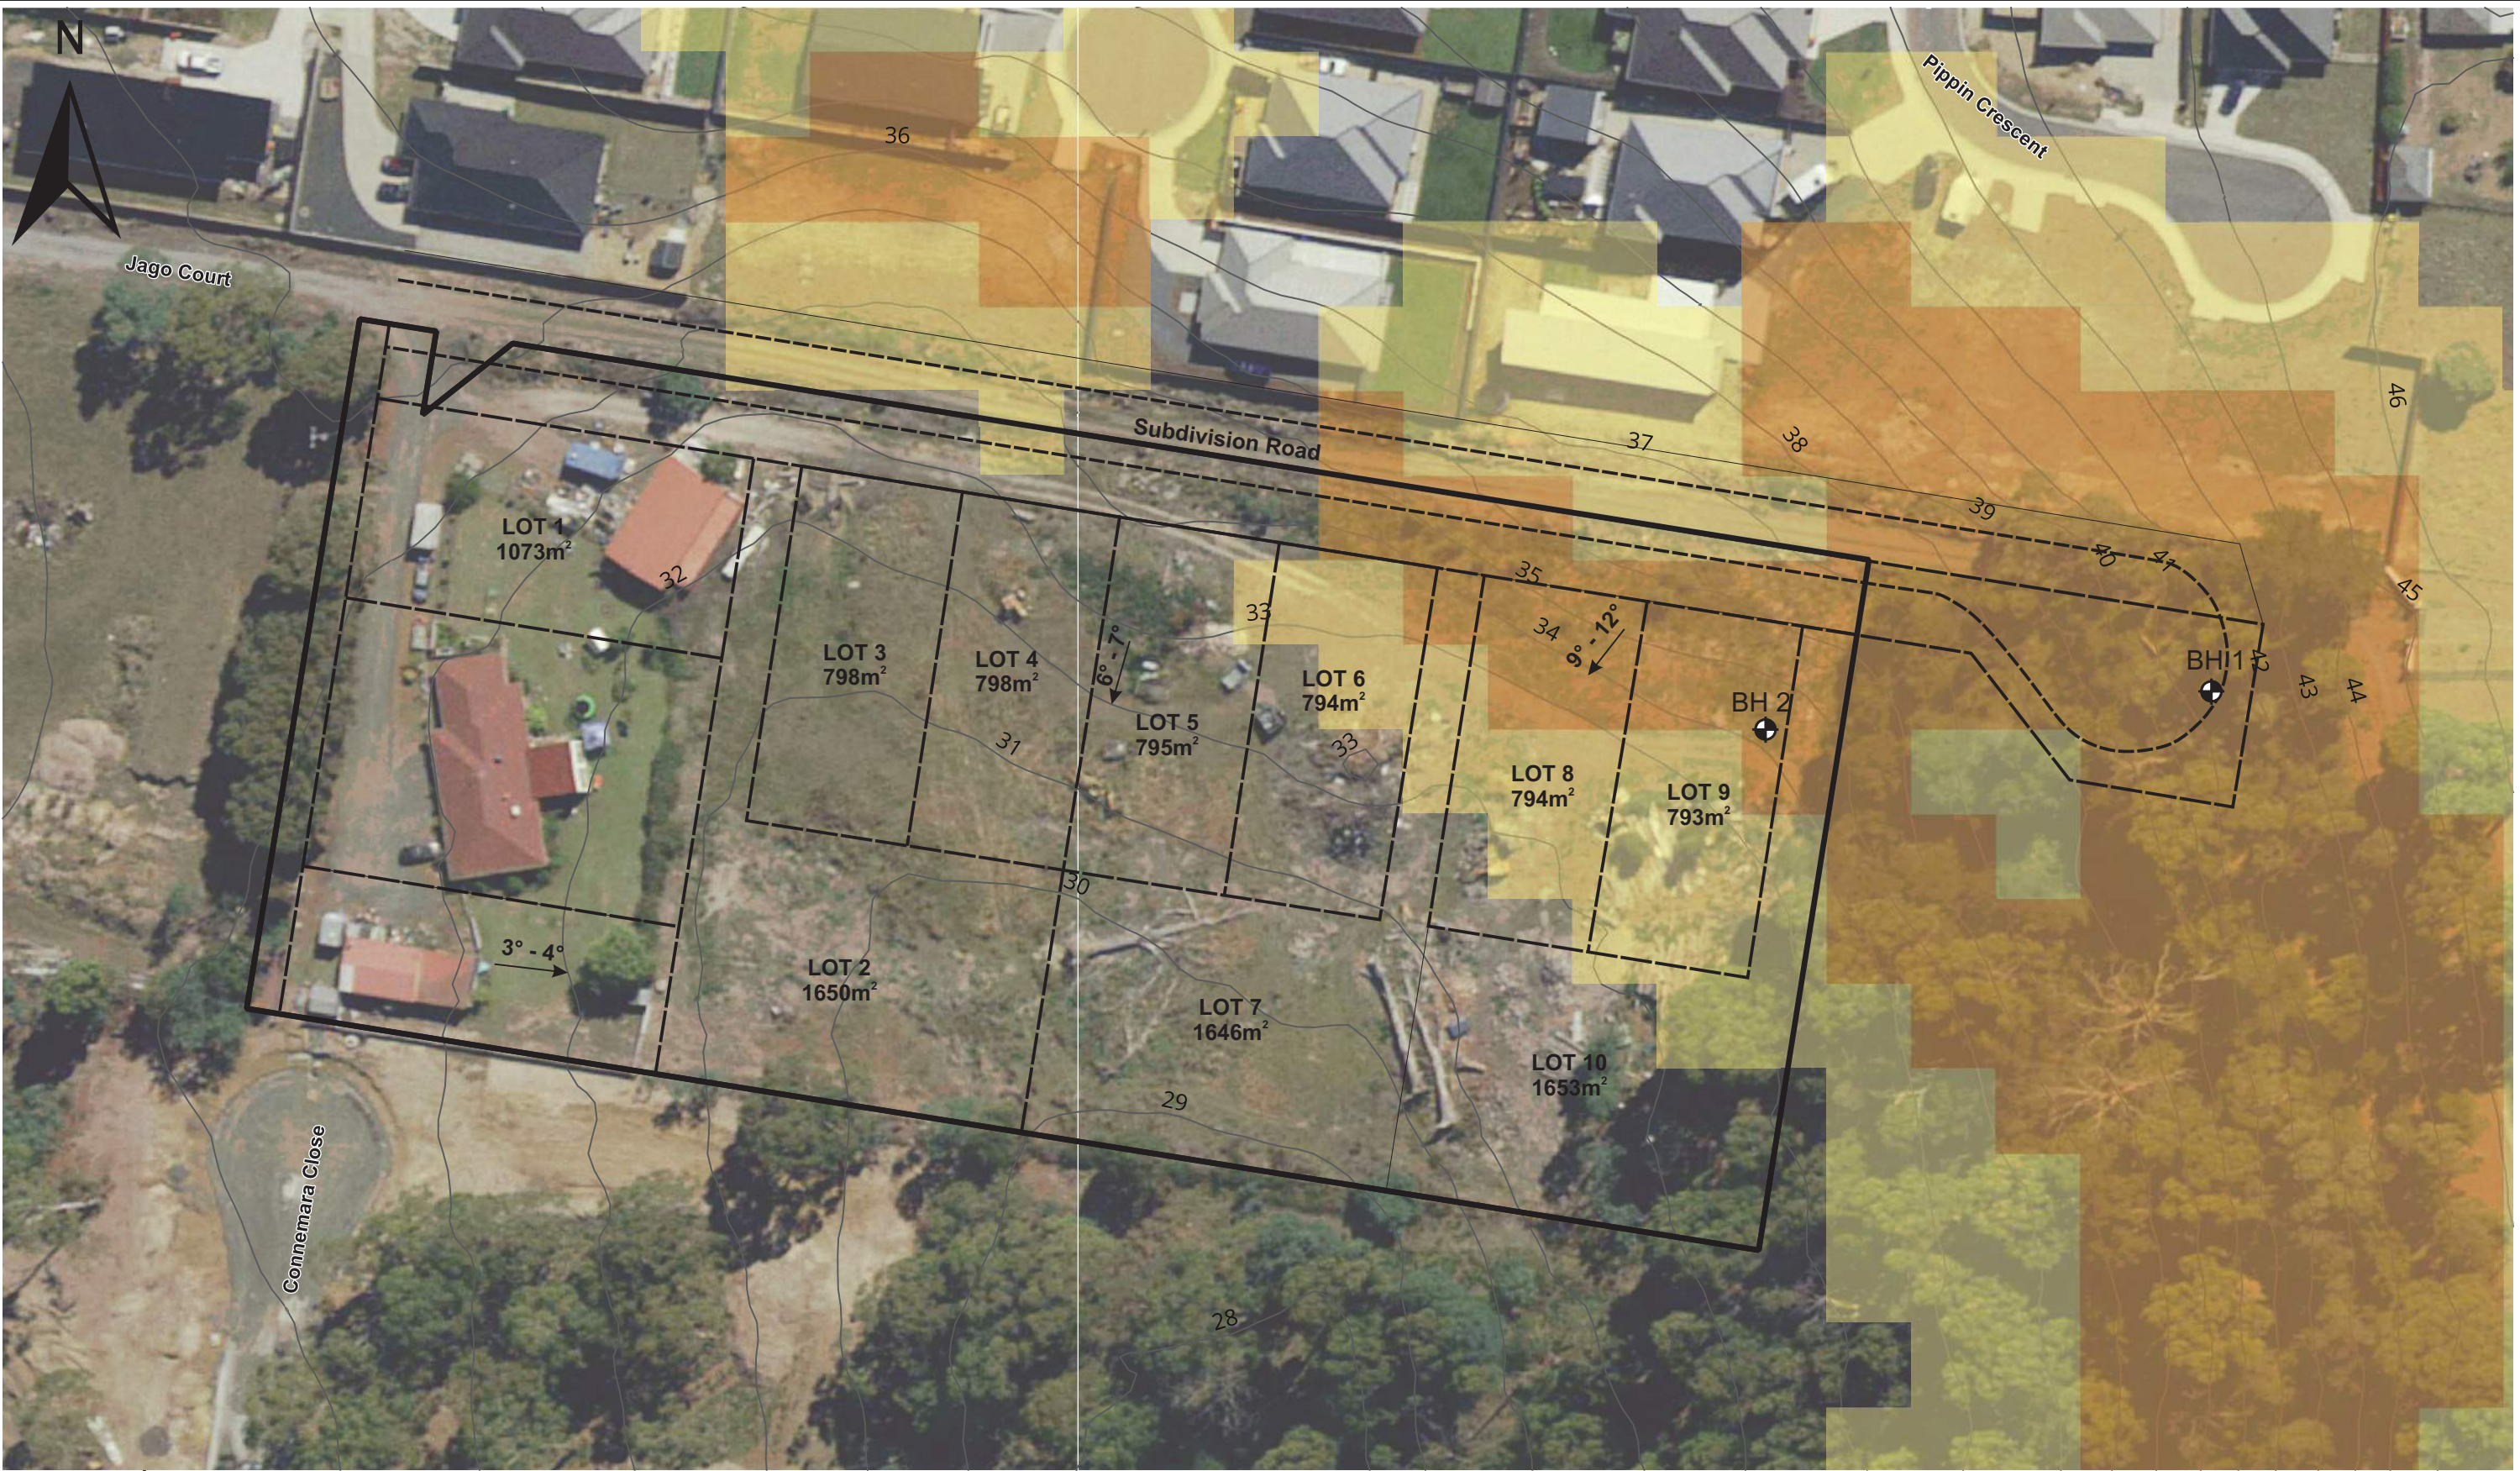
- BH 1
Approximate Borehole Location
- 5°
Approximate Slope angle in Degrees
- Contour in Metres (LiDAR Derived)
- Cadastral Parcels

Medium Landslide Hazard Band (LIST)

GEOTON Pty Ltd				Client: M + M CLIFFORD	
				Project: 176A FRESHWATER POINT ROAD LEGANA	
Date	28/10/2025	Drawn	SS	Title: SITE PLAN	
Scale	As Shown	Approved	TB		
Original size	A3	Rev		Project no: GL25602A	Drawing no. 1

A review of the Land Information System Tasmania (LIST) website shows that the steeper areas within the northeastern portion of the site are mapped within a low to medium landslide hazard band (refer to Drawing 1), and hence an area of doubtful stability. As such a landslide risk assessment is required in accordance with Sections C15.6.1 (Building and works within a landslip hazard area) and C15.7.1 (Subdivision within a landslip hazard area) of the Landslide Hazard Code of the Tasmanian Planning Scheme – West Tamar Council.

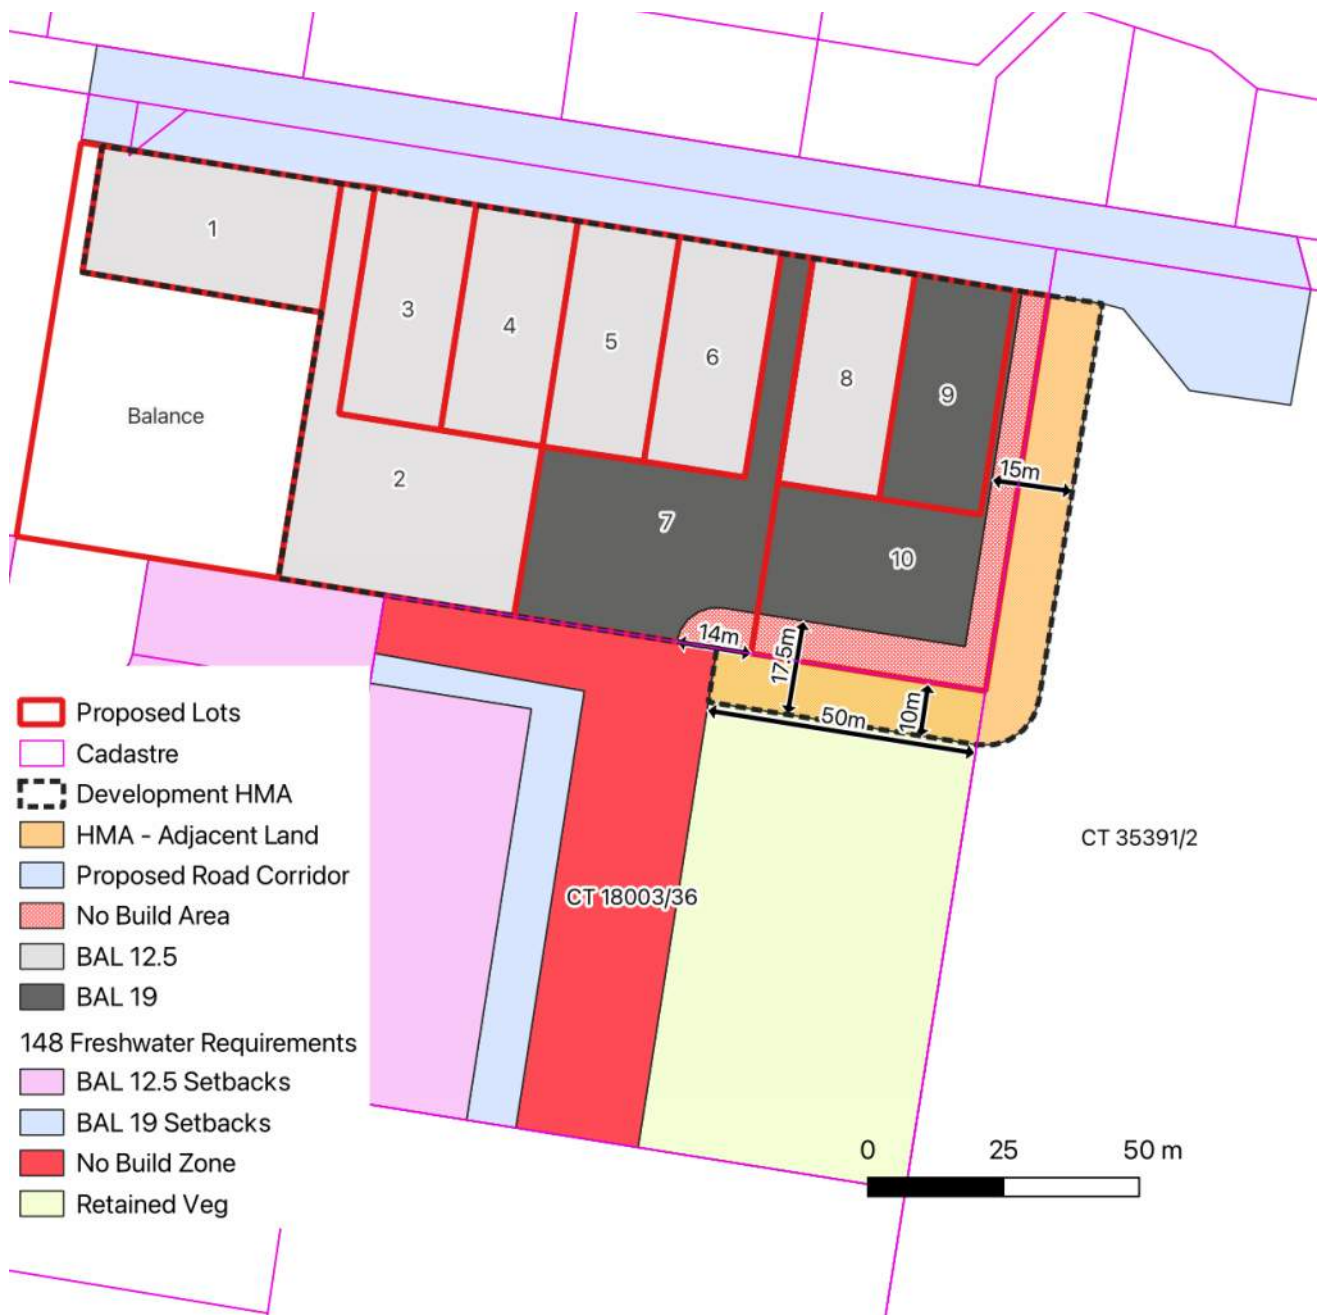
Figure 4-2: BAL 19 & BAL 12.5 construction areas

To the east is 176b Freshwater Point Rd (CT 35391/2). This title is 3.9ha in area and has an existing dwelling and associated gardens in the most south eastern corner. The balance of the title is covered in native vegetation, which, from a bushfire perspective, is classed as forest vegetation. A small section in the north western corner of this title is proposed to be included in the proposed development, to enable the construction of a cul-de-sac turning head. Furthermore, a 10m wide strip of land along this title's western boundary, that is shared with the subject site, is proposed to be managed in a low fuel state as part of the Hazard Management Area for the development on 176a Freshwater Point Rd (see Figure 4-2).

To the south are titles associated with a recent subdivision on 148 Freshwater Point Rd (see Figure A3-3, for the Bushfire Hazard Management Plan (BHMP) associated with this subdivision). There are two new titles that are directly adjacent to the southern boundary of the subject title. While neither of these titles have had dwellings constructed on them, it is a requirement of the BHMP that both are maintained in a low fuel state regardless. This is except for a 50m wide strip of land along the eastern boundary of the most eastern of the two titles, CT 18600/36. This 50m wide strip can be retained as forest vegetation. To assist with the Hazard Management Area on the subject title, a 10m wide strip of land (currently forest vegetation) along this title's northern boundary that is shared with the proposed Lot 10 and the most eastern 6.5m of Lot 5 on the subject site (50m total length) is proposed to be managed in a low fuel state (see Figure 4-2).

See Figure 4-2 for the strips of land to be managed. The adjacent landholders have entered into agreements for the these strips to be managed as per above. These agreements can be provided to Council and/or the TFS upon request.

The HMA requirements for each new lot are identified in Table 4-3. HMAs and associated BAL building areas are shown in Figure 4-2. Figure 4-2 also shows the identified BAL requirements for the recent subdivision to the south. As per the BHMP for this adjacent site, all land, except for the identified retained vegetation area, is required to be managed in a low fuel state (see Figure A3-3).

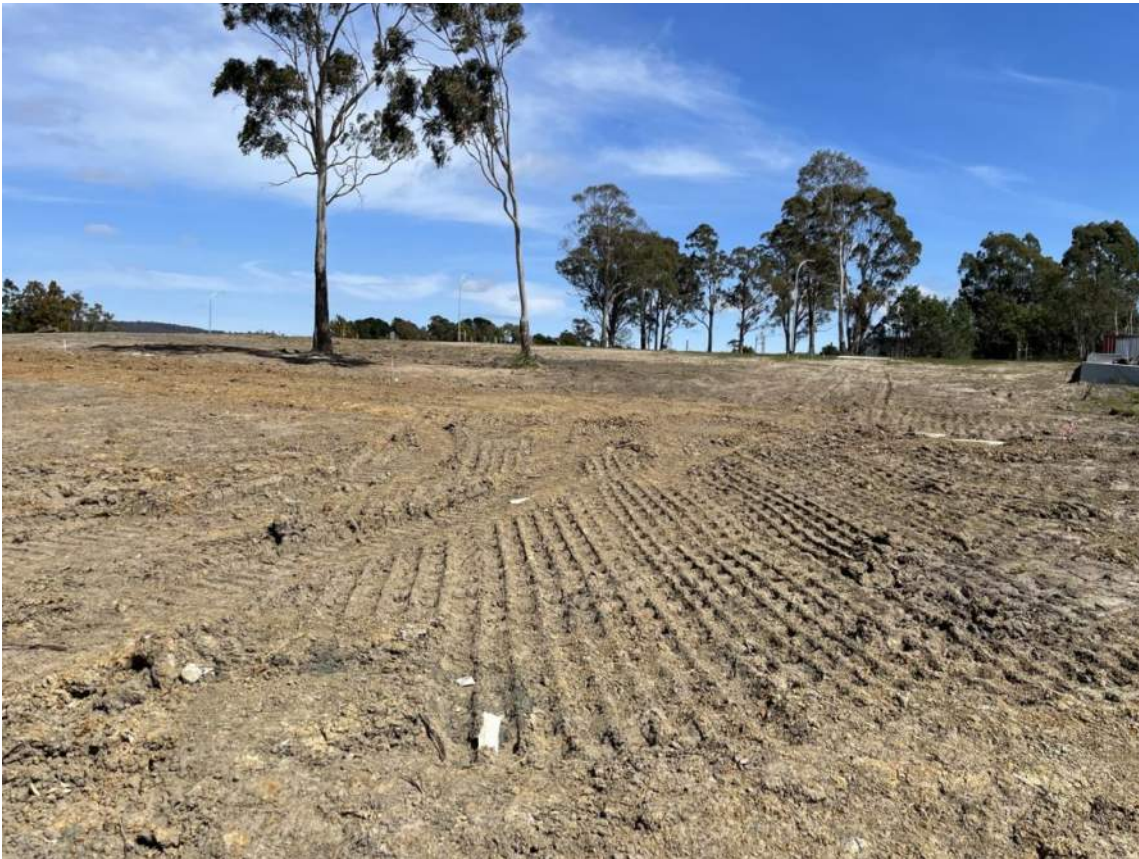
Figure A1-3: View south of land that has been cleared for development on 148 Freshwater Point Rd. This land must be managed as low threat vegetation

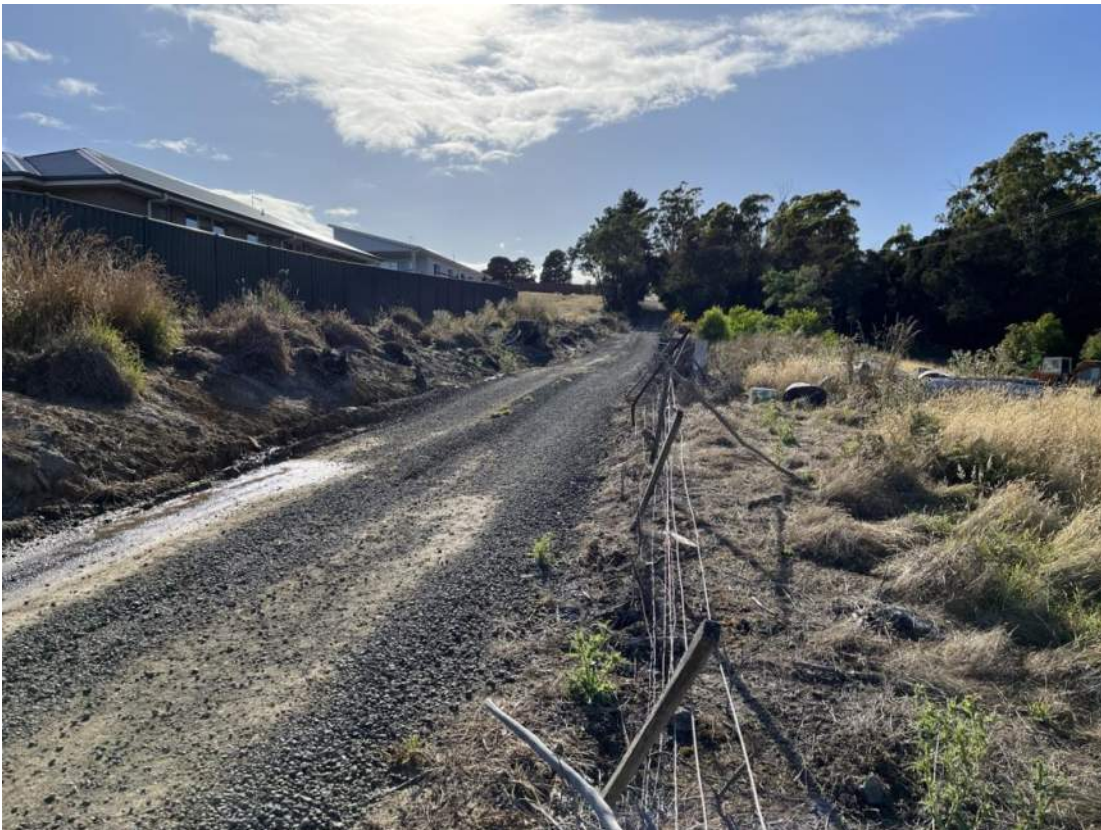
Figure A1-6: Existing access road that will be upgraded to comply with bushfire standards
