## PLANNING APPLICATION FORM

| Location / Address: | 11 Upper McEwan Road, Legana |

**BUSHFIRE HAZARD REPORT - Version 3**

**LANDSLIDE RISK ASSESSMENT  
PROPOSED SUBDIVISION  
11 UPPER MCEWANS ROAD, LEGANA**

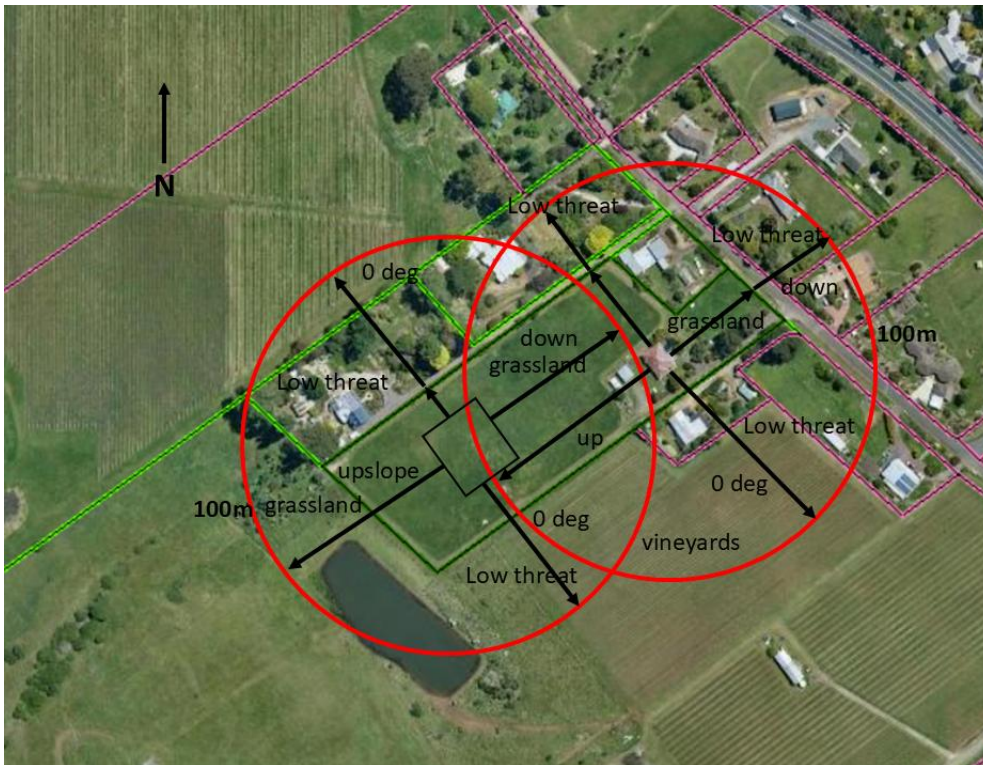
Image 4.1.7 – Site Analysis

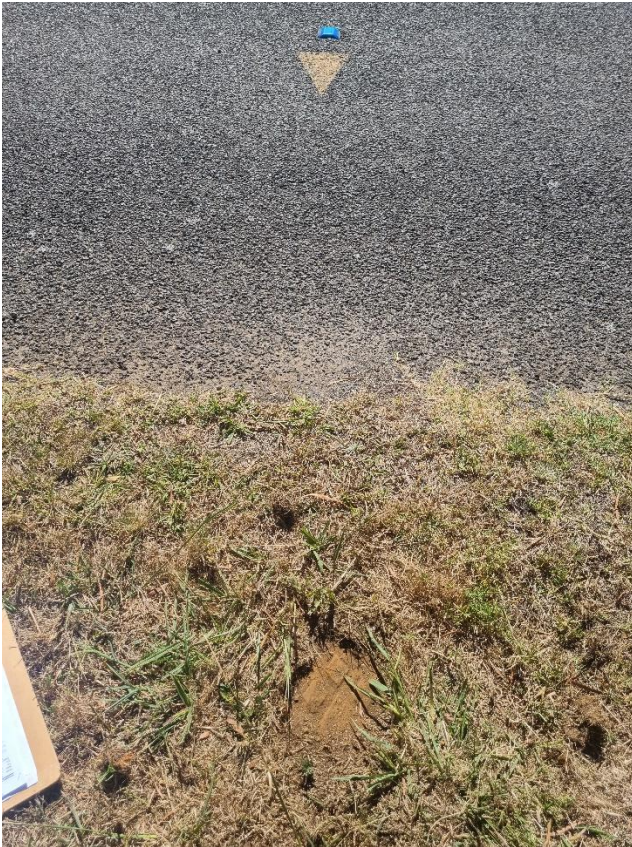
Image 5.1 – Hydrant located northwest on Upper McEwans Road

- The property has Tas water reticulated hydrants in the area located along Upper McEwans Road.
- The hose lay from the existing dwelling within lot 1 to the fire hydrant to the northwest of the property was measured at 110m.
- Reticulated water supply for firefighting purposes meets the requirements of Table C13.4 of Bushfire Prone Areas Code C13.

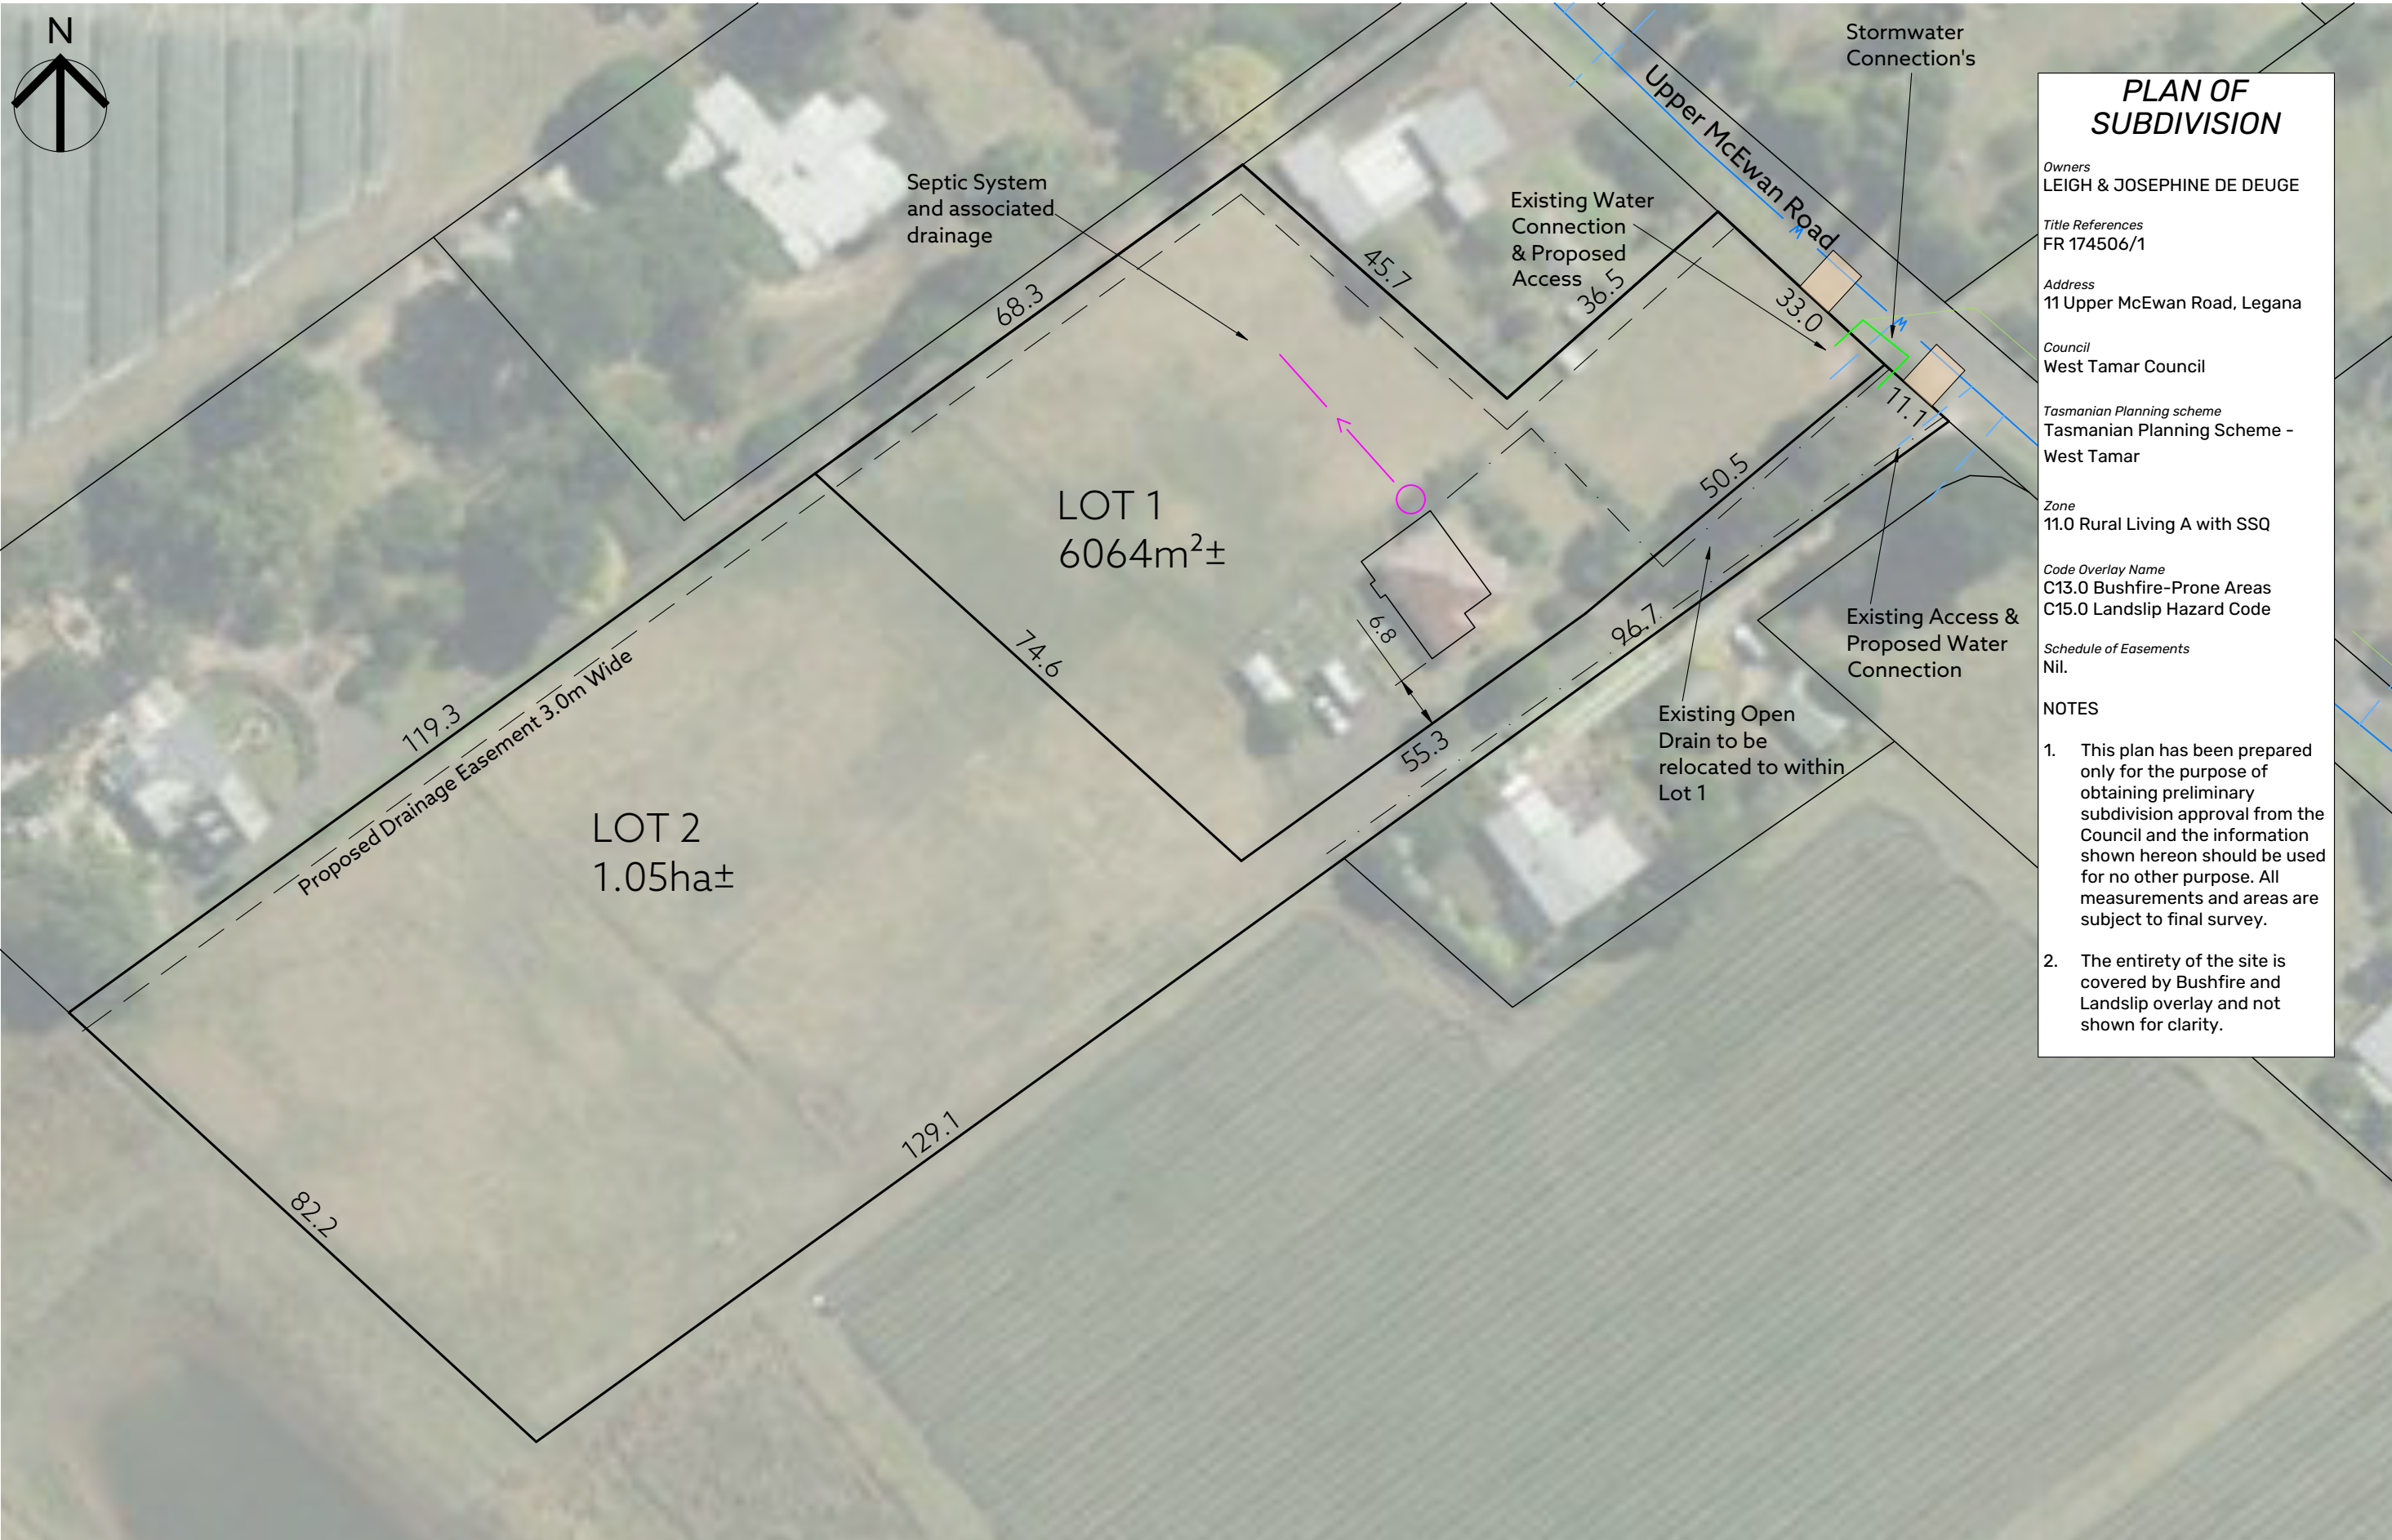
2. The entirety of the site is covered by Bushfire and Landslip overlay and not shown for clarity.

| E | | | | | NOTES: | SURVEYOR<br><b>N/A</b> | GEOCIVIL<br><b>N/A</b> | PLAN OF SUBDIVISION<br>11 Upper McEwan Road, Legana<br>FR 174506/1<br>Leigh & Josephine De Deuge | <br><b>PDA</b><br>SURVEYORS, ENGINEERS & PLANNERS | 3/23 Brisbane Street,<br>Launceston, Tasmania, 7250<br>PHONE: +61 03 6331 4099<br>EMAIL: pda.ltn@pda.com.au<br>www.pda.com.au<br>Also at: Hobart, Burnie,<br>Devonport, Swansea & Huonville | SCALE | PAPER |

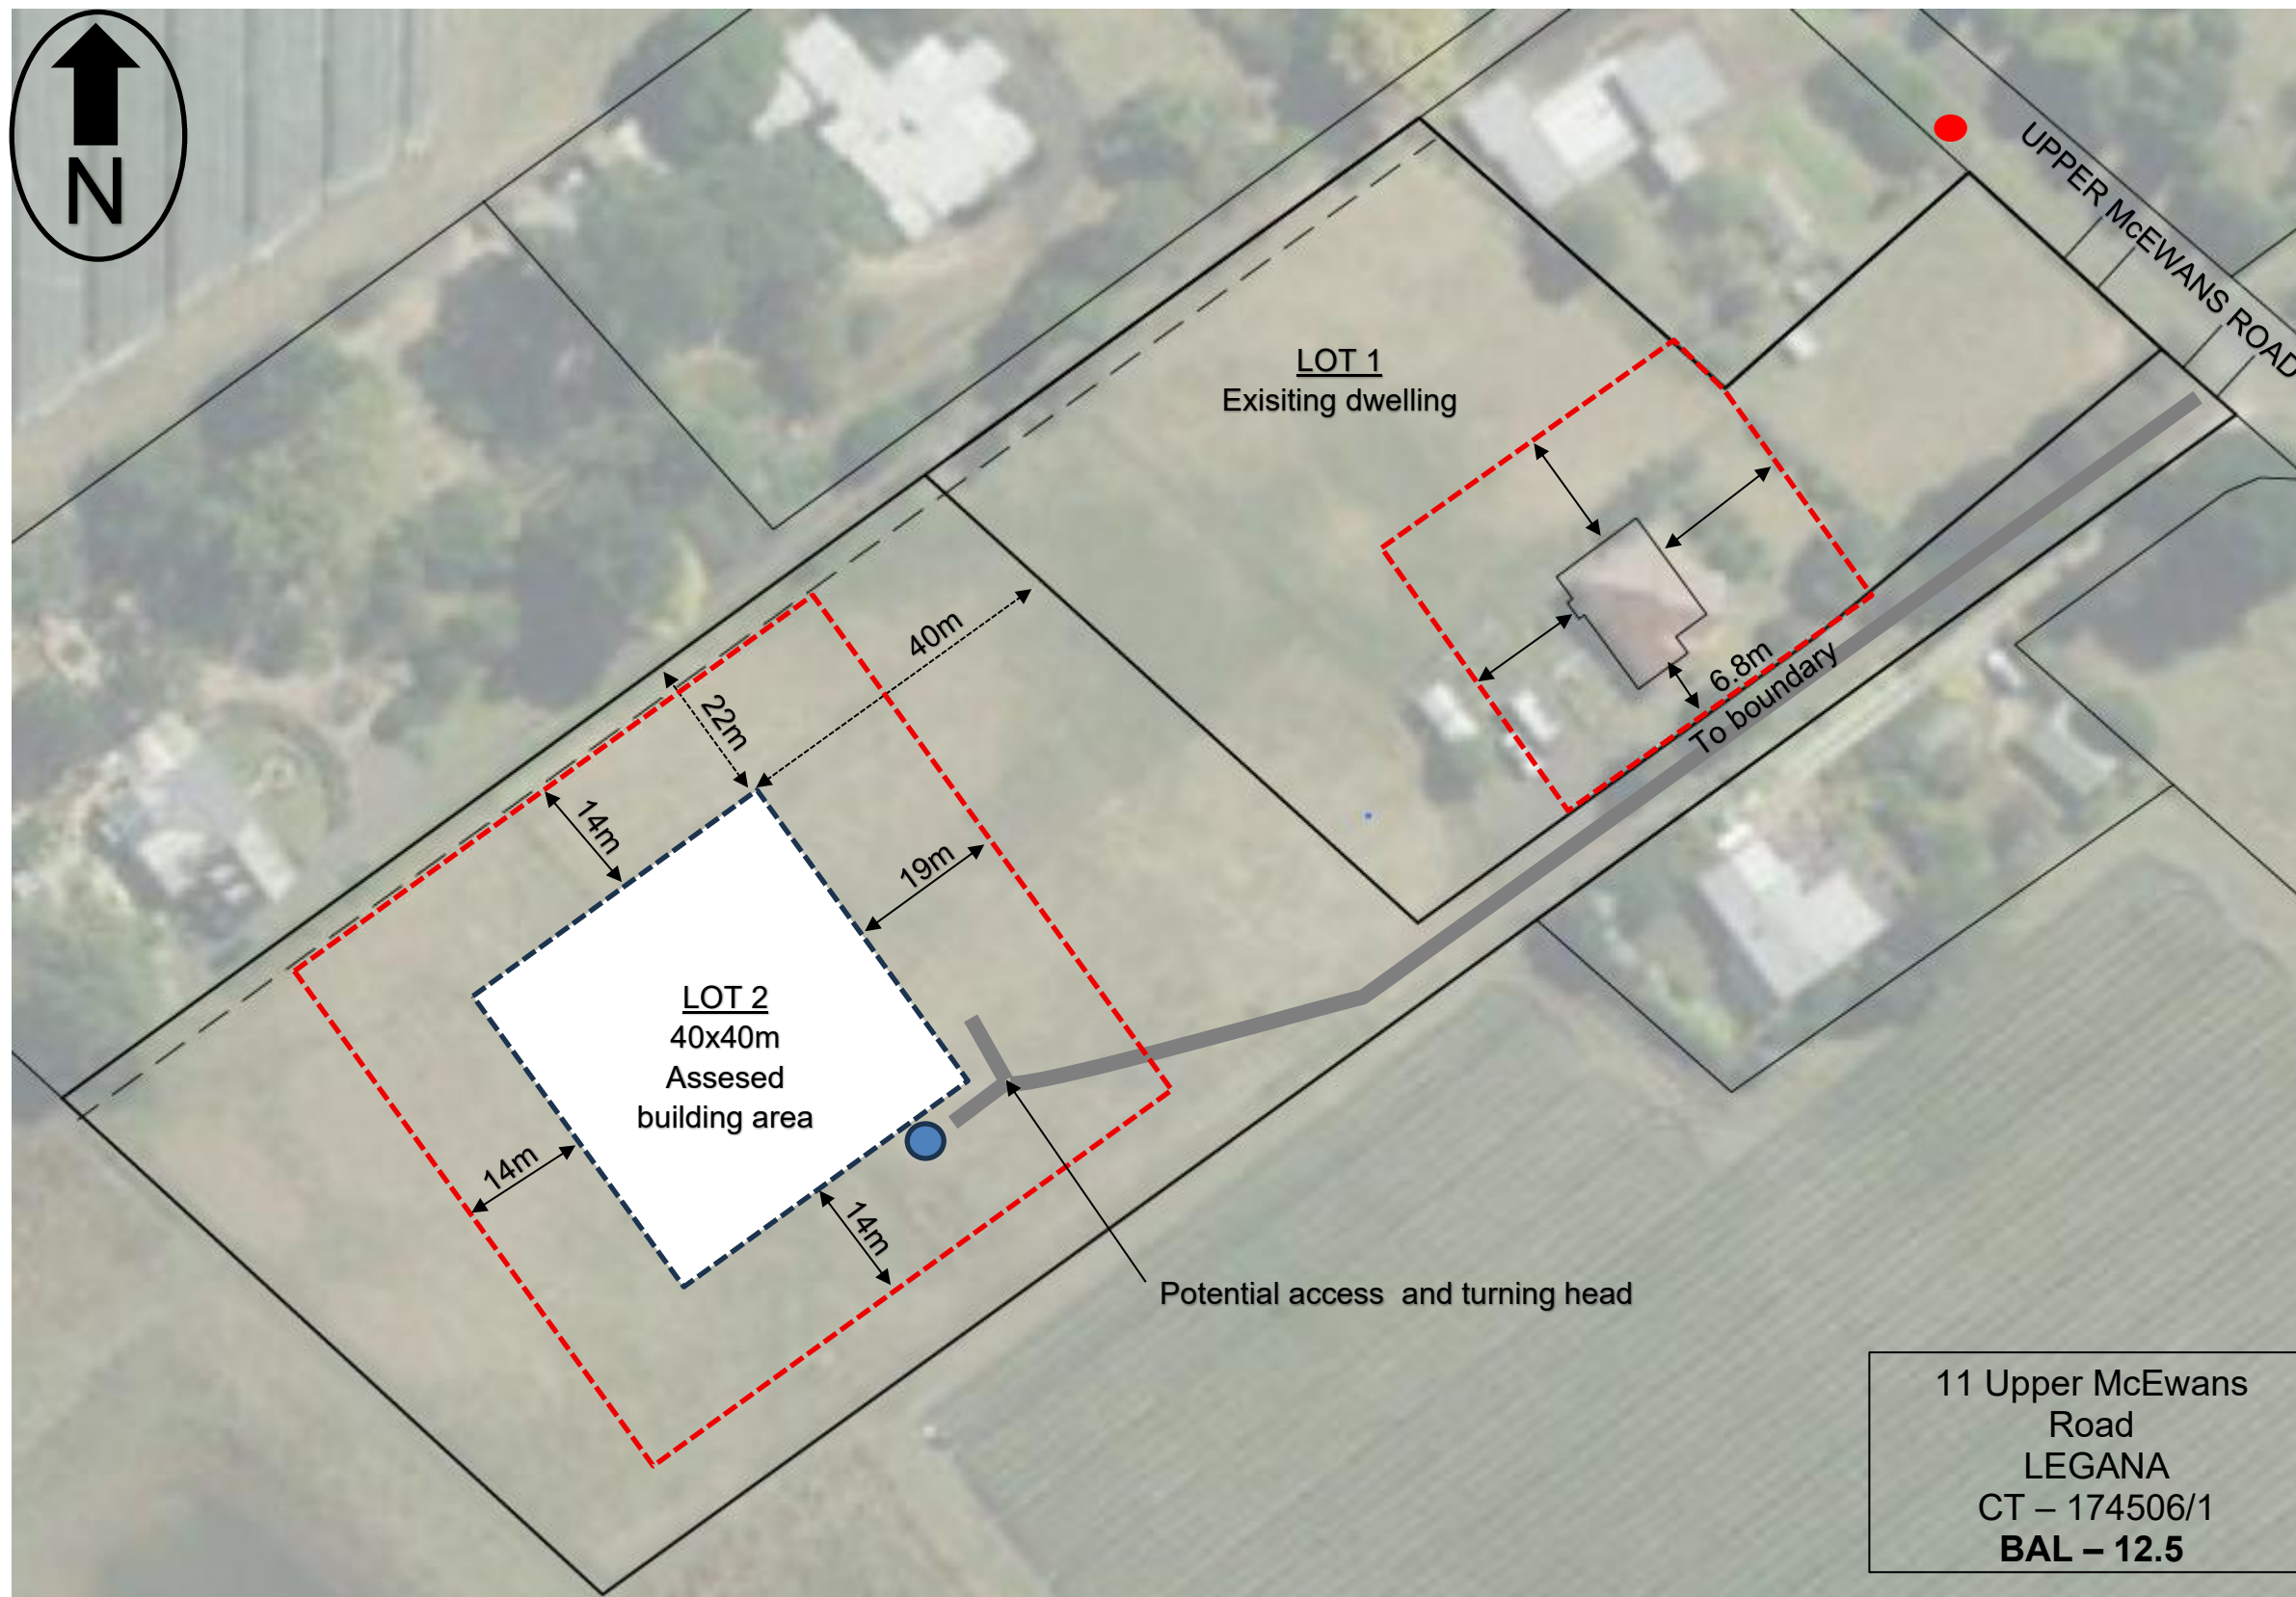
## Appendix B – Hazard Management Plan

- LEGEND**
- Hazard Management Area
  - Fire Hydrant
  - Static Water Supply

Lot 1 - A Hazard Management Area must be established and maintained as shown on the Hazard management plan drawing at appendix B to the building surveyor's satisfaction and maintained by the owner thereafter.

- If a future habitable building is constructed within the assessed building area within the lot a Hazard Management Area must be established and maintained as shown on the Hazard management plan drawing at appendix B to the building surveyor's satisfaction and maintained by the owner thereafter.

The 40m x 40m building area shown on the hazard management plan for Lot 2 is for assessment purposes only.

A bushfire hazard management plan is required and attached as appendix B. This Bushfire Hazard Report must be read in conjunction with the bushfire hazard management plan.

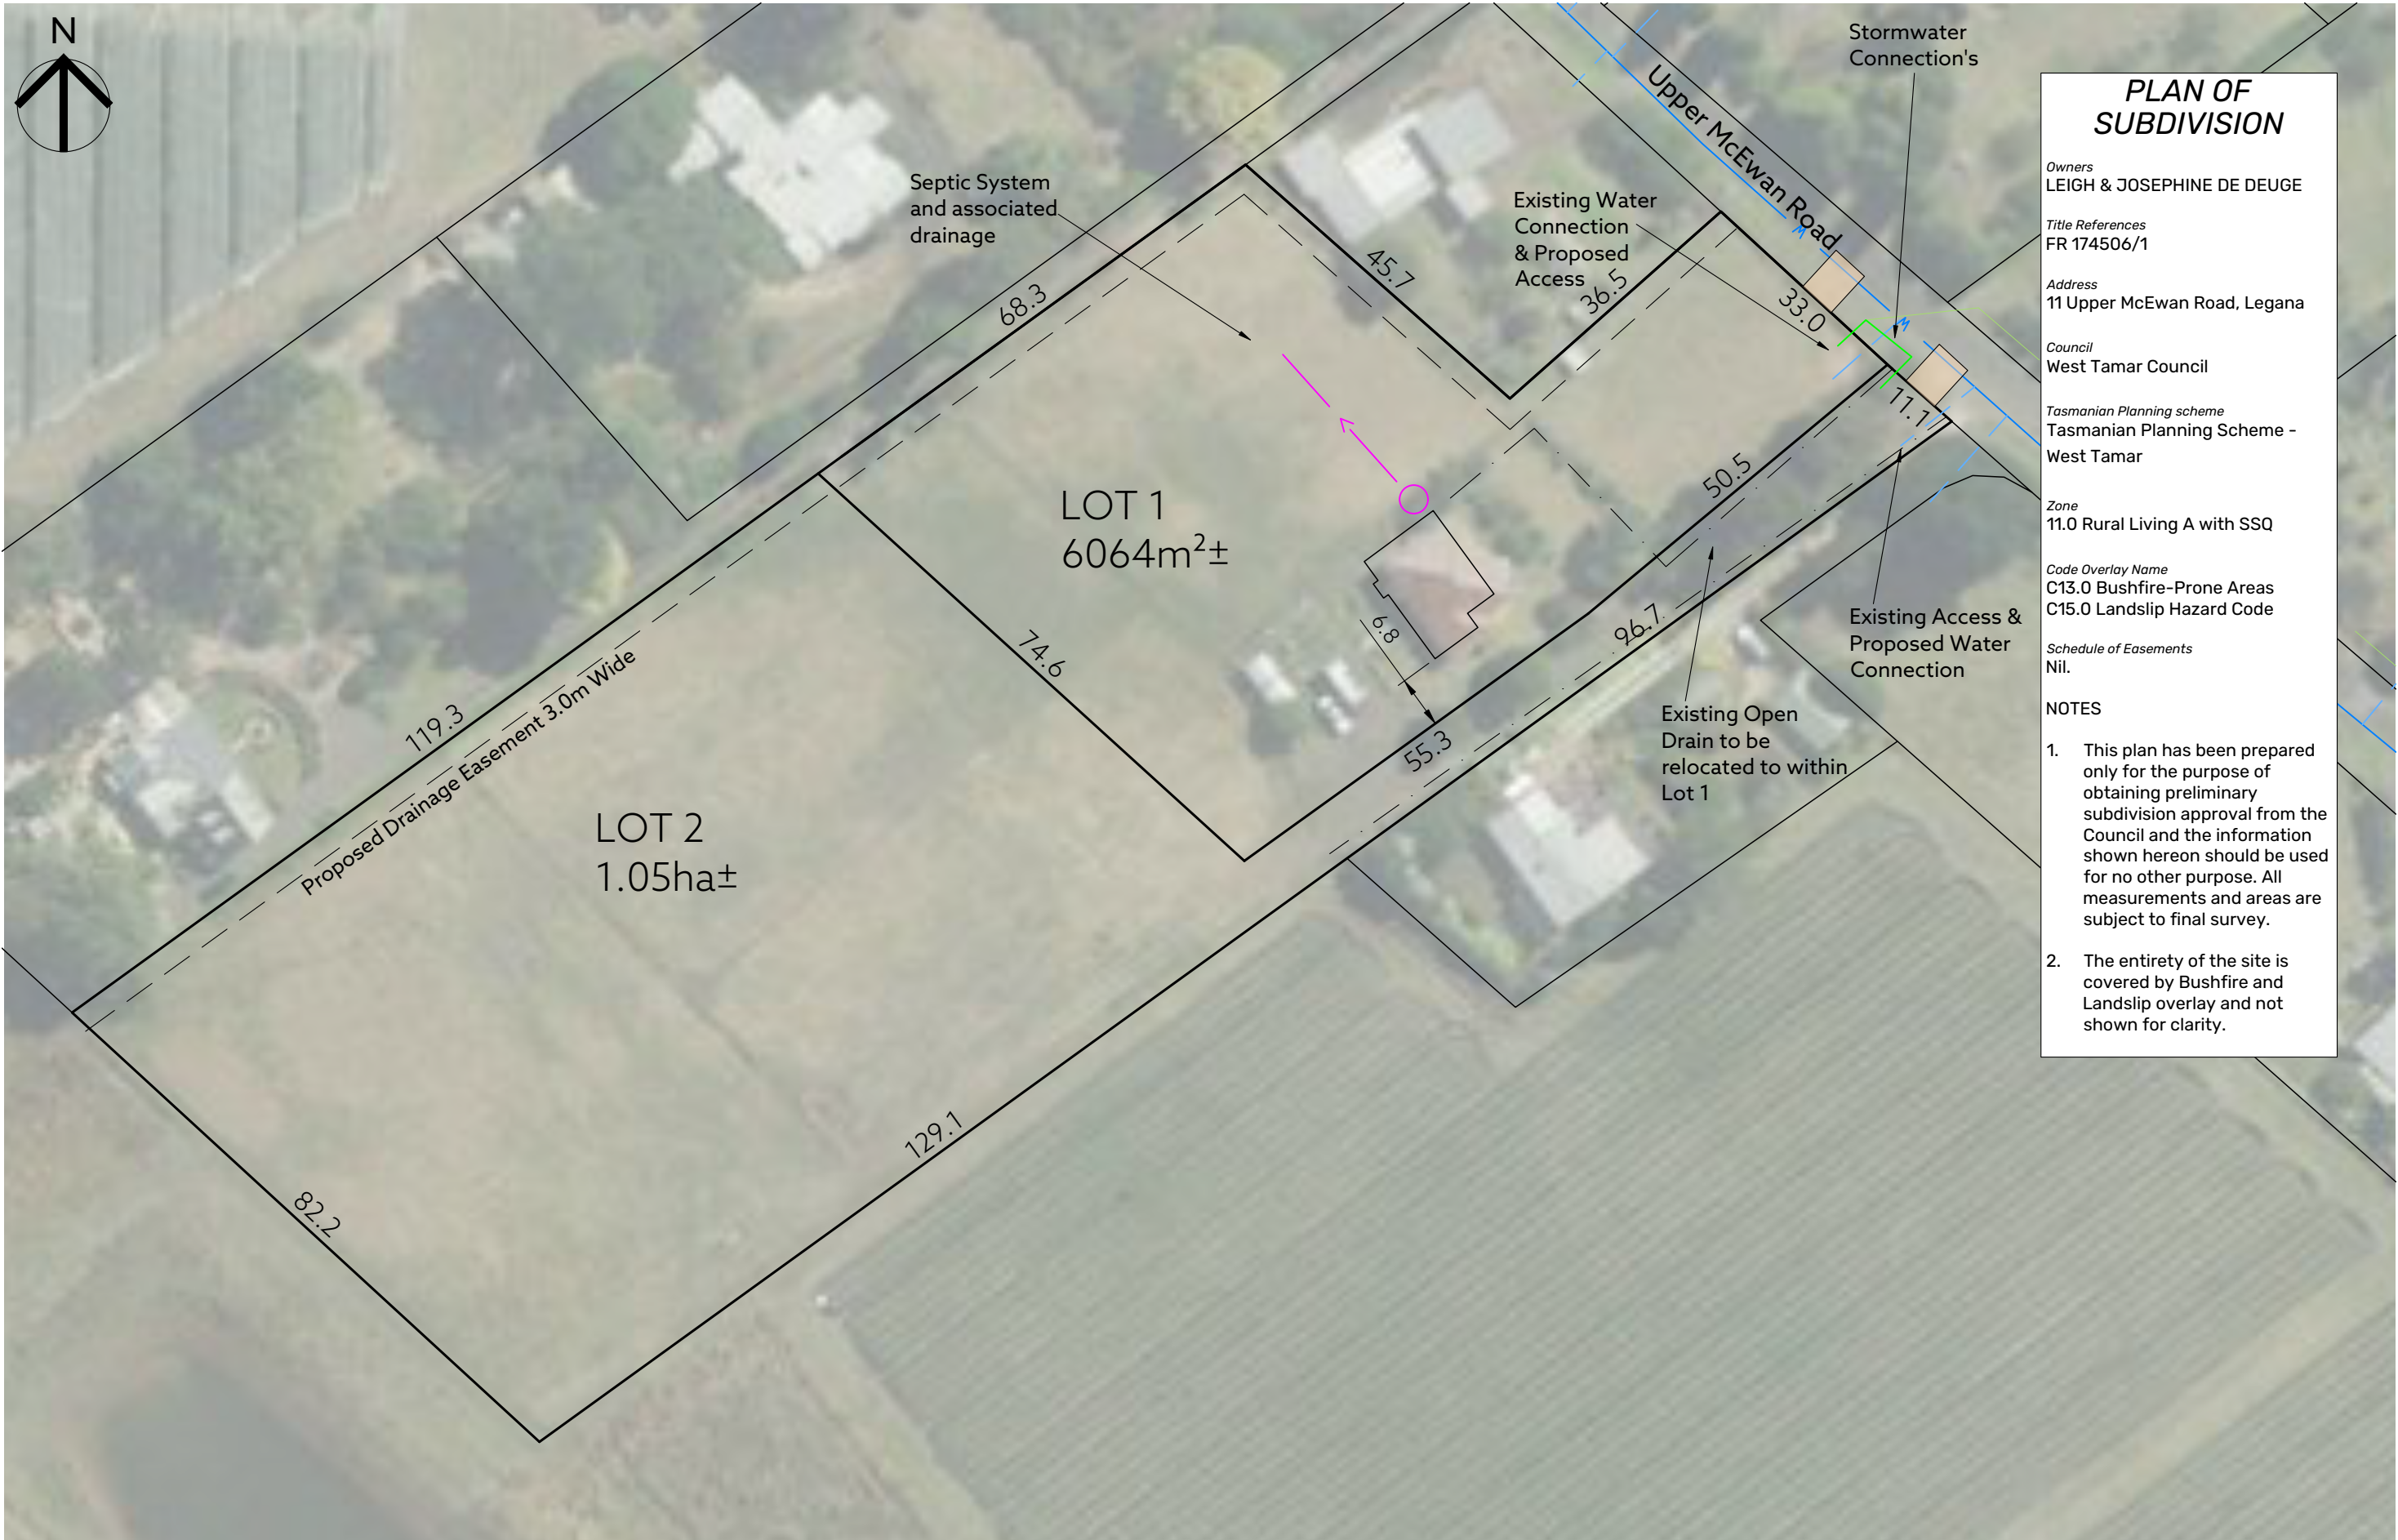
### PLAN OF SUBDIVISION

*Owners*  
LEIGH & JOSEPHINE DE DEUGE

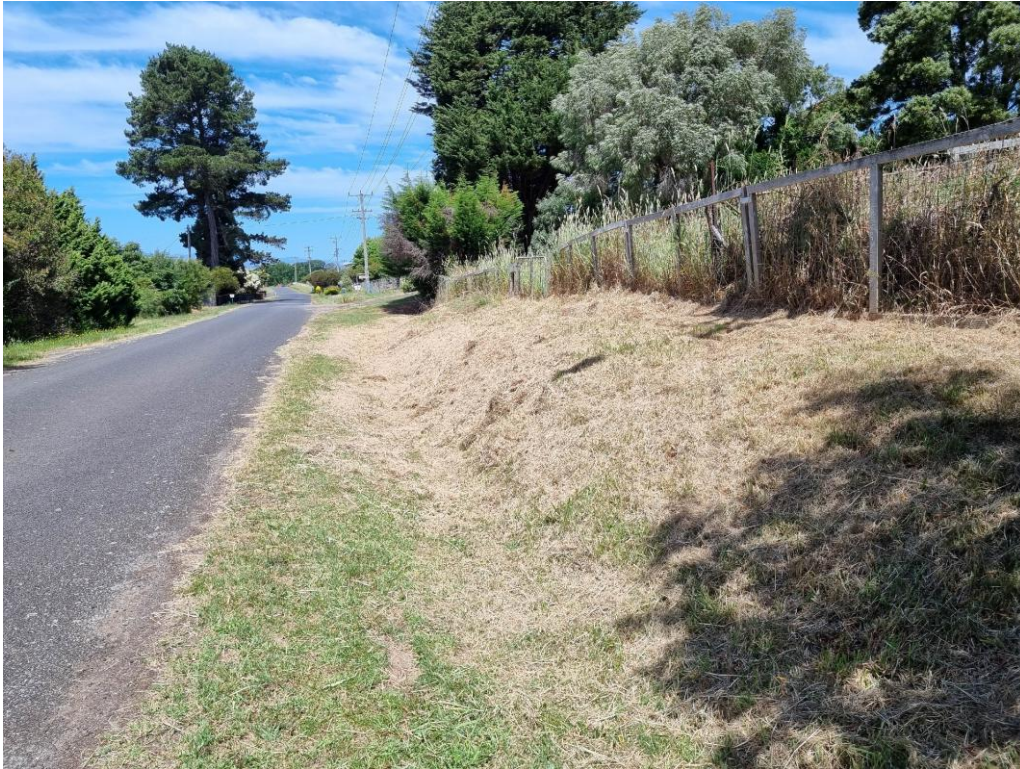
Photo 3. Cut slope up to ~0.7m high on between Upper McEwans Road and northeastern boundary of site, looking southeast.

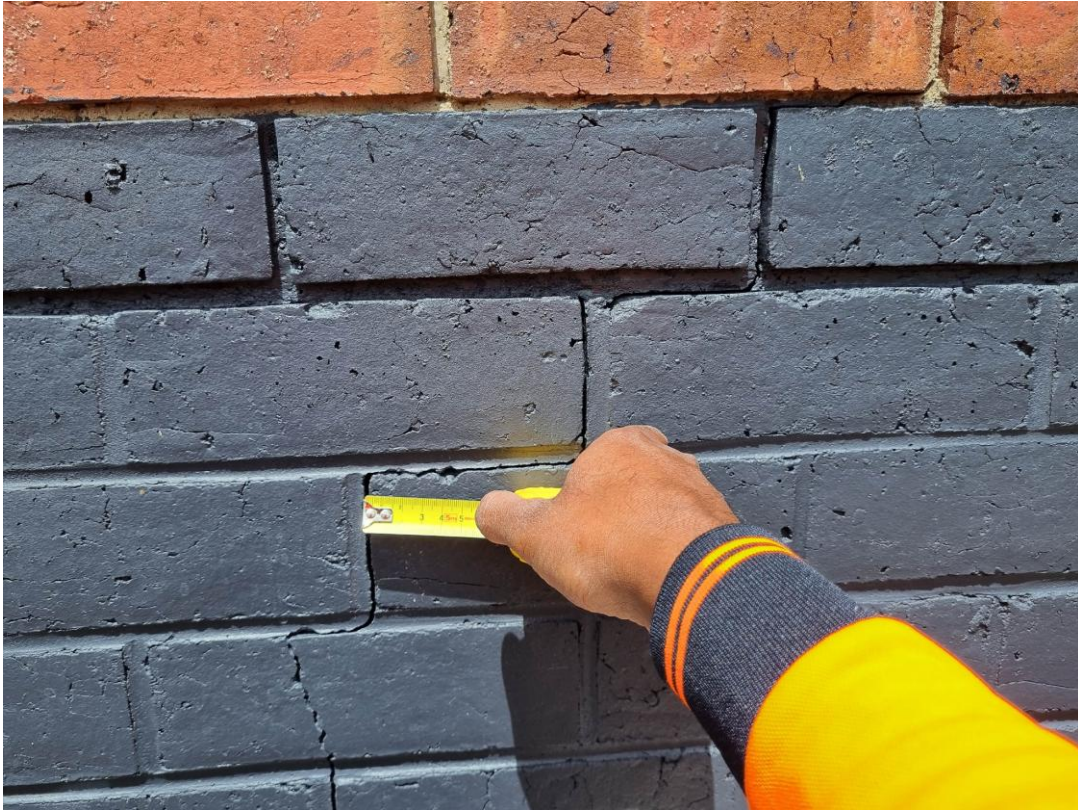
Photo 7. Cracked brickwork in north-western wall of existing dwelling.

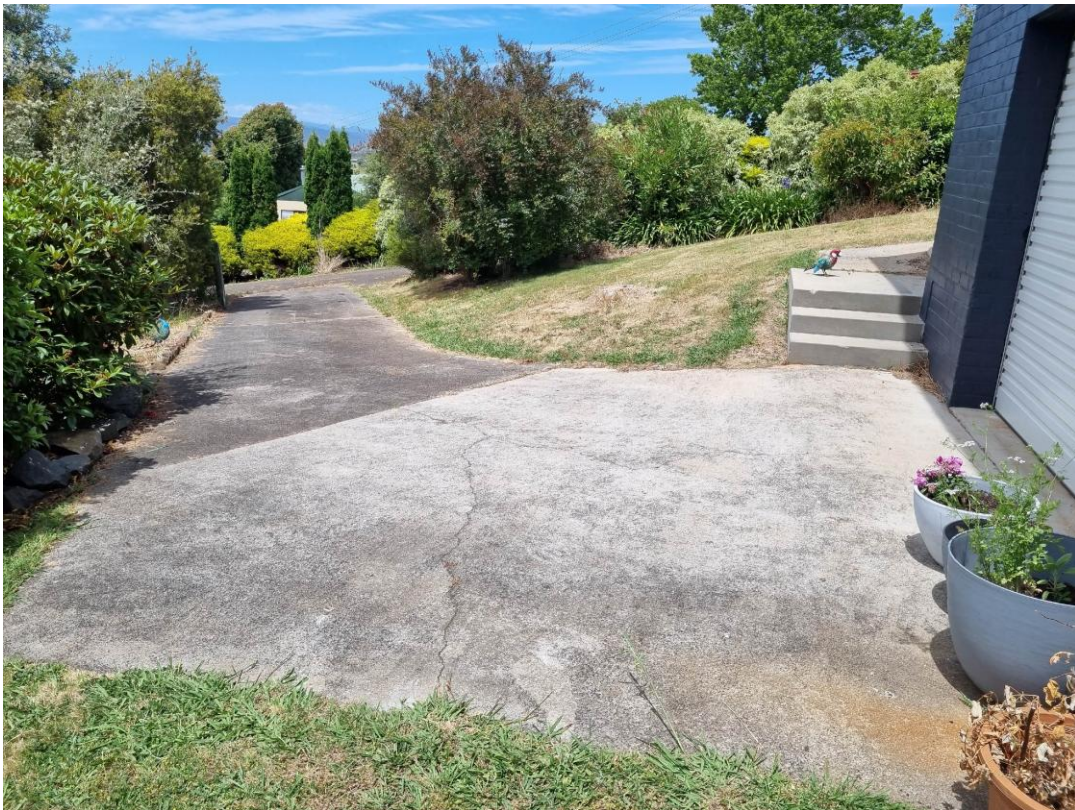
Photo 8. Cracking in existing concrete driveway, looking southeast.

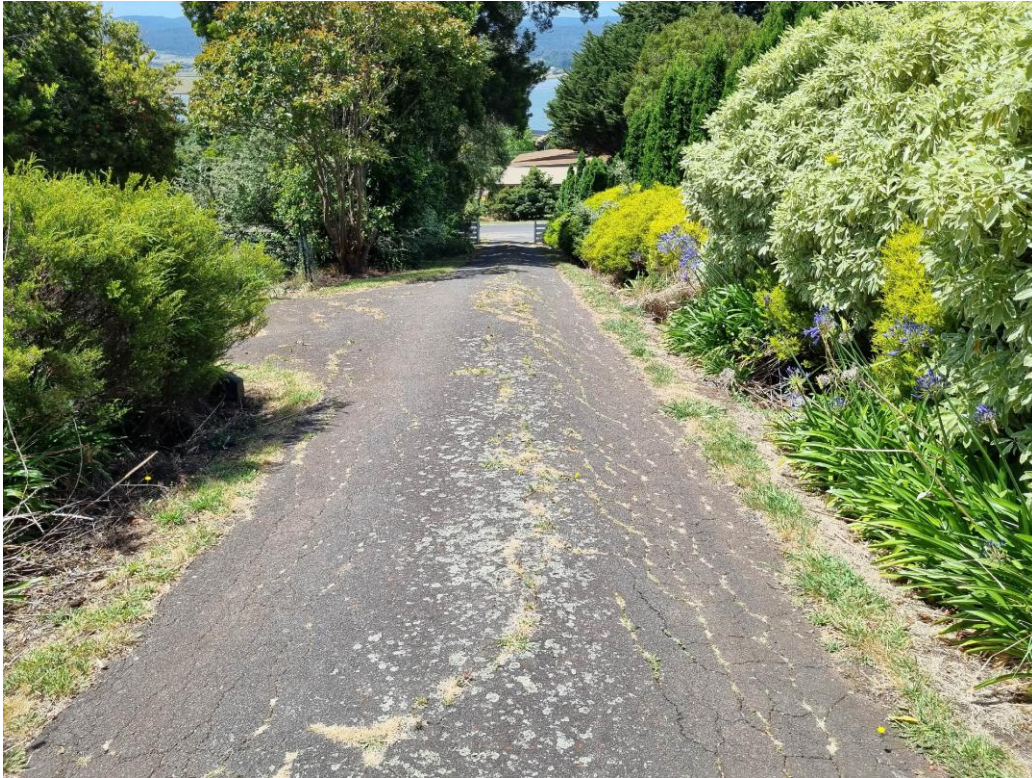
Photo 9. Cracking in existing asphalt driveway, looking northeast.

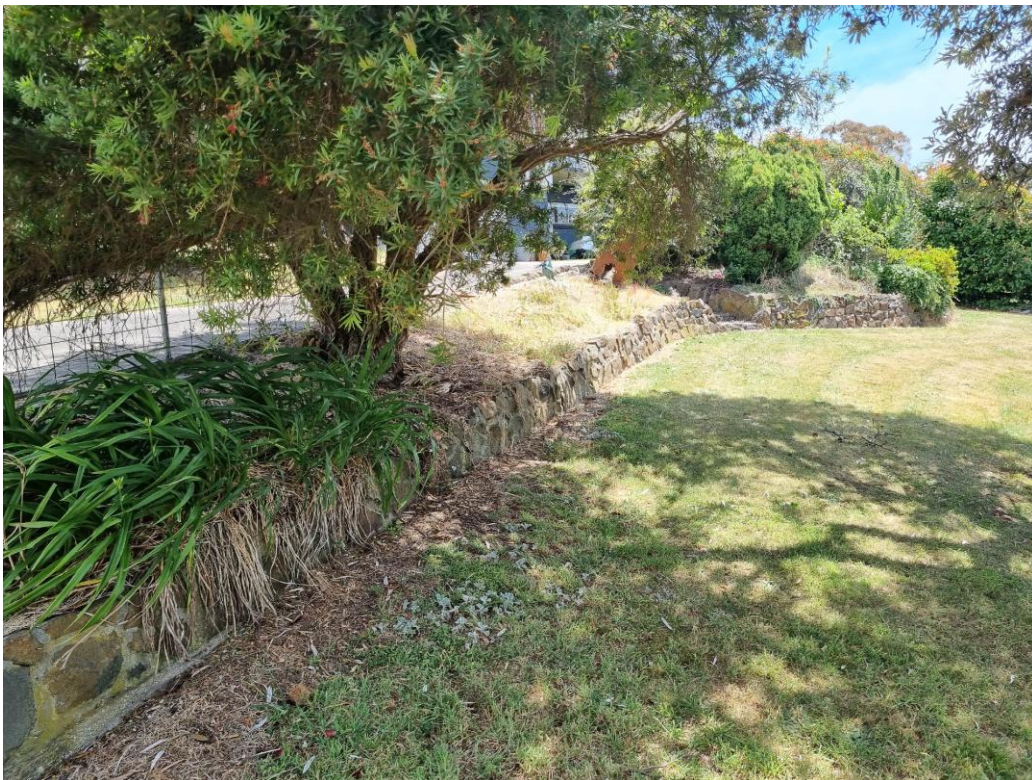
Photo 10. Cobble/boulder and concrete landscape retaining wall in front yard of existing dwelling, looking northwest.

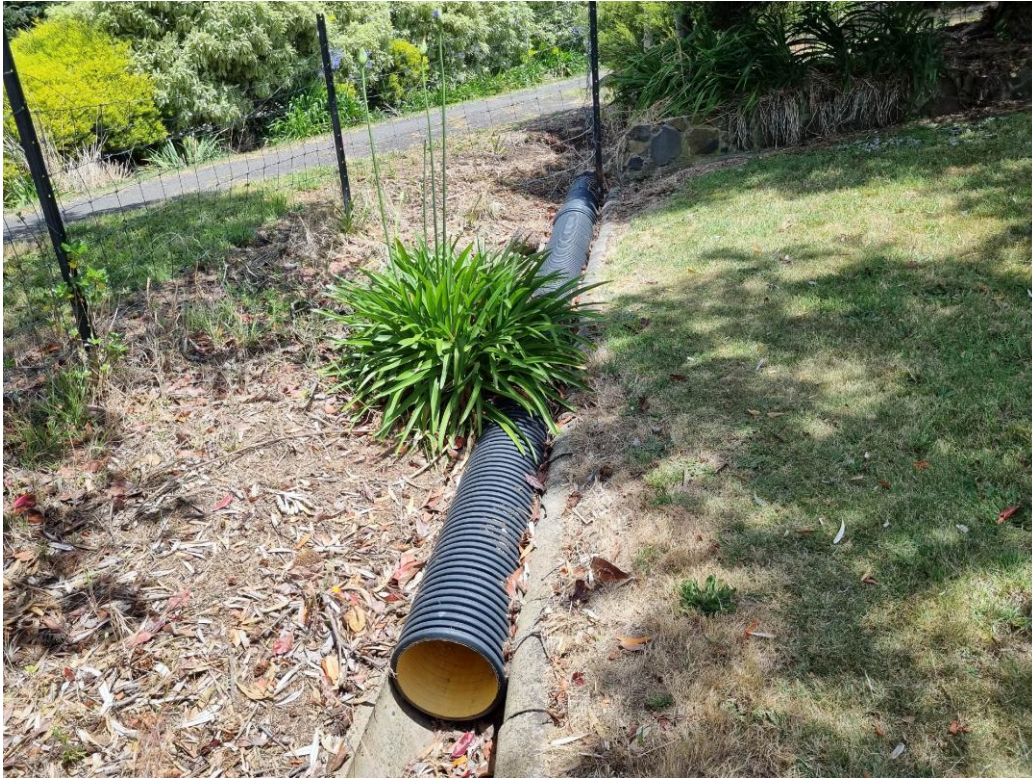
Photo 11. Culvert under existing driveway and concrete spoon drain, looking southwest.

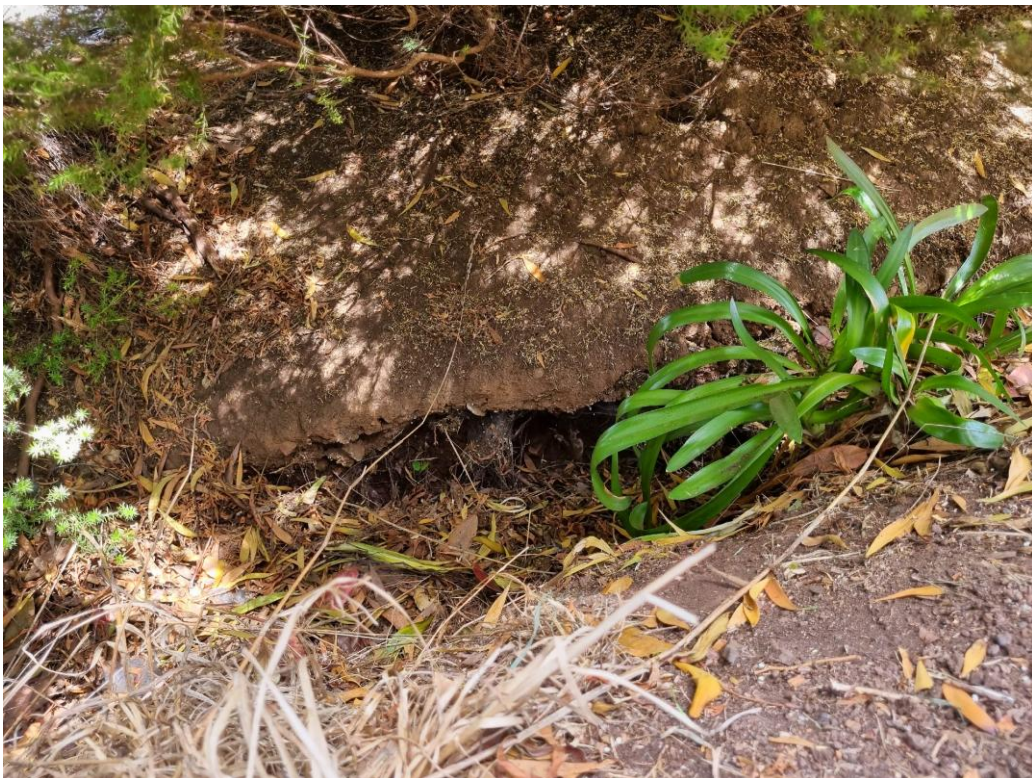
Photo 12. Erosion in unlined table drain on southern side of existing driveway.

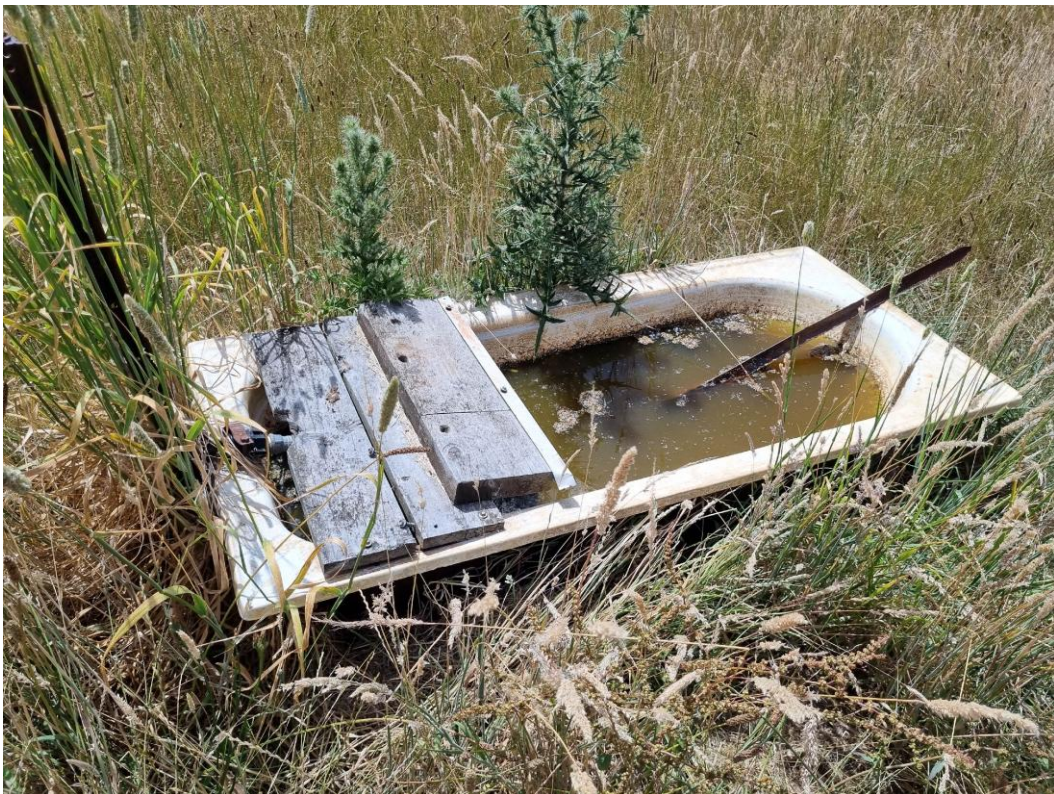
Photo 17. Water trough at proposed Lot 2 connected to underground 25mm diameter polypipe.

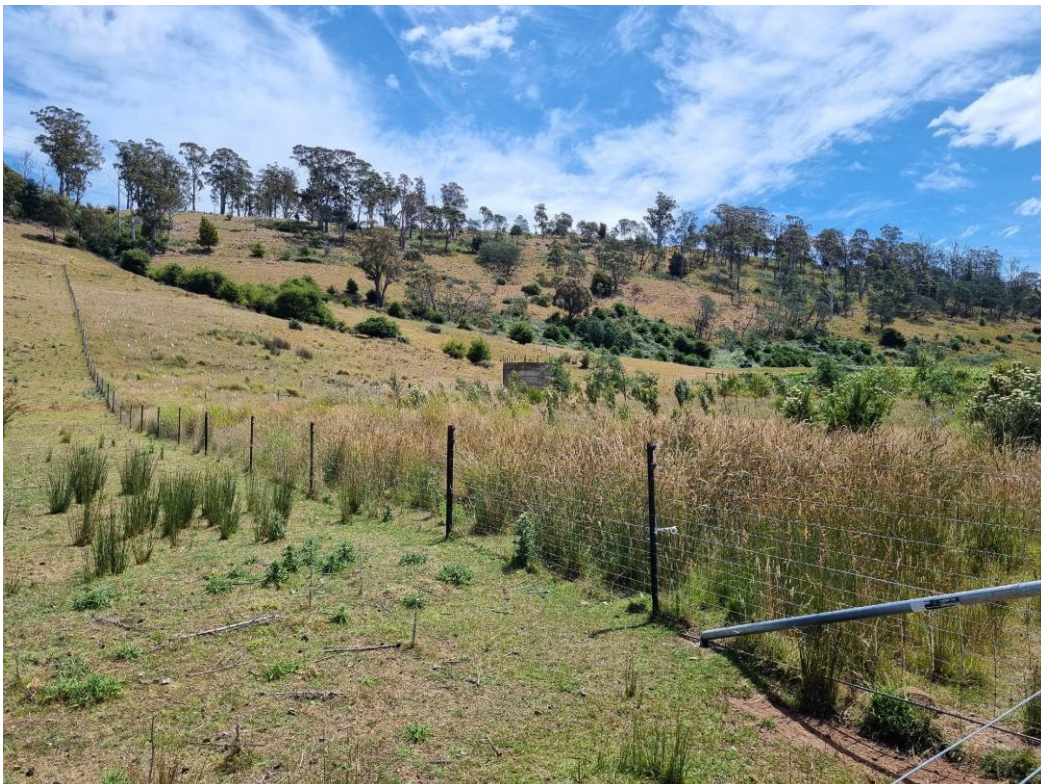
Photo 19. Natural drainage line on 5 Upper McEwans Road, to west of proposed Lot 2, looking west. Note water-loving reeds growing on flatter area and young trees recently planted on steeper hillslope.

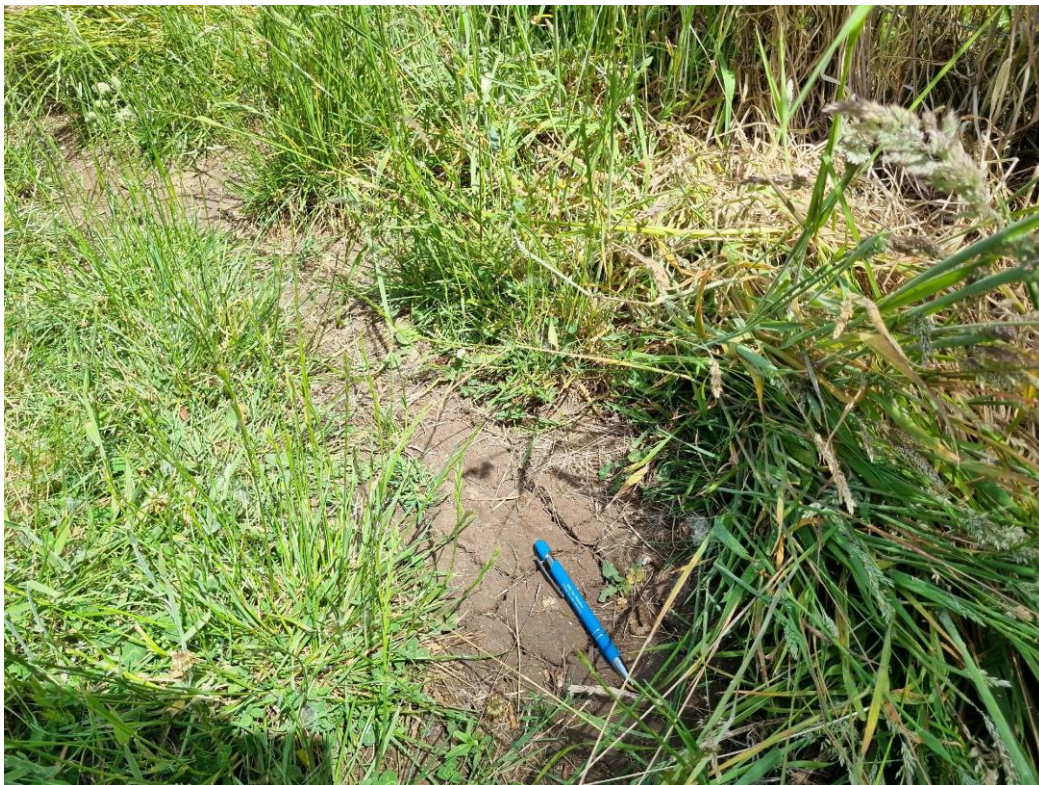
Photo 20. Desiccation cracking in surface soils on proposed Lot 2.

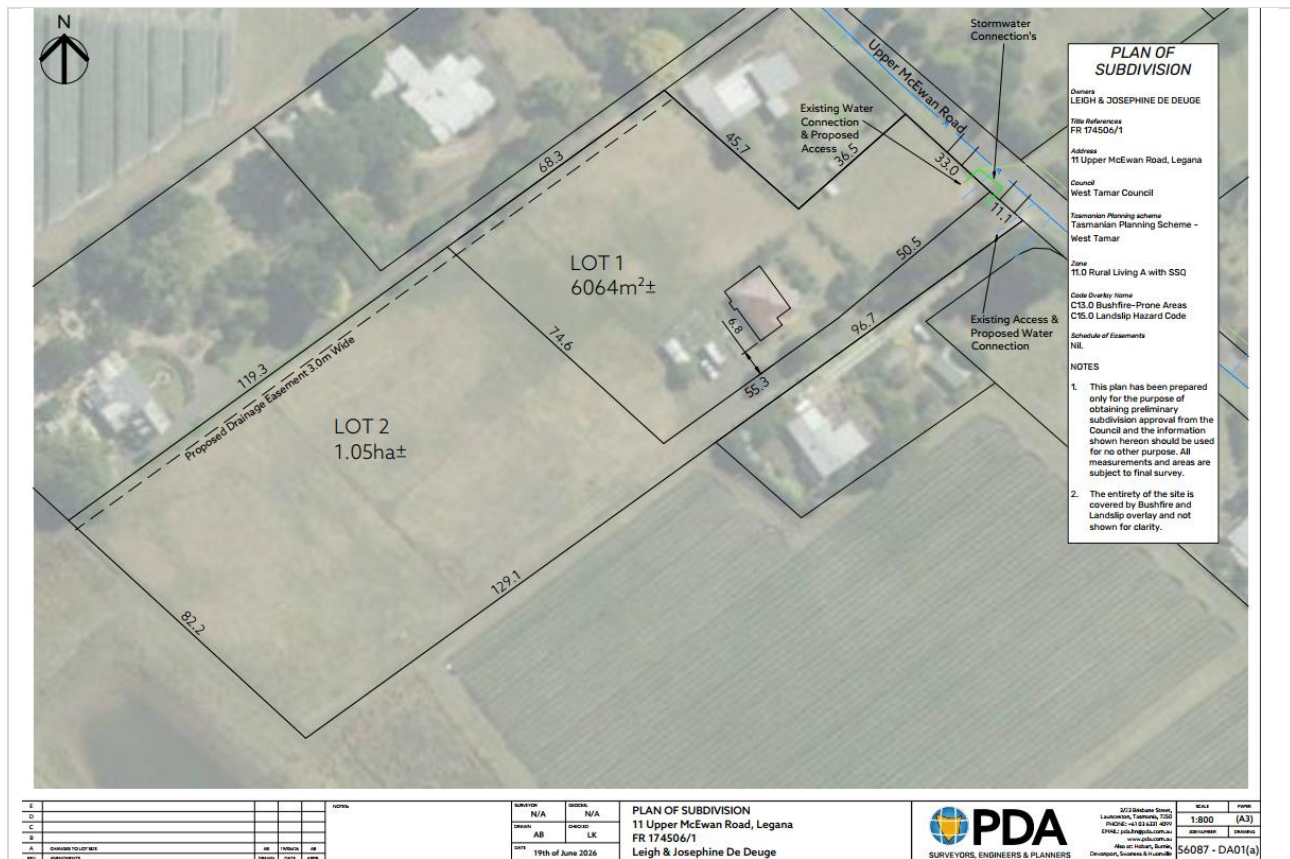
Figure 2 – Proposal Overview 11 Upper Mcewans Road, Legana

The purpose of this proposal is to create a 2 Lot subdivision. Lot 1 will retain the existing dwelling and utilise existing water connection but require new driveway. Lot 2 will retain the existing access but require new water connection. The arrangements will likely alter the stormwater and new arrangement's will be required for both.
