## PLANNING APPLICATION FORM

| Location / Address: | 11 Upper McEwan Road, Legana |

**BUSHFIRE HAZARD REPORT - Version 3**

**LANDSLIDE RISK ASSESSMENT  
PROPOSED SUBDIVISION  
11 UPPER MCEWANS ROAD, LEGANA**

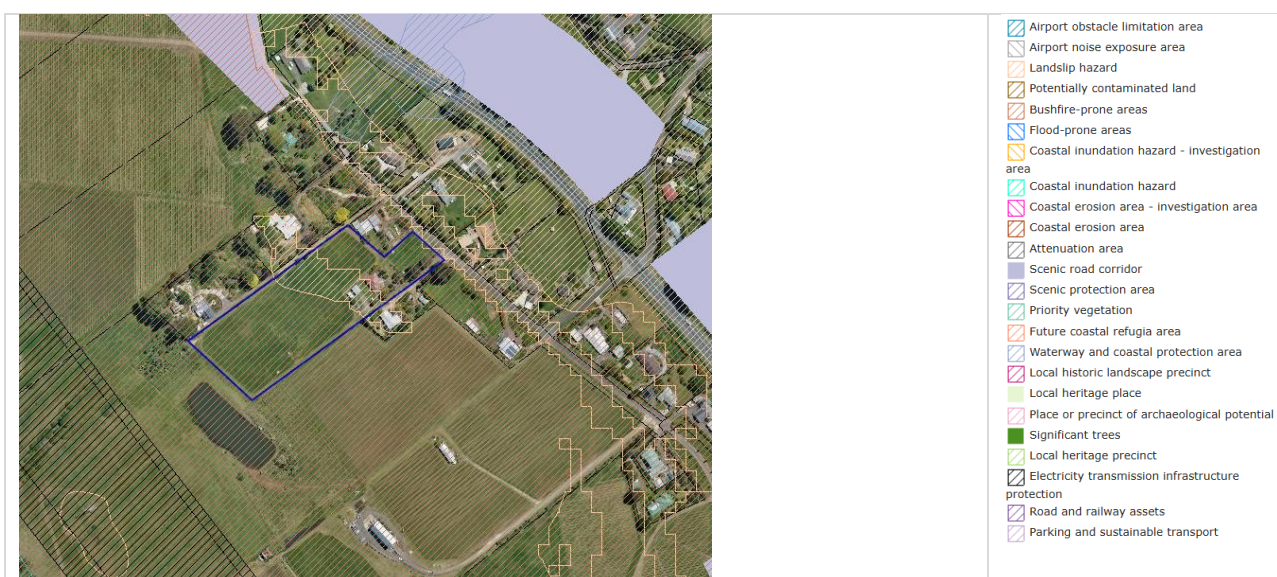
Figure 4 – Planning Scheme Overlays, 11 Upper Mcewans Road, Legana – source: [www.thelist.tas.gov.au](http://www.thelist.tas.gov.au)

Overlays featured in Figure 4 above are discussed in greater detail in the Codes section of this report.
